Sanborn Regional School District

Facilities Study

Capital Improvement Projects 2018-2022

Marinace Architects

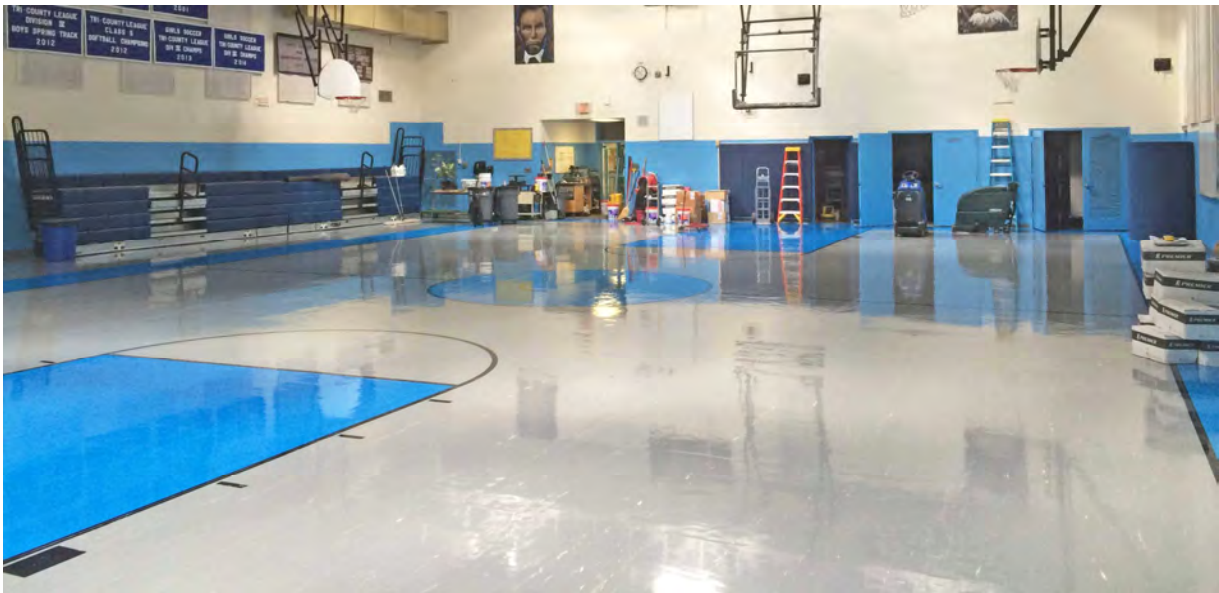
- Gym Floor: Vinyl floor is old and difficult to maintain. Replace the vinyl gym floor with a new sports floor with inlaid lines.

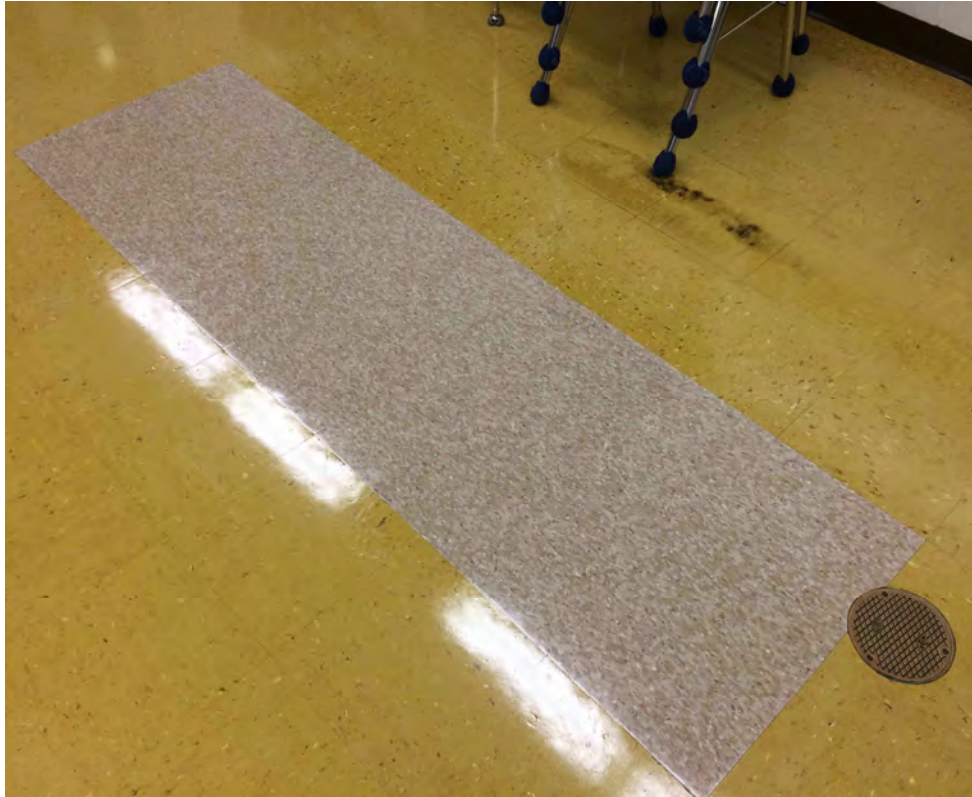
- The VCT flooring throughout Areas A & B is old and has been patched many times over the years. This flooring should be replaced with new VCT. It is reported that there are some asbestos-containing materials in this flooring, which will have to be dealt with. We have budgeted for this work in the cost estimate.

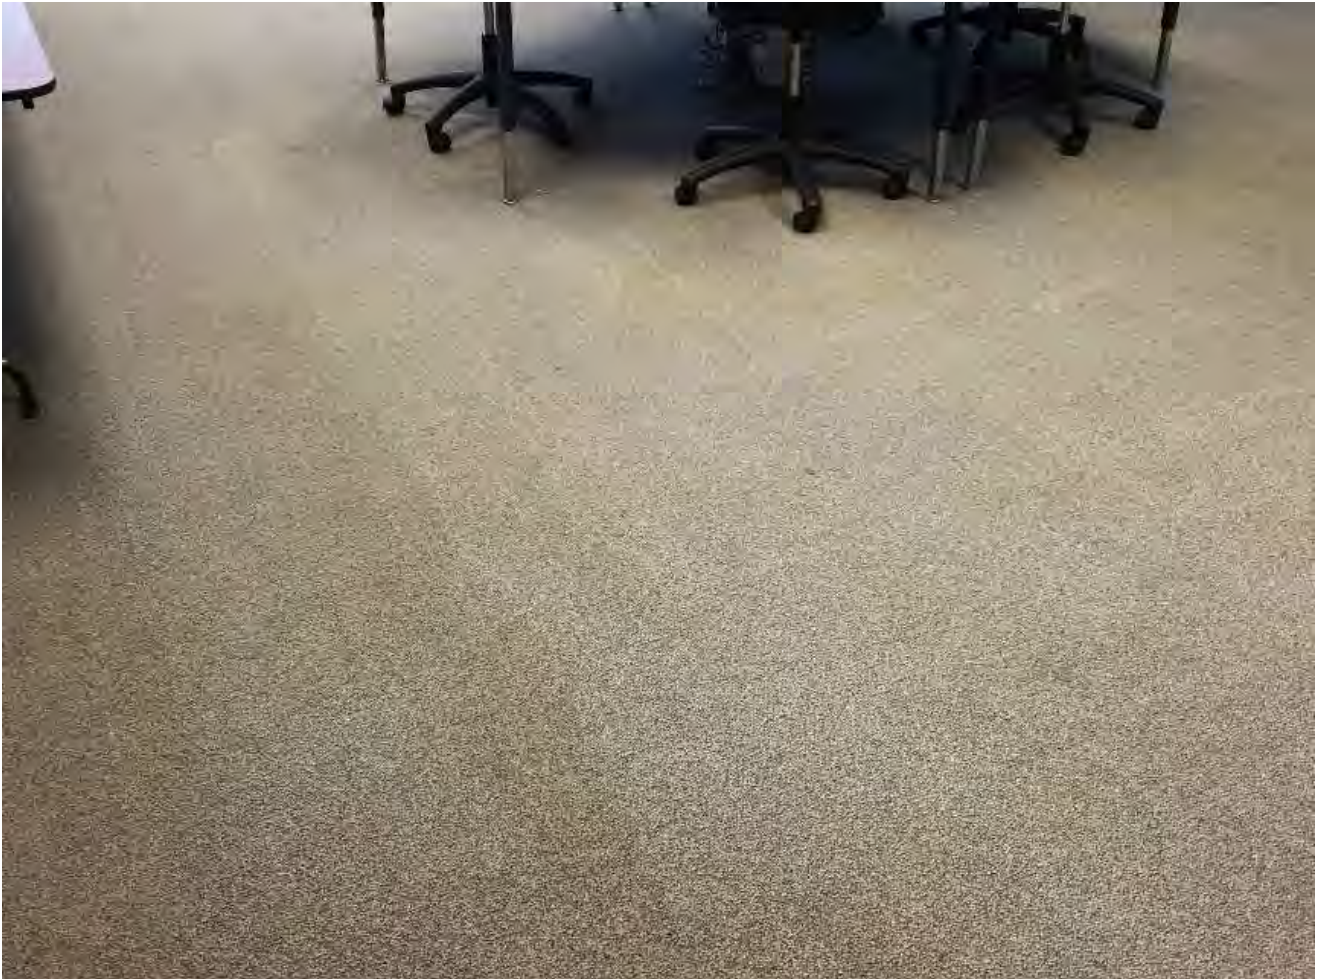
- The carpet in the offices and conference room is worn. Replace carpet.

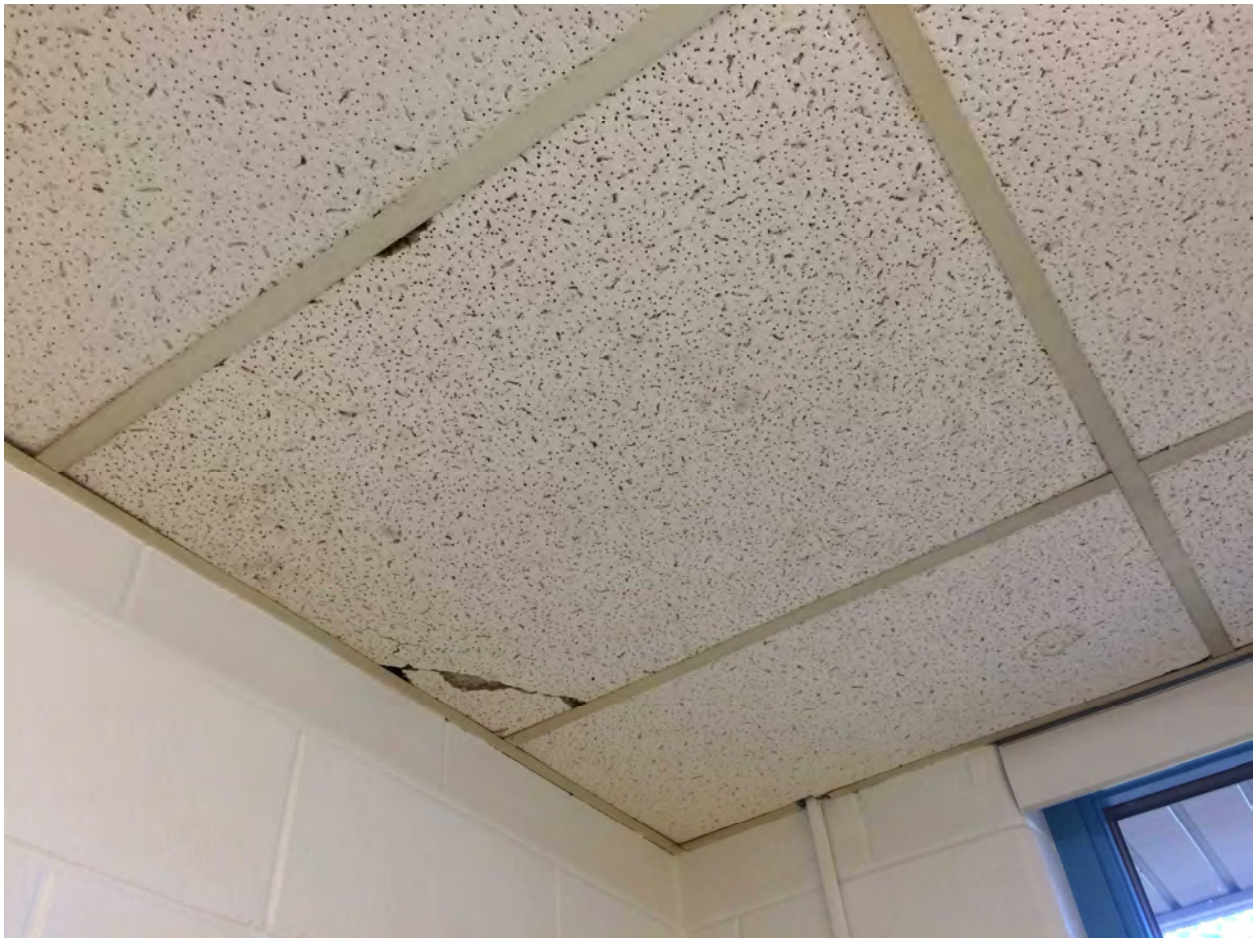
- The ceilings in Areas A & B are in poor condition and should be replaced. There is fiberglass batt insulation laying on top of the ceiling which will need to be removed as it is no longer considered a viable or safe insulation for schools. Since this is the only insulation in the roof assembly and the roofing itself is not scheduled to be replaced any time soon, we will need to add 3" of spray urethane insulation to the underside of the roof deck. We will then install a new suspended ceiling system and new LED lighting, with pendant lights in the classrooms.

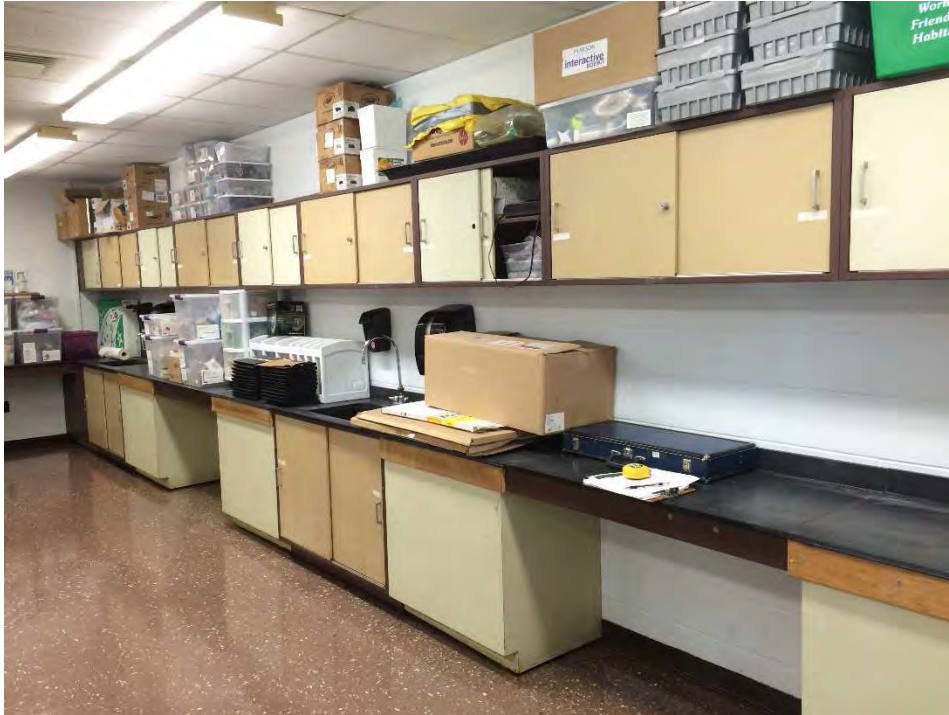
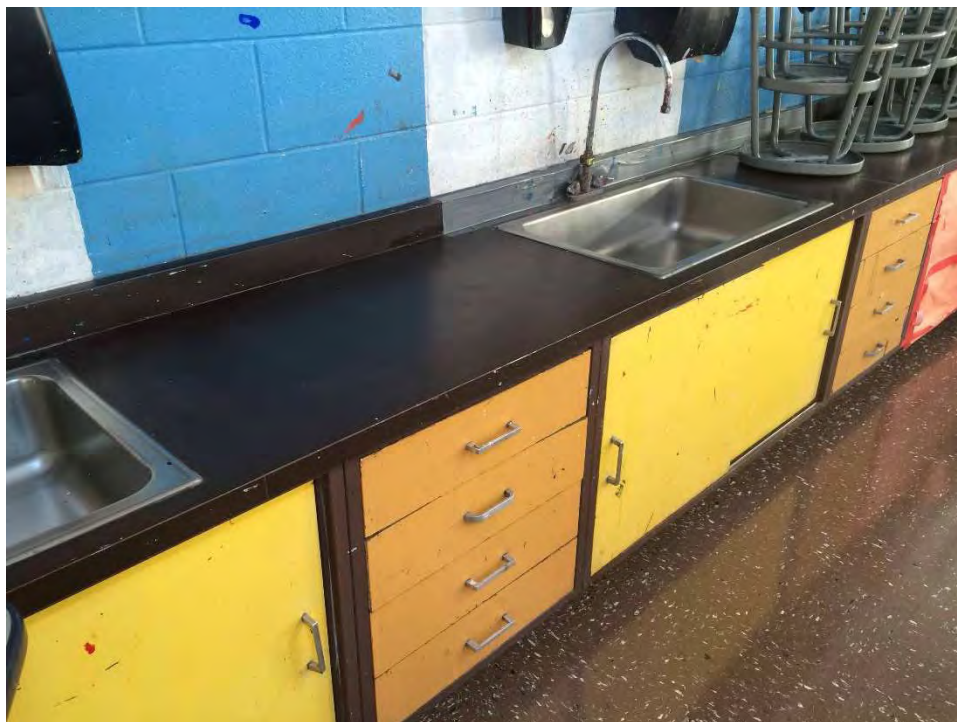
- Replace old, worn casework, counters, sinks & faucets in Classrooms, Art, Tech Ed, Nurse's room, and the Media Center.

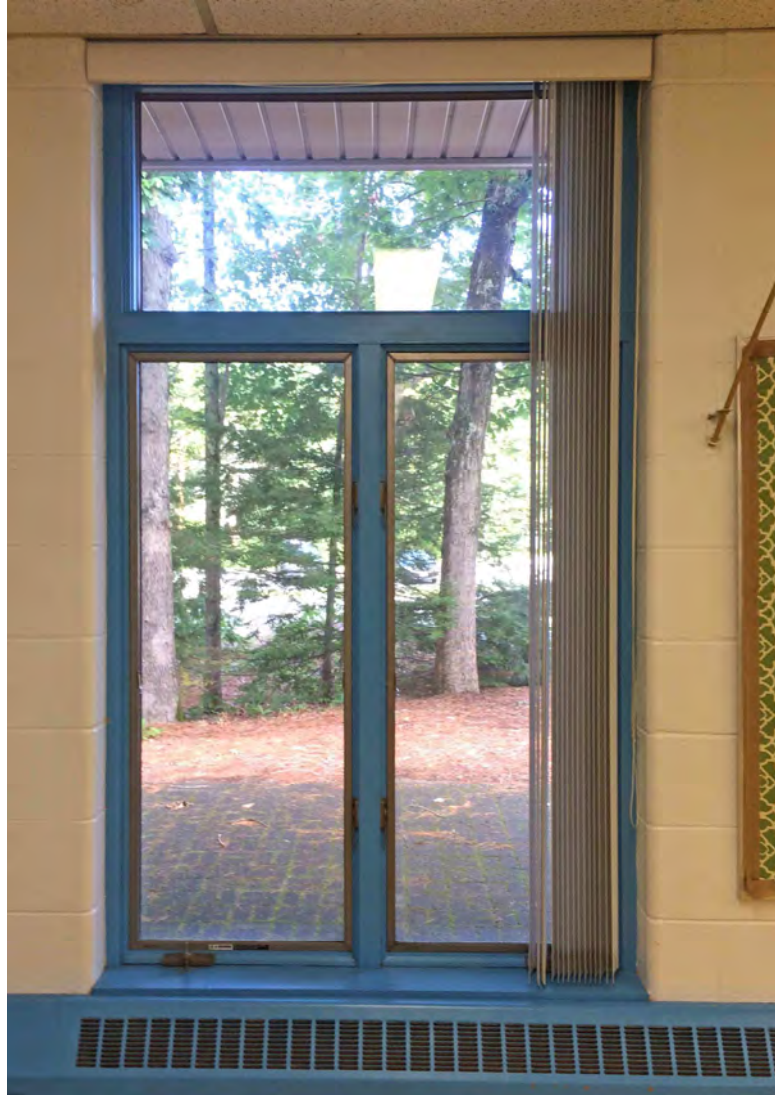
- Windows blinds in the entire school are vertical blind, and operate poorly. All blinds should be replaced with commercial grade roller type blinds.

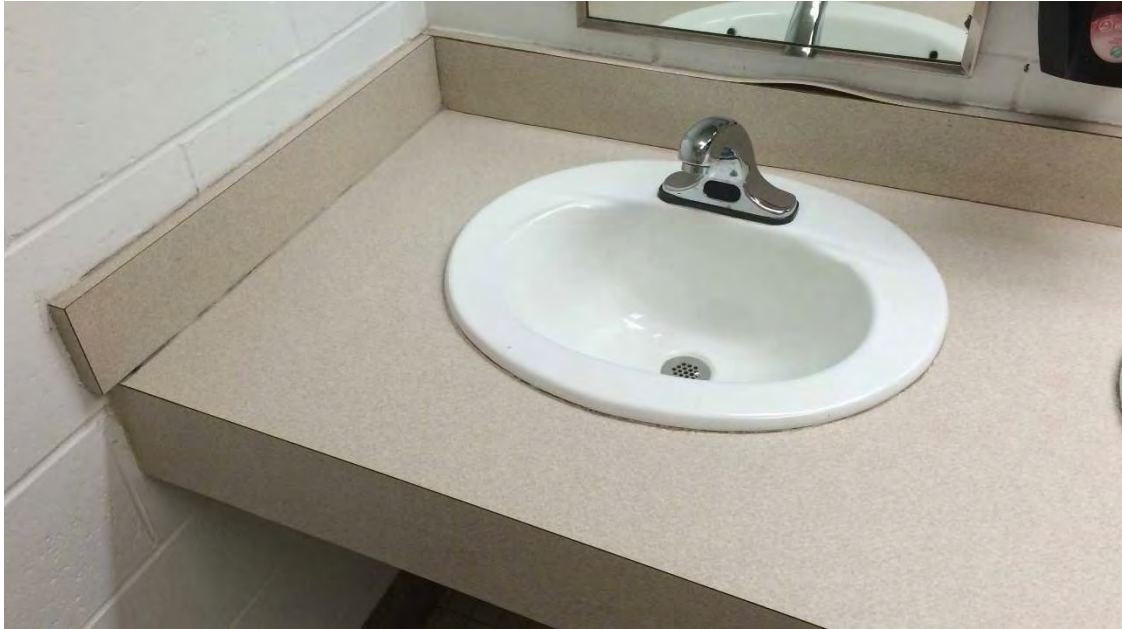
- Counters and sinks in the two large Area A corridor toilets are in poor condition, and should be replaced with solid surface countertops and sinks, and new faucets.

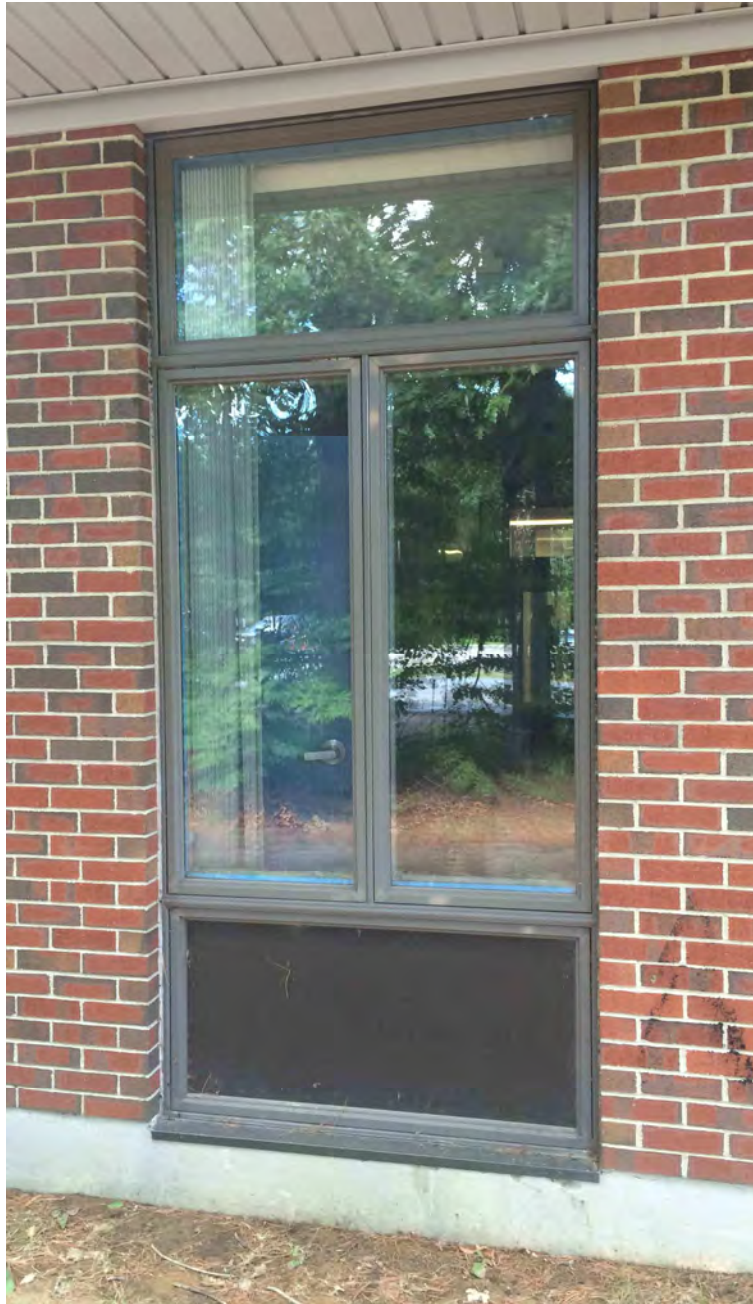
- Windows in Areas A & B (except two science rooms) are original to 1978, not energy efficient, and do not provide the required opening size to comply with fire codes. Replace with new heavy duty commercial aluminum windows. Replace insulated panels below windows with new insulated panels.

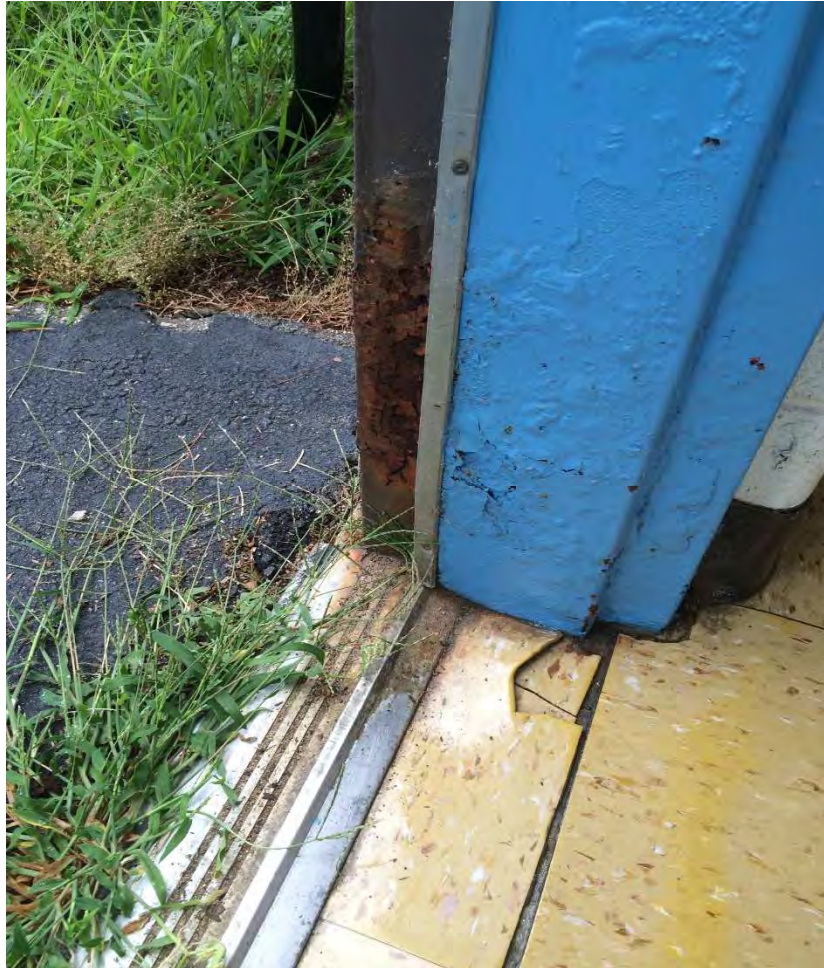
- The two classroom exterior doors at the end of Area B are very rusted and don't operate well. These doors and frames should be replaced with new hollow metal doors and frames.

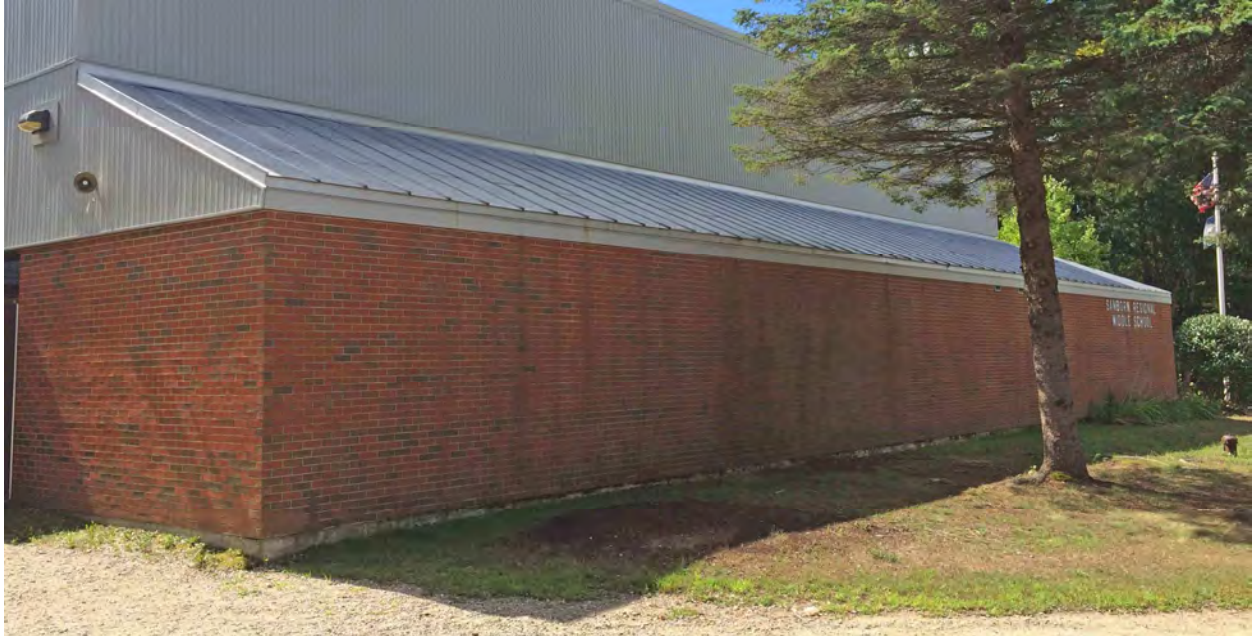
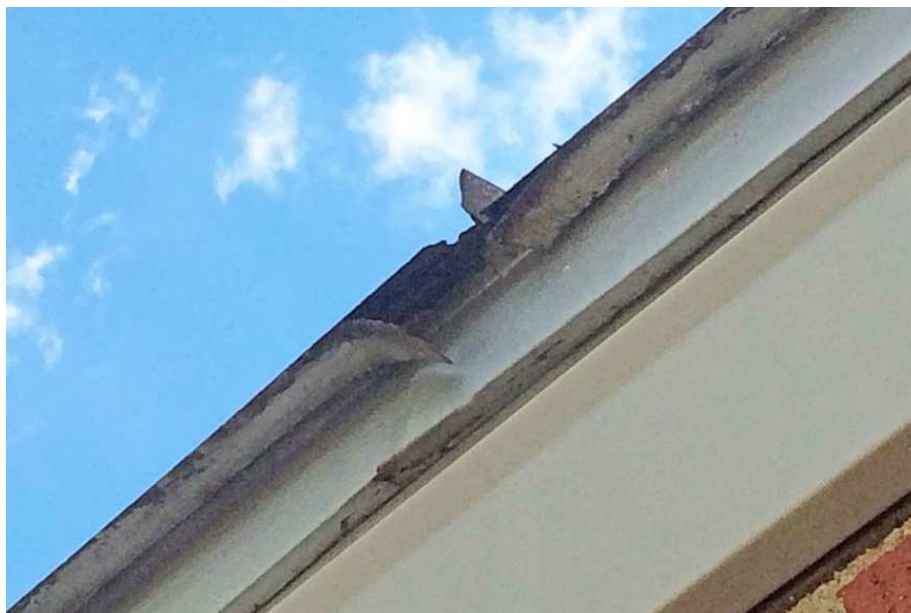
- The standing seam metal roof over the gym storage area is showing signs of age, and is rusting along the eaves. It has a relatively small overhang, which, combined with the eave deterioration, appear to have allowed water to run down the brick wall, causing damage. This roof should be replaced with a new standing seam metal roof with a larger overhang. A crushed stone drip area should be placed on the ground below this roof to reduce splashing dirt on the wall.

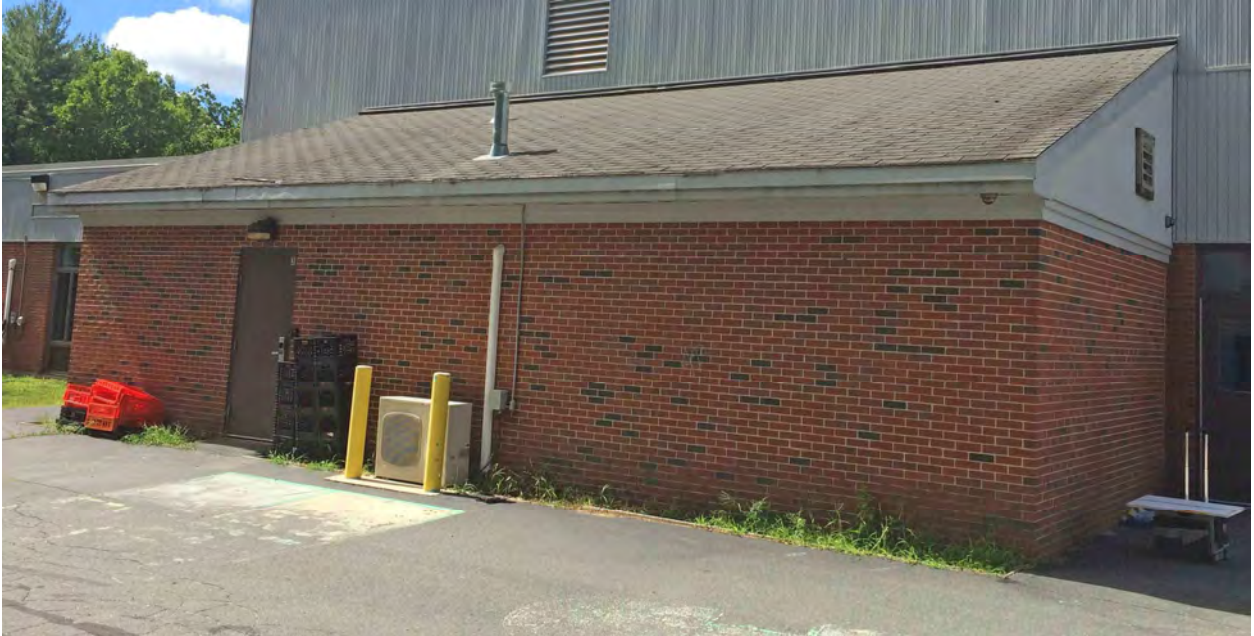
- The asphalt shingle roof over the kitchen looks old and weathered. It should be replaced with a similar roof.

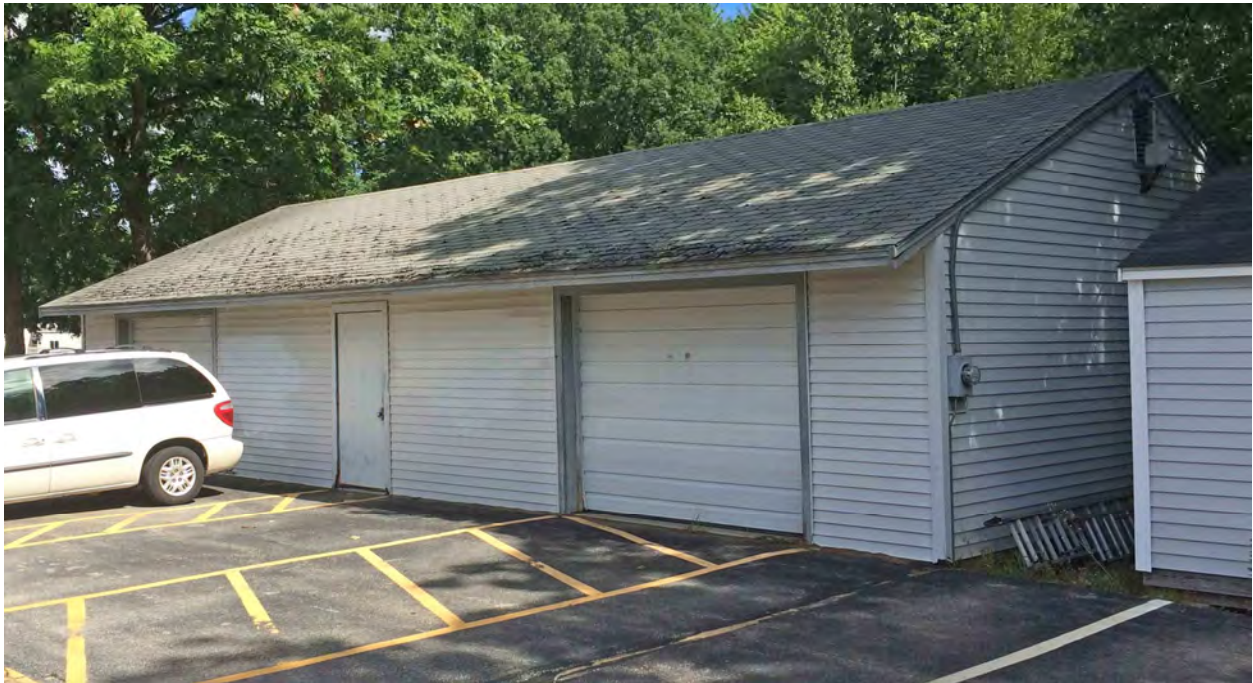
- The exterior storage building vinyl siding, asphalt shingle roof, and hollow metal / overhead doors are deteriorating badly, and should be replaced with products similar to existing. PVC trim should be used in place of wood.

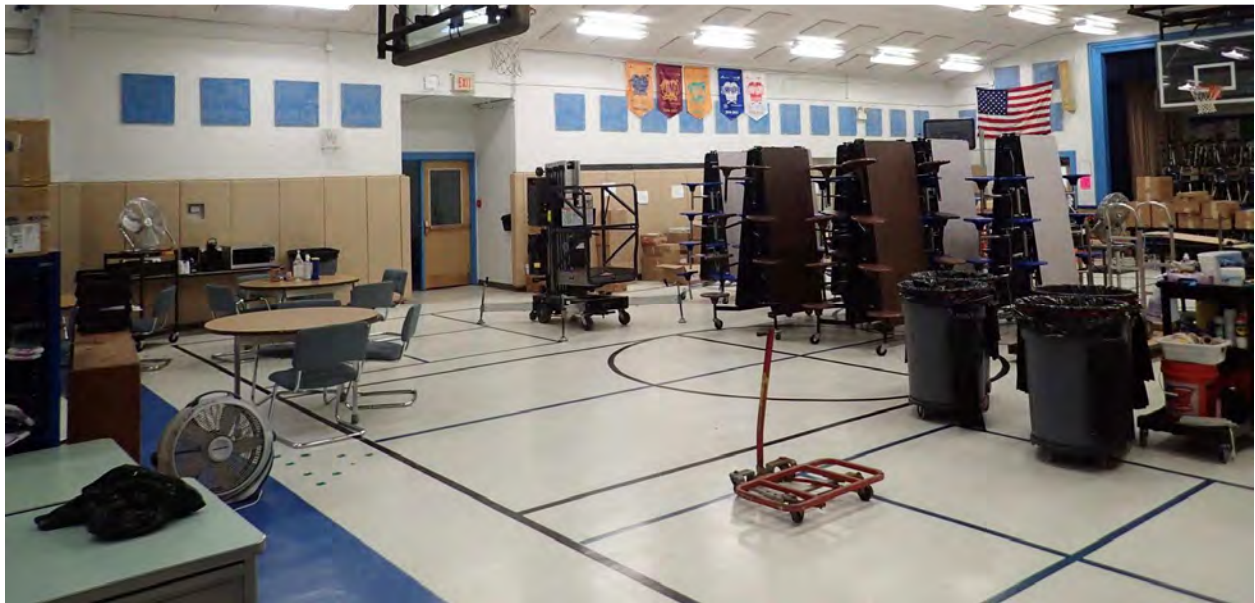
- Gym Floor: VCT is worn. Demolish old floor, prep slab, install a new VCT floor with inlaid lines.

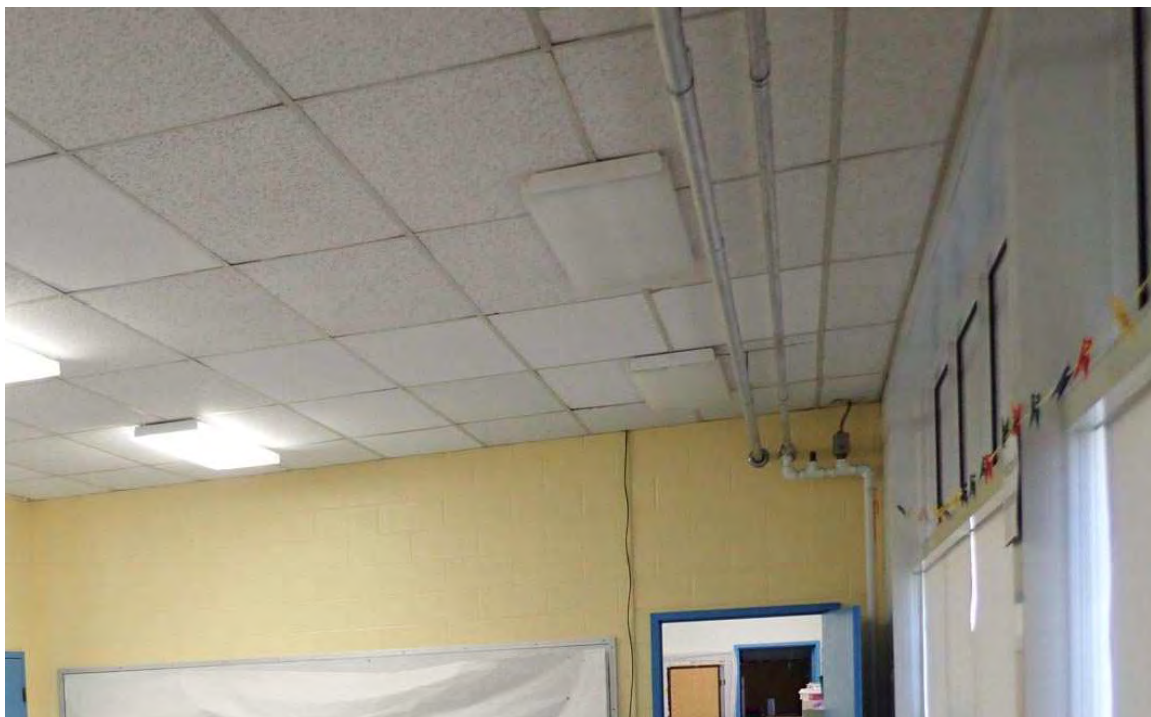
- In Area B, ceilings are old and in poor condition. Replace ceiling grid & tiles. New indirect lighting in place of existing.

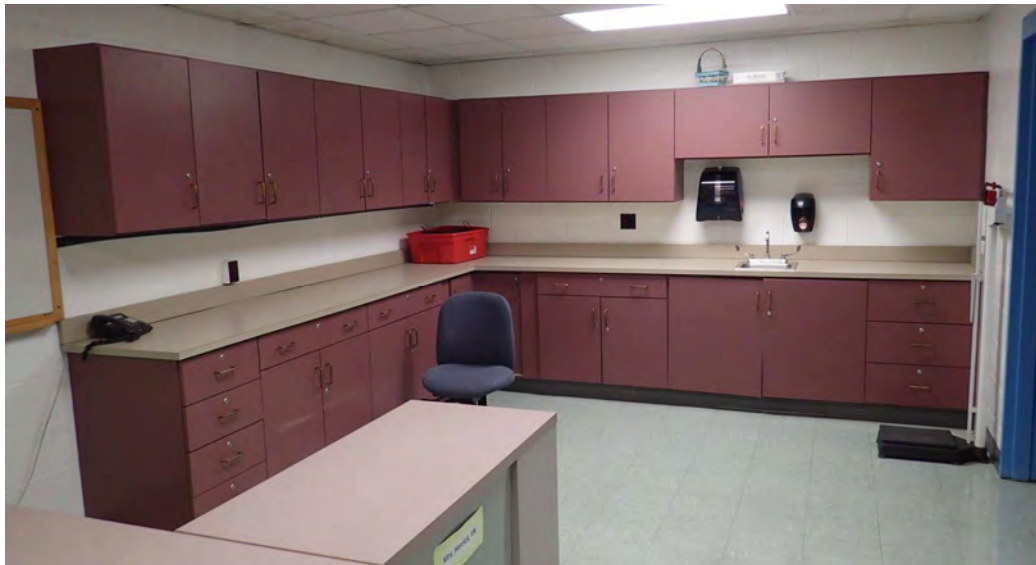
- Replace all casework, sinks & faucets in the building except those in the General Office area and Area B. Because frequent splashing by young students quickly delaminates plastic laminate counters, use solid surface counters & sinks at classrooms.

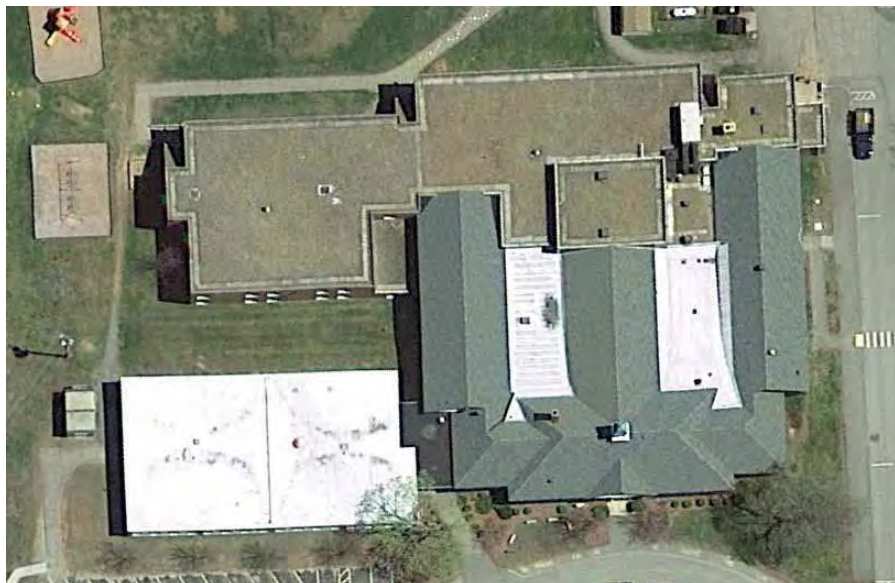
- The Area B roof will need to be replaced in the next 5 years.

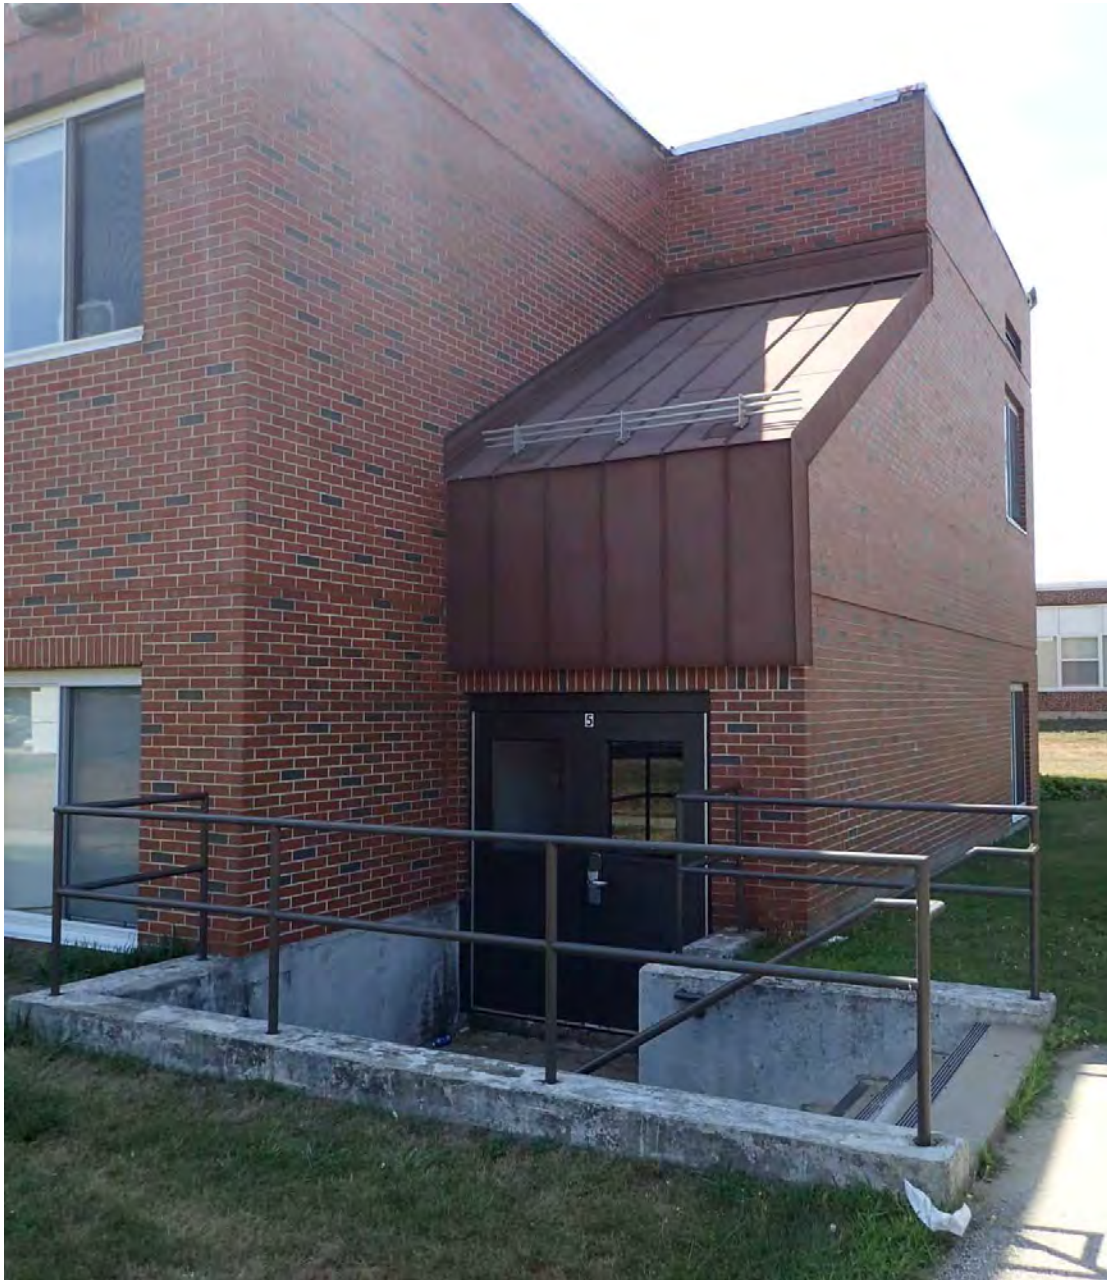
- The metal roofs at the three stair wells of Area C reportedly leak, and appear to be a hazard as they drop snow and water on the doors below. The leaking is likely due to the sloping flashing condition, which doesn't penetrate the cavity wall. At a minimum the roofs should be replaced, and the flashing corrected. The best solution would be to eliminate the sloping condition, and change these areas to flat membrane roofs which would capture snow and ice. This would involve taking off the existing roofs, building up the block / brick walls to the correct height, and adding new roof structure, insulation and roofing on top, with new roof drains.

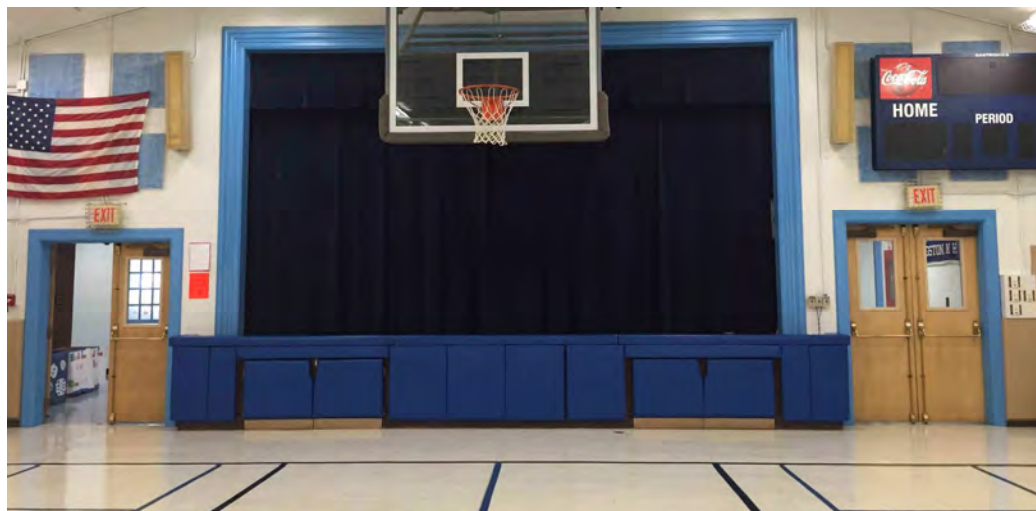
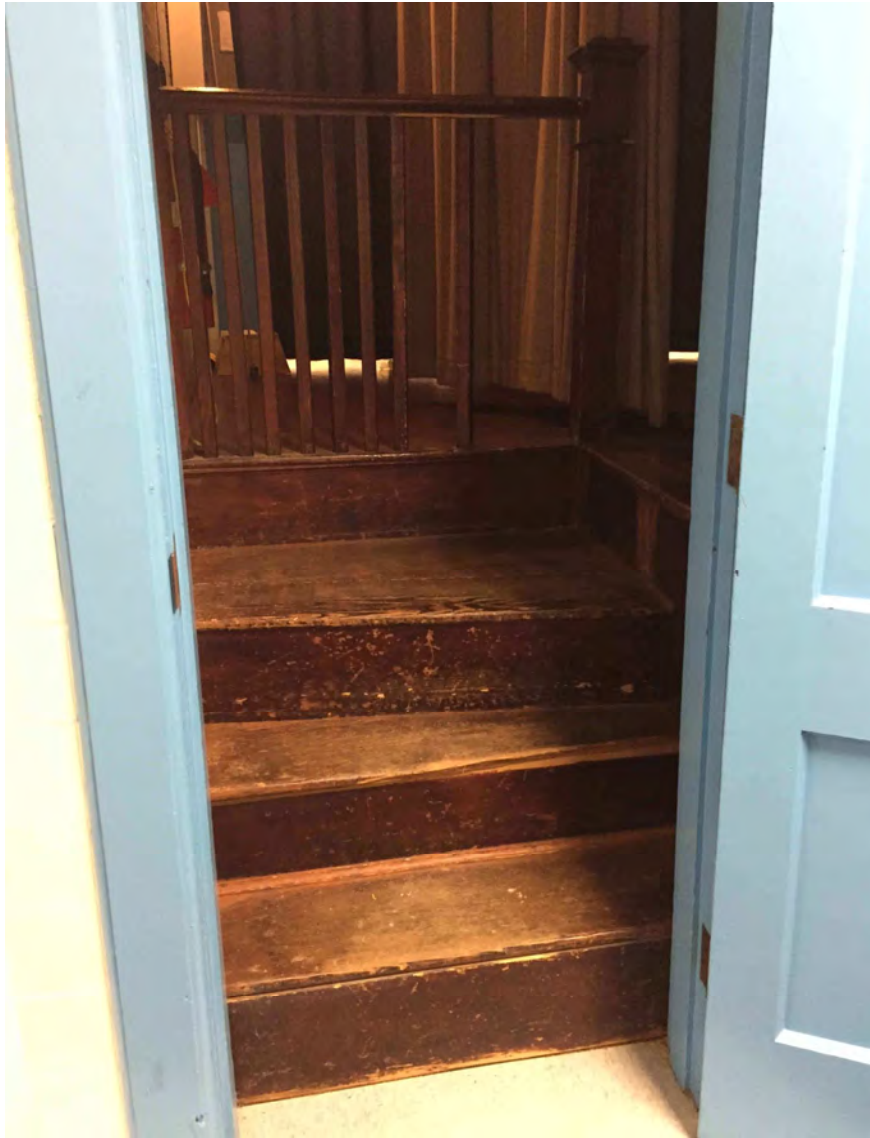
- While we did not perform a comprehensive ADA analysis, one obvious issue is handicap access to the stage. The stage is so small that there is no practical way to gain access with a ramp or built-in handicap lift within the stage space. It appears that there are more exit doors than required from the Multi-Purpose Room, and the short corridor between the Stage and the Nurse could be converted to a space for a lift and stair, which is our recommendation.

Stage stair is not Handicap accessible

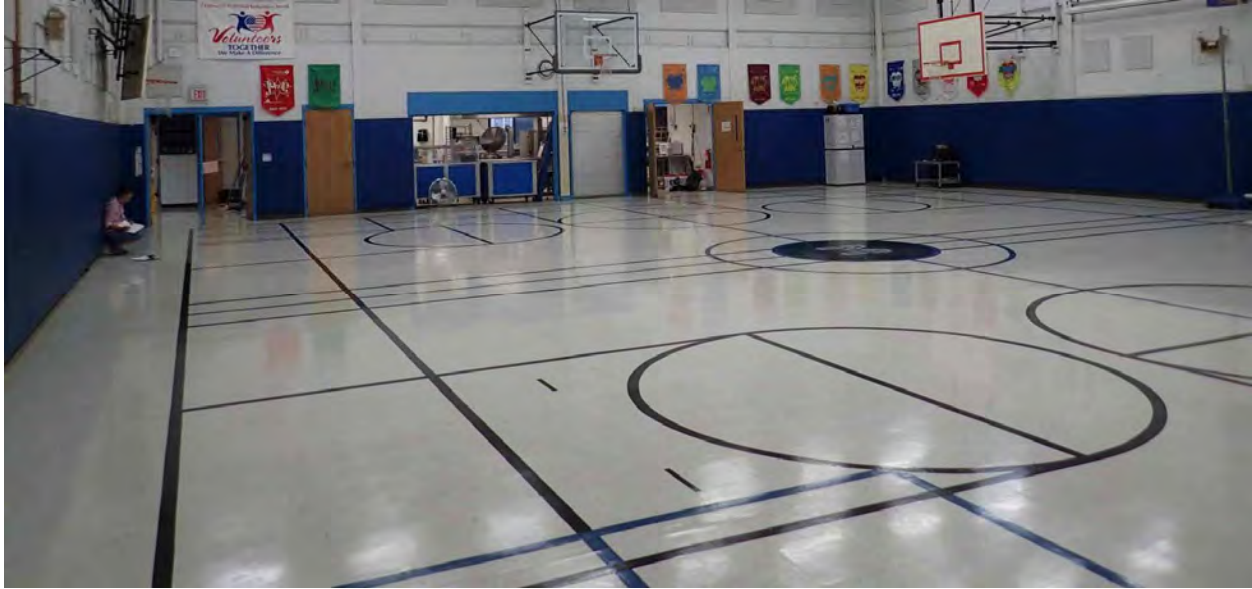
- Gym Floor: Floor is worn. Demo existing VCT floor, prep slab, install a new VCT floor with inlaid lines.

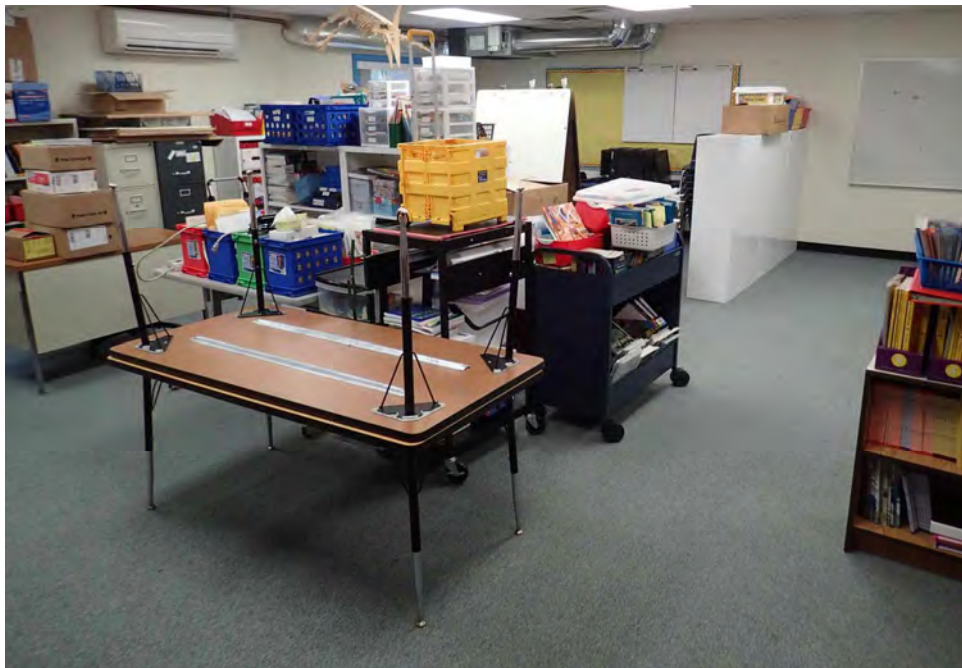
- Replace VCT flooring in the Gym Storage room.
- Classroom Floors: Carpet is worn at the portable classrooms. Replace carpet if portable classrooms themselves are not replaced.

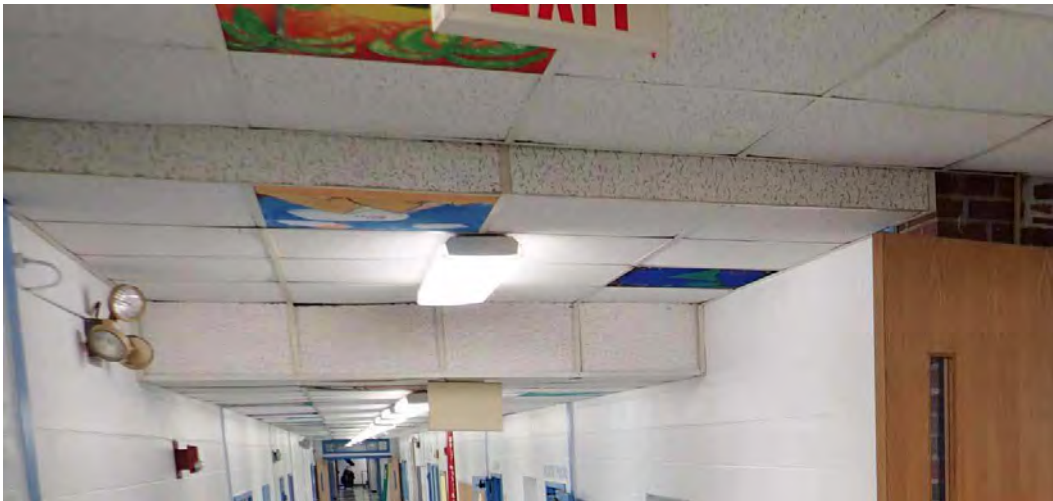
- Replace sagging kitchen ceiling tiles with moisture resistant vinyl faced tile, such as Armstrong “clean room mylar”.
- Area B: Ceilings in this area are showing significant signs of wear, the grid is yellowed, and the tiles are a patchwork. Our recommendation is to replace the grid & tiles in the classrooms and corridor. Lights should also be replaced at that time with LED fixtures, and indirect fixtures in classrooms. The ceilings in the small toilet rooms are in very bad condition. Ceilings and lights should be replaced in these rooms.

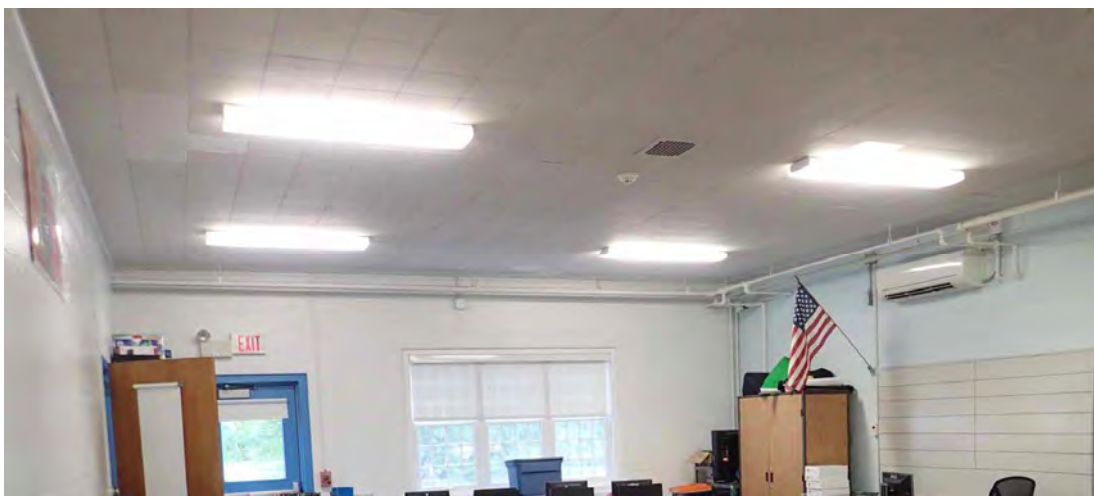
- Area A: This area has the original ceiling tiles. To improve acoustics and lighting, a suspended ceiling should be installed just below the existing with new LED indirect lighting.

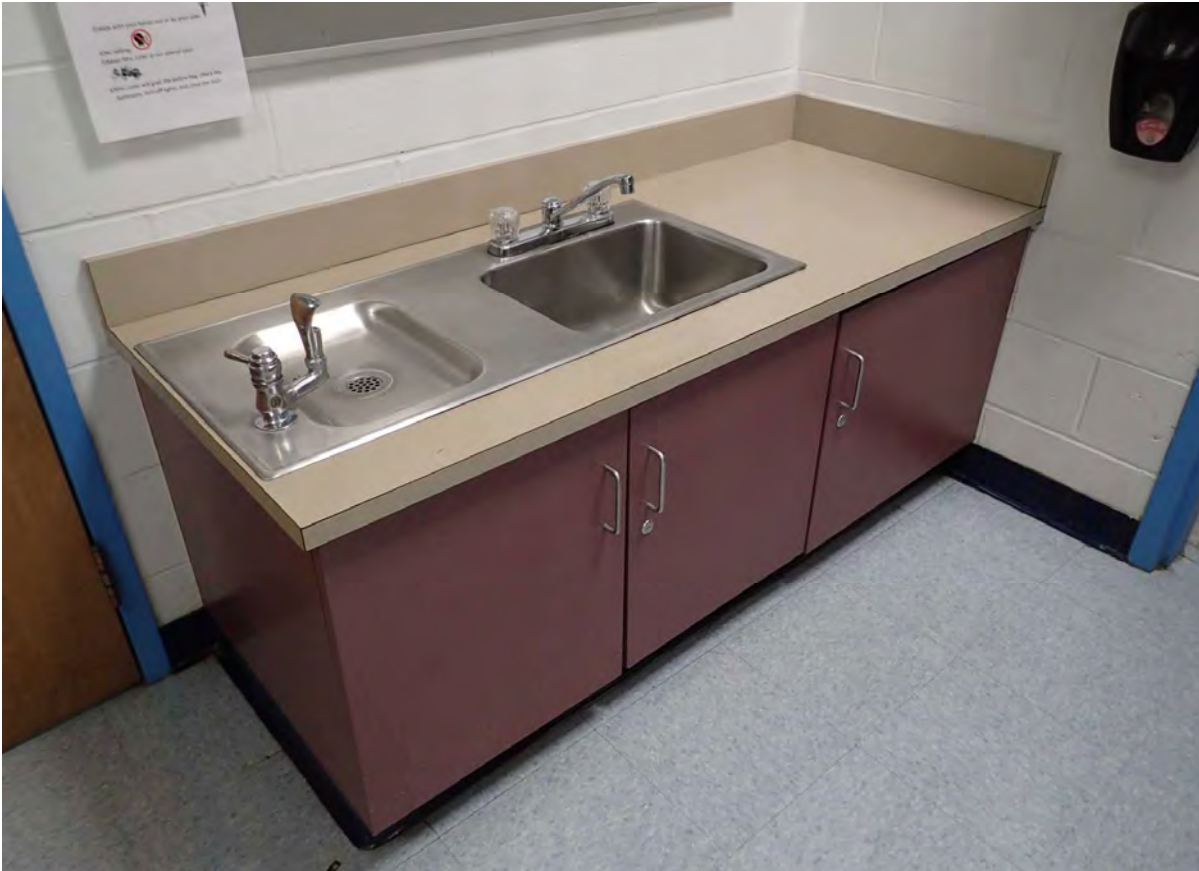
- Classroom casework in Area D is old, counters are failing, and many doors and hinges are broken. Replace fixtures & casework. Because frequent splashing by young students quickly delaminates plastic laminate counters, use solid surface counters & sinks.
