Sanborn Regional School District

Facilities Study

Capital Improvement Projects 2018-2022

Marinace Architects

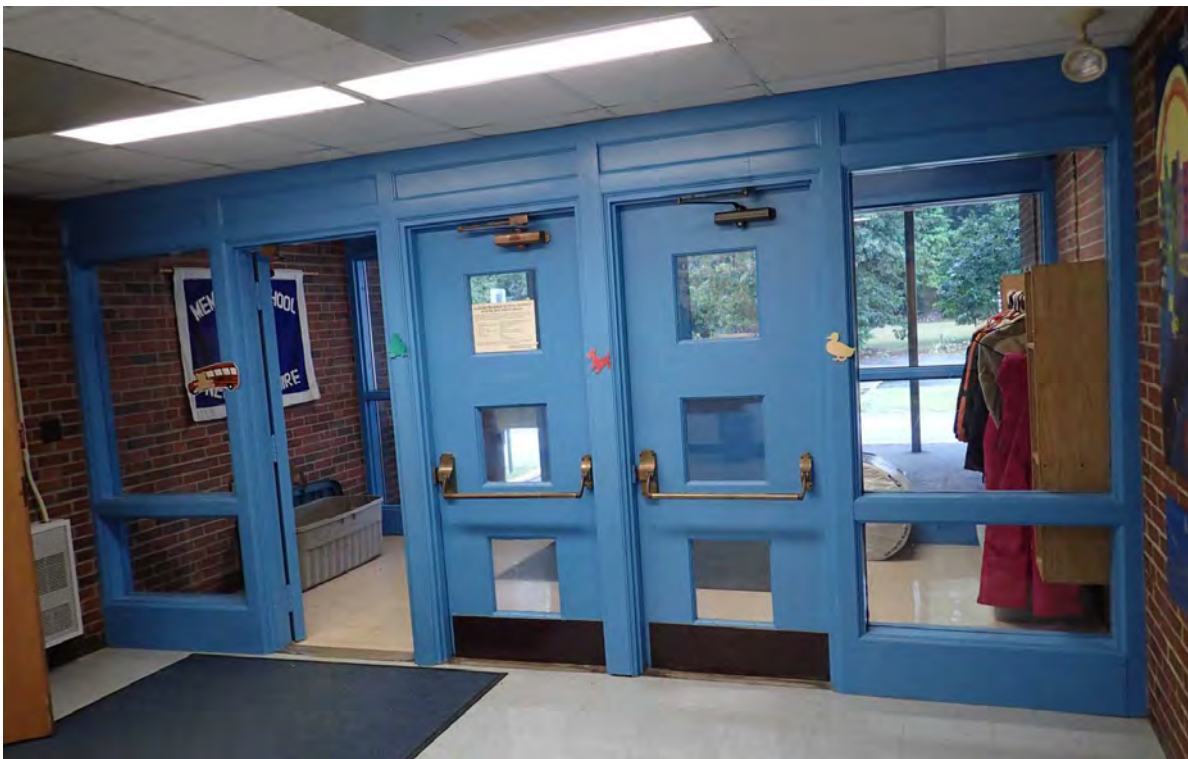
- The inner vestibule doors at Area B are old wood and glass. The glass should be tempered or wire glass, and is a safety concern, so these doors and the surrounding frame should be replaced with a hollow metal frame and tempered glass.
- The public has access to much of the building when using the Gym after hours. Add a set of security doors in Area D to isolate the lobby.

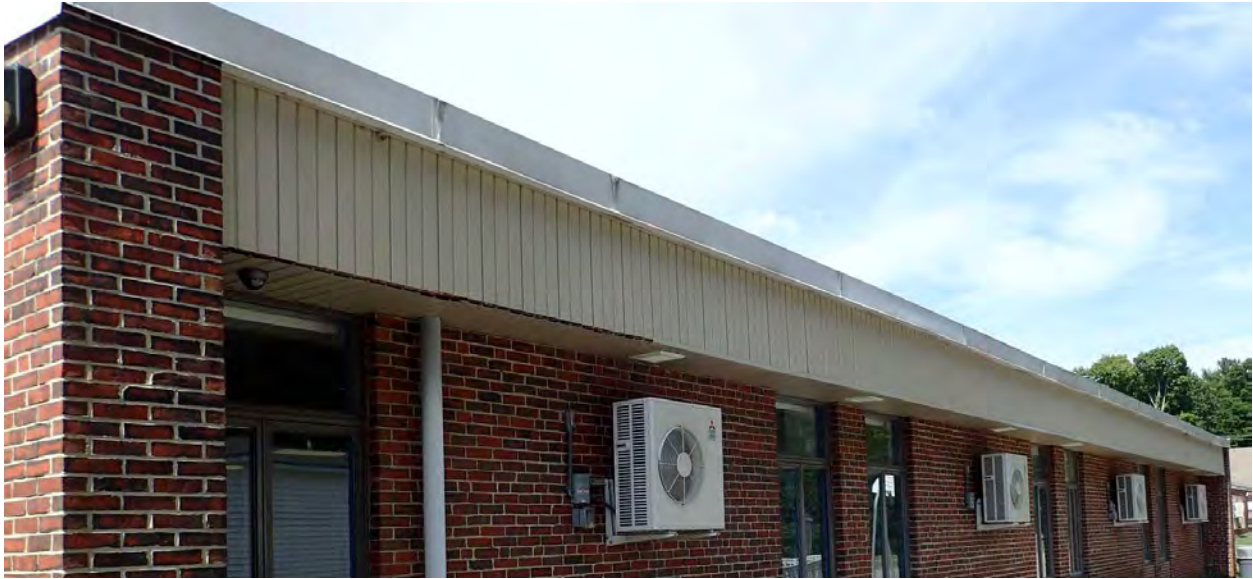
- The vinyl soffits in area C are old, of low quality and durability, and deteriorating quickly. Replace soffits with painted steel panels to match Area D.

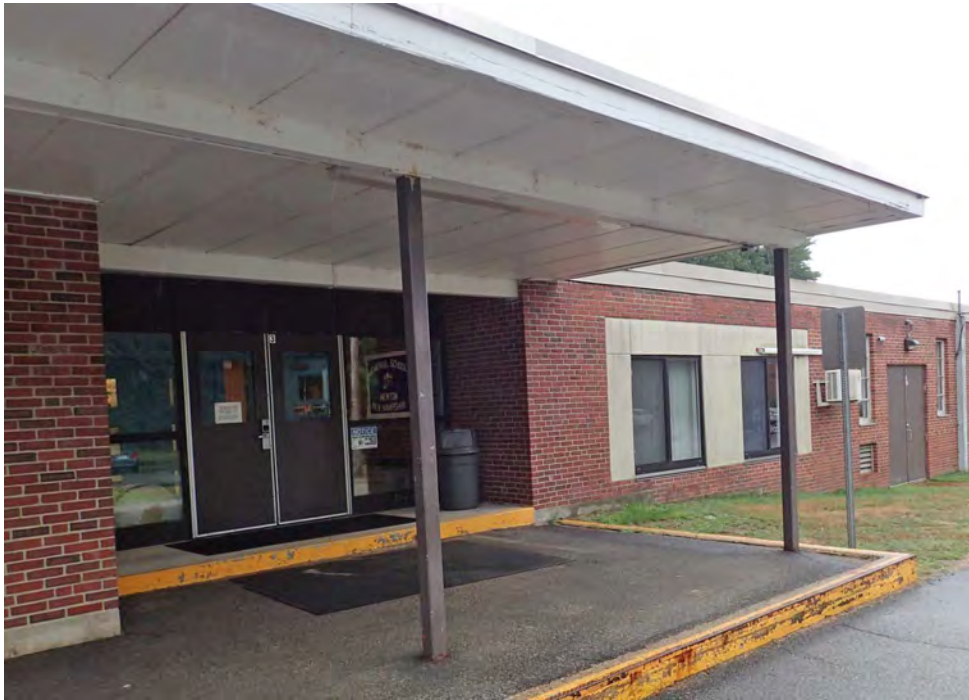
- The canopy at Area A needs to have rust removed from the steel underside, and have all surfaces painted. Replace wood roof edge trim with PVC.

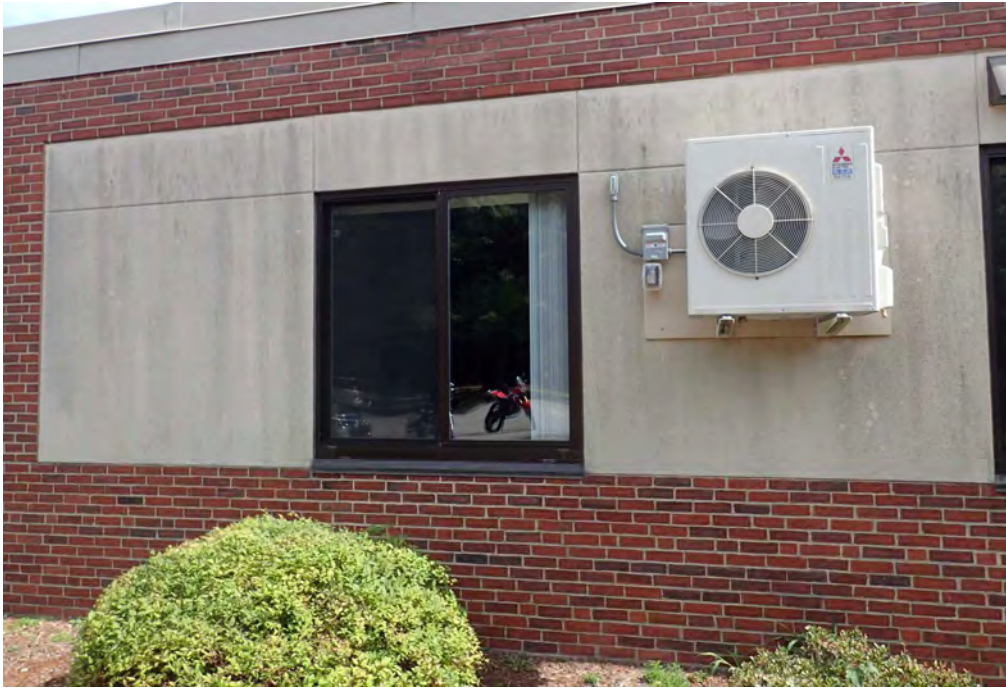
- Replace old caulking around EIFS panels in Area B. Paint EIFS panels.

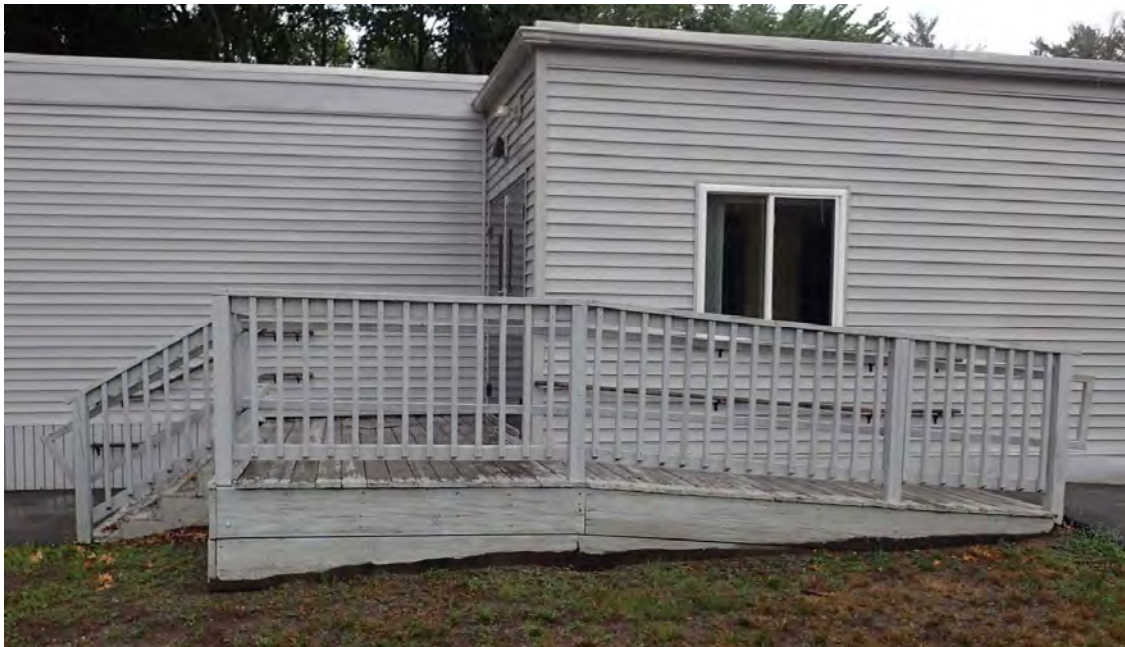
- If the portable classrooms are not replaced, remove the wood deck & ramp at the exit and replace with a composite deck & ramp. Wood is deteriorating.

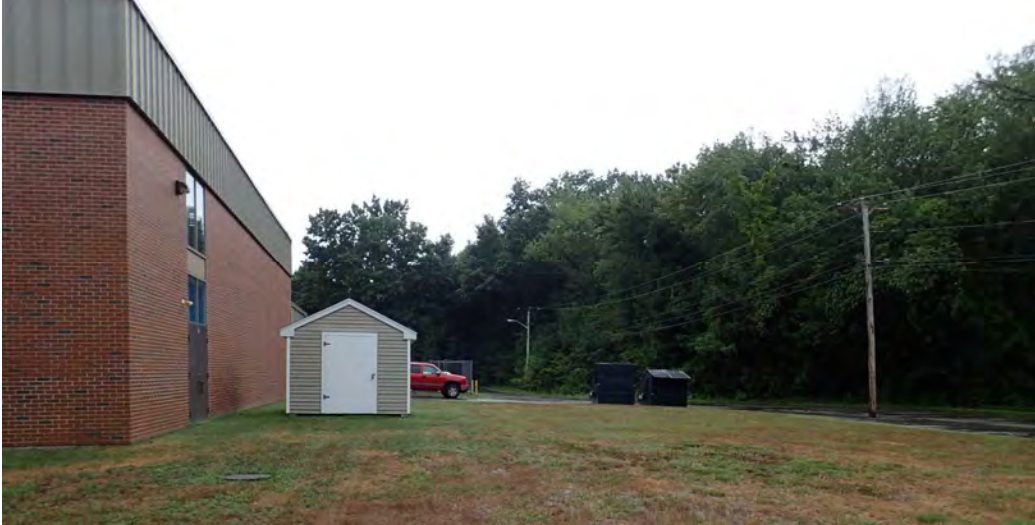
- There is a double egress door out the back of the gym with no sidewalk leading to a street. This must be kept clear of snow in the winter, so a sidewalk should be added between the building and the driveway.

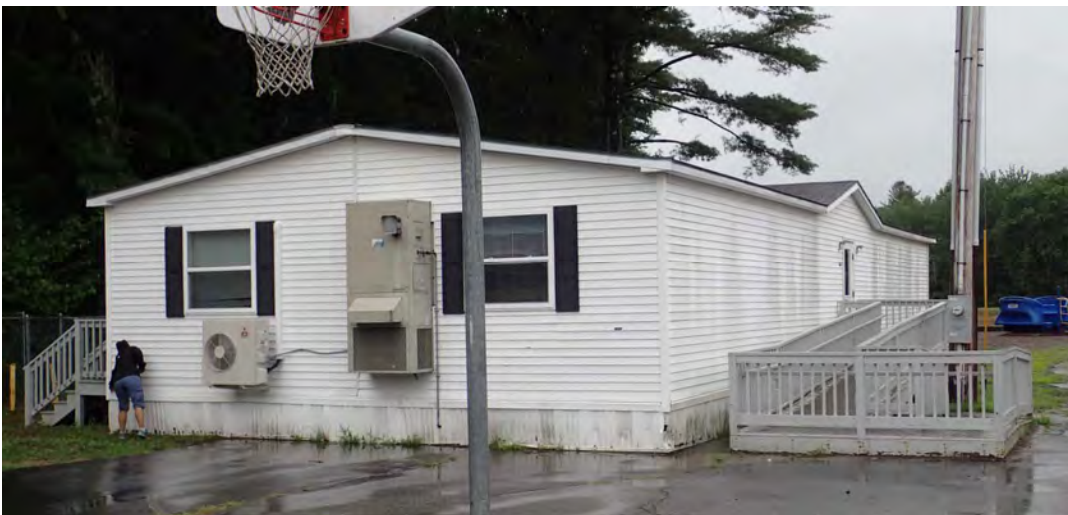
- As student security becomes a larger issue in schools, having remote classrooms has become less palatable to most school districts. It is very difficult to ensure student safety if they have to travel between buildings. Additionally, portable classrooms are an ongoing maintenance cost. Based on these two factors, we recommend that the four existing portable classrooms be replaced with permanent, high quality construction in the location of the two existing portables.

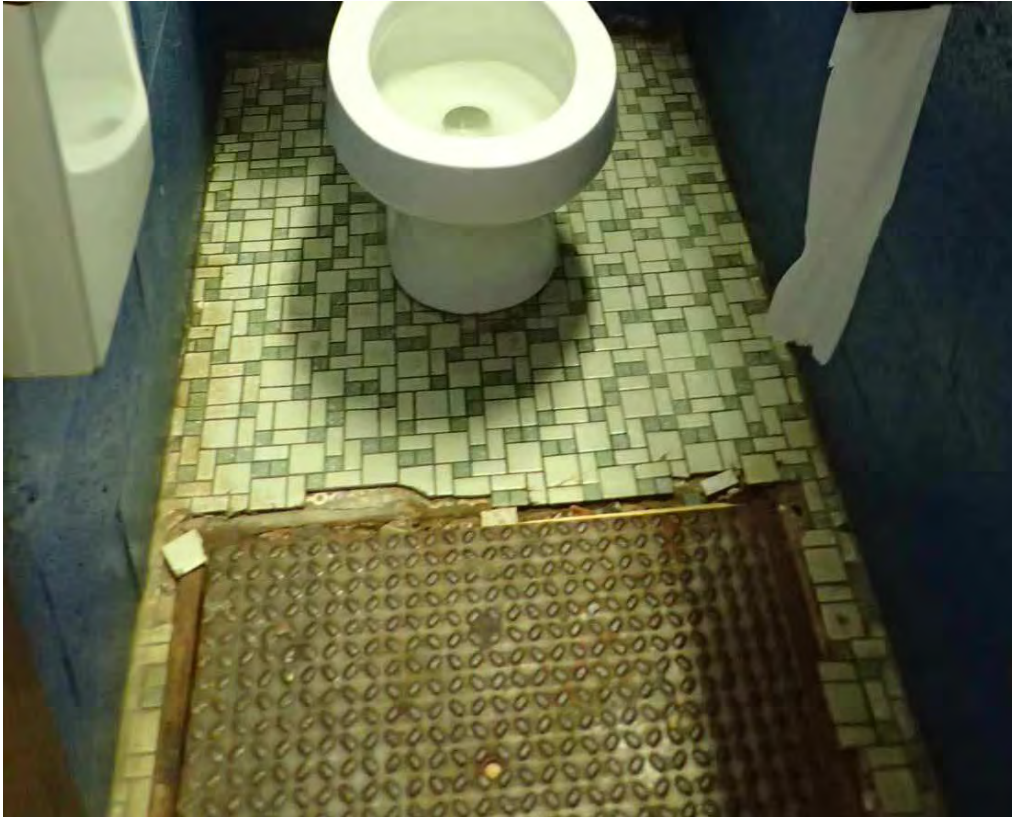
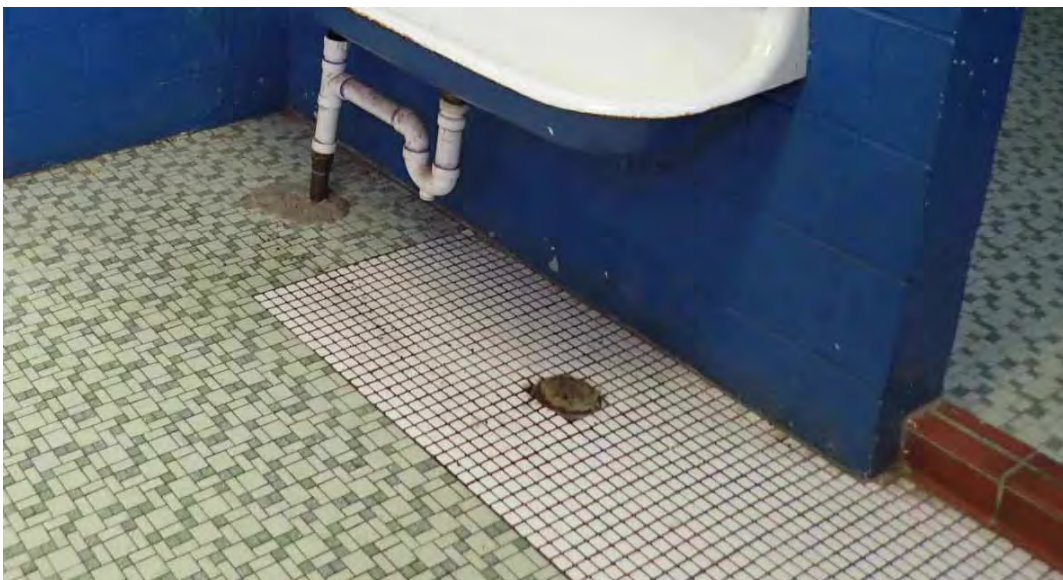
- Demo existing ceramic floor tile in both Locker Rooms and replace.

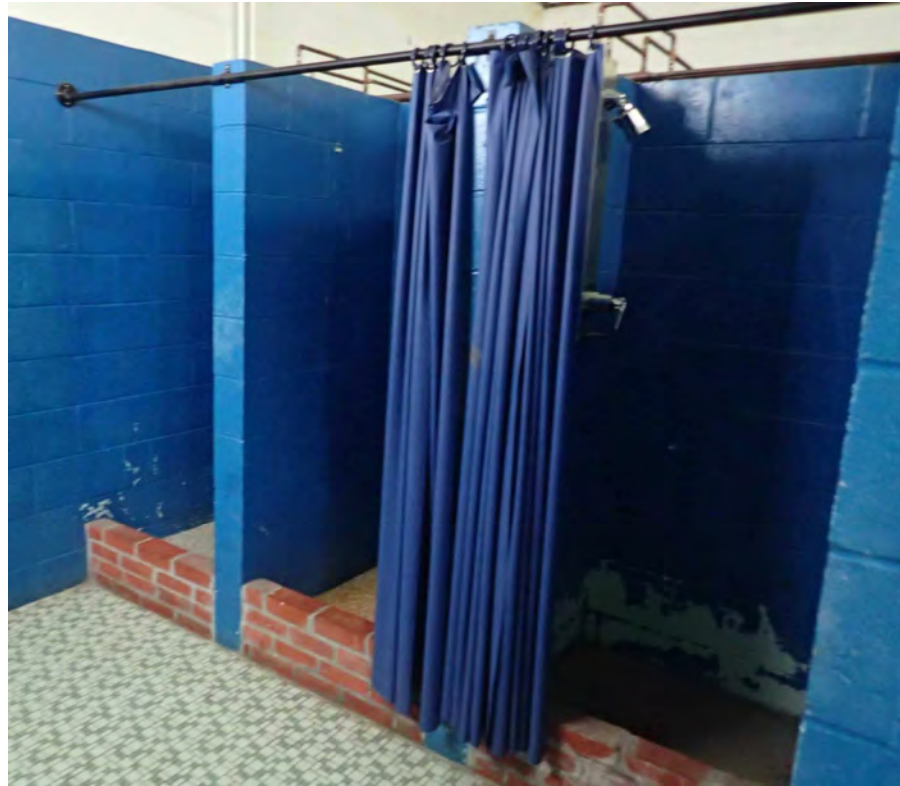
- Shower stalls are neither functional, nor ADA accessible. They have been cobbled together over the years, and are in poor condition. They should be demolished and rebuilt using ceramic tile-covered concrete block and HDPE partitions. Gang showers should be converted to stalls. Demo plumbing to showers and install new piping, drains & fixtures.

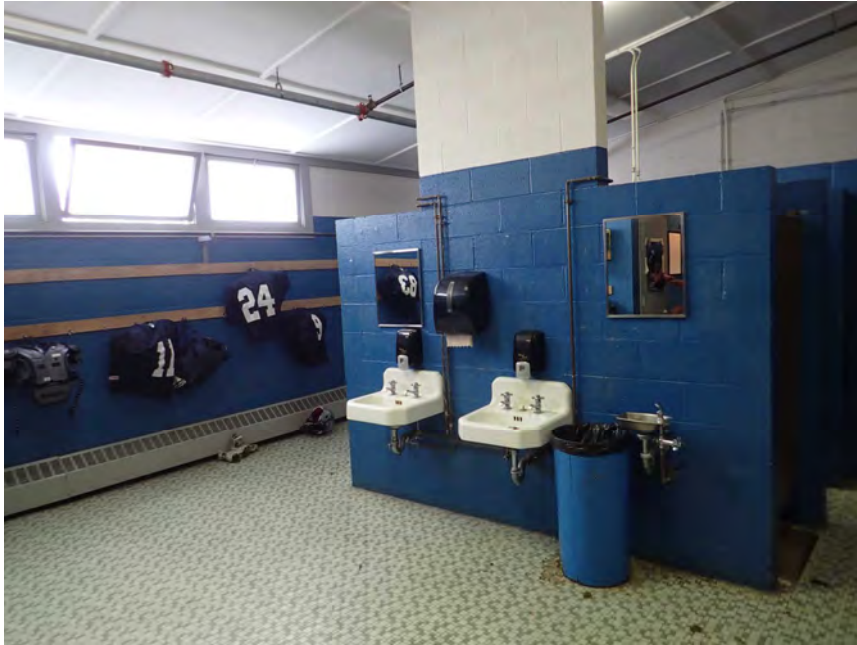
- Paint walls & ceilings in Boys and Girls Locker Rooms.

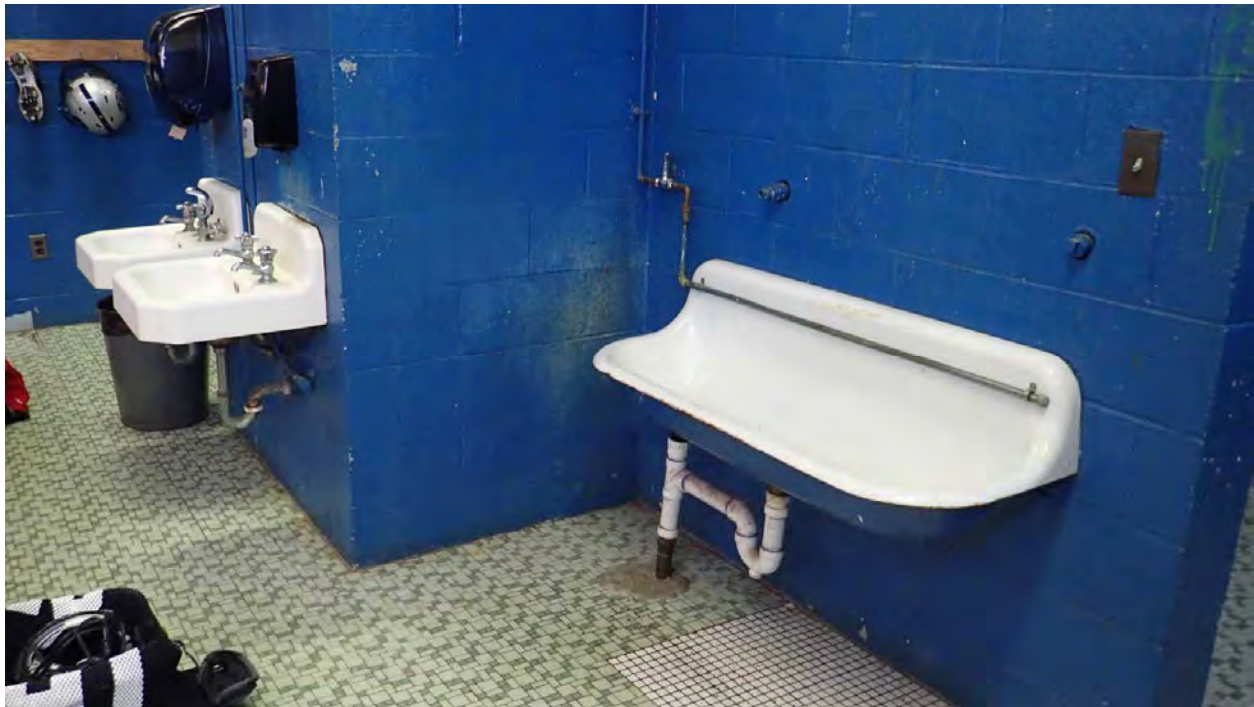
- The Boys and Girls Locker Rooms need to have all fixtures replaced, including sinks, counters, toilets, and showers. This will involve some new plumbing and wall demolition / construction. Provide ADA compliant toilets & sinks in each locker room.

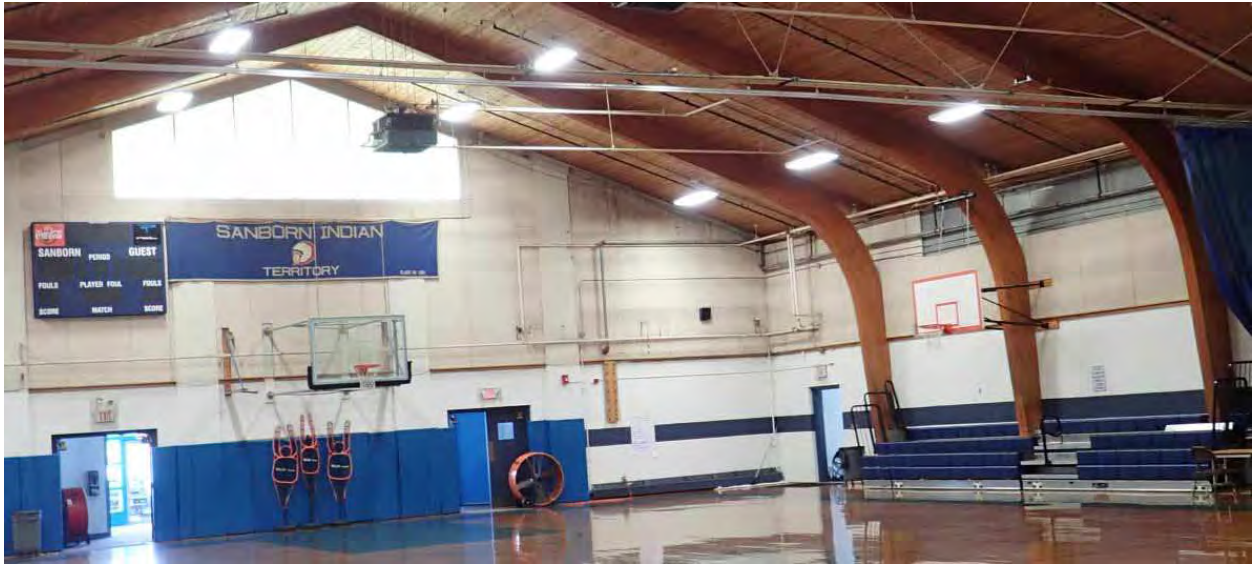
- Paint walls of gymnasium, including tectum panels.

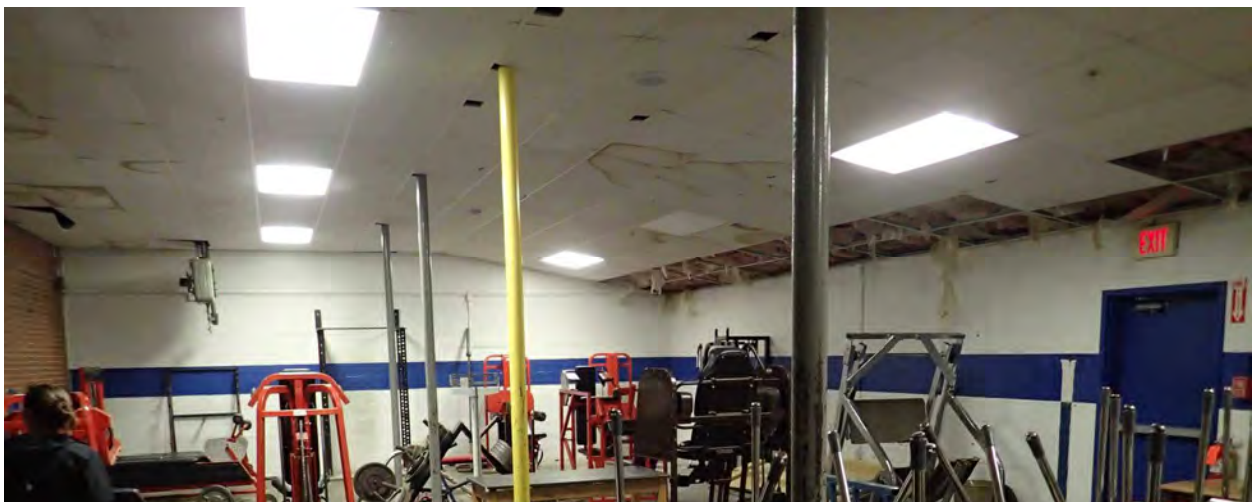
- Suspended ceiling in the Weight Room is in terrible condition and is falling down. Replace ceiling tiles after roof has been repaired. Reuse lights.

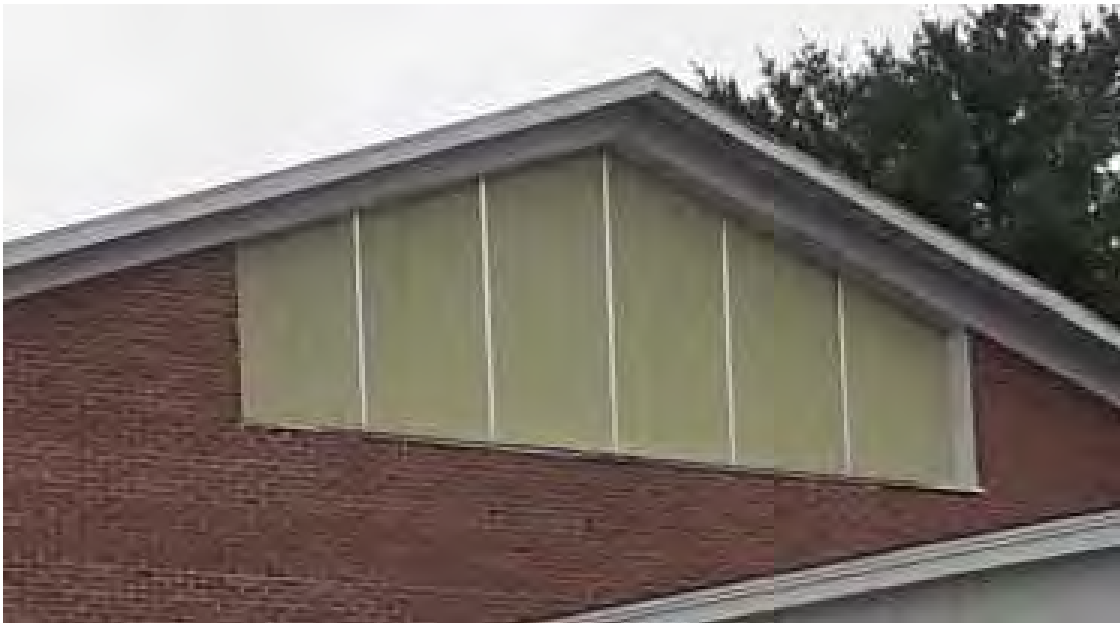
- Replace the Kalwall panels high in the gym with new Kalwall panels.

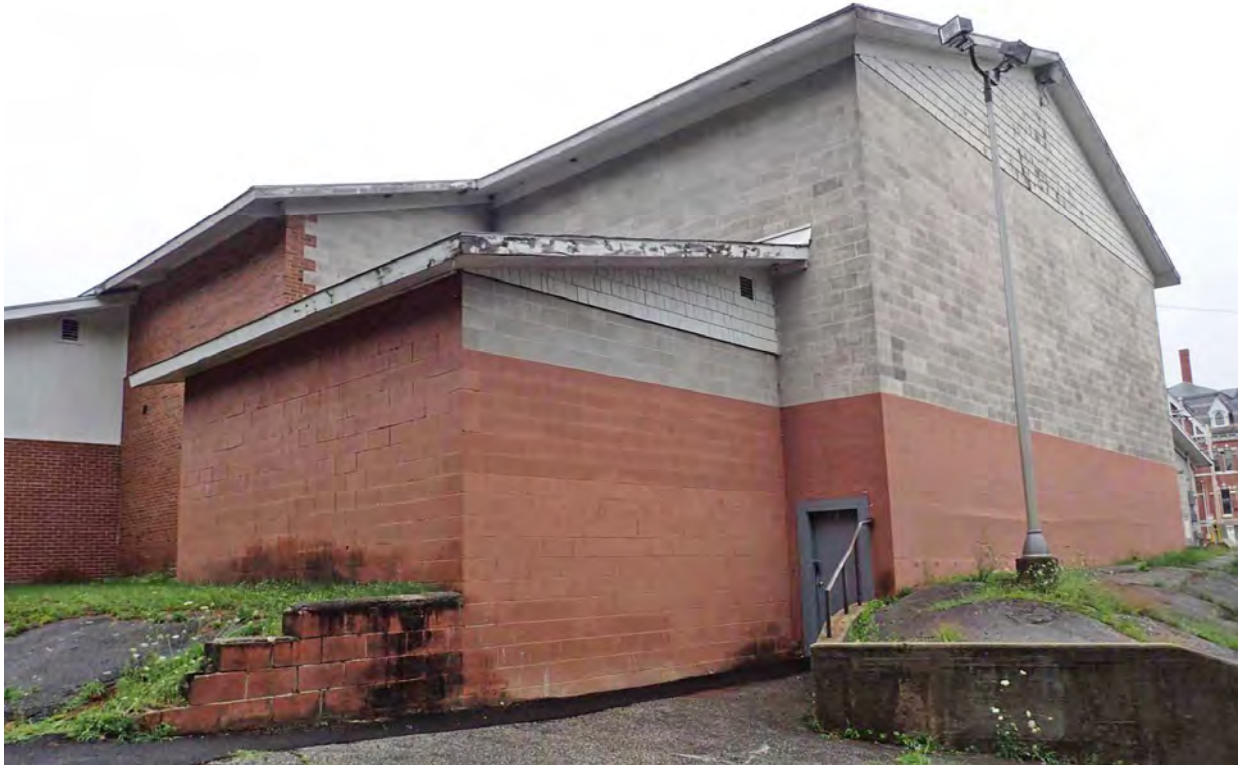
- The back half of the building is primarily painted concrete block, and badly needs to be patched and repainted. Clean, caulk all masonry joints, paint walls.

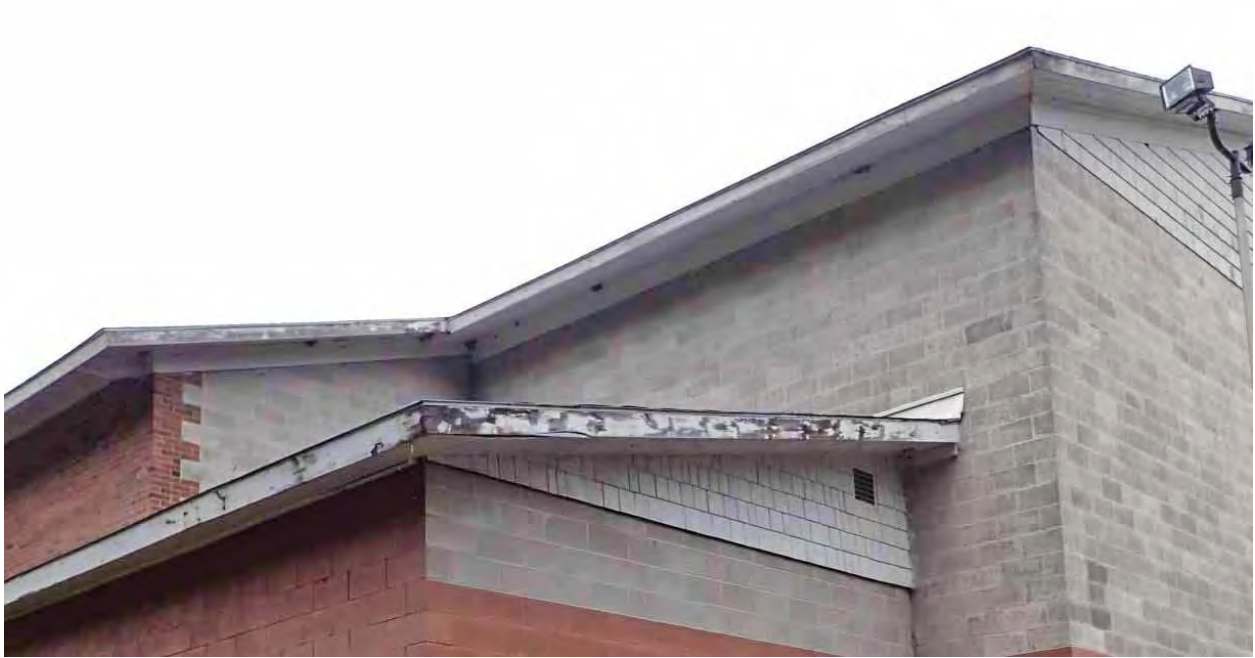
- The wood trim around the roof edge is in terrible condition and is rotting in some areas, and peeling extensively everywhere else. This trim should be taken off when the roof is replaced, and replaced with PVC trim.

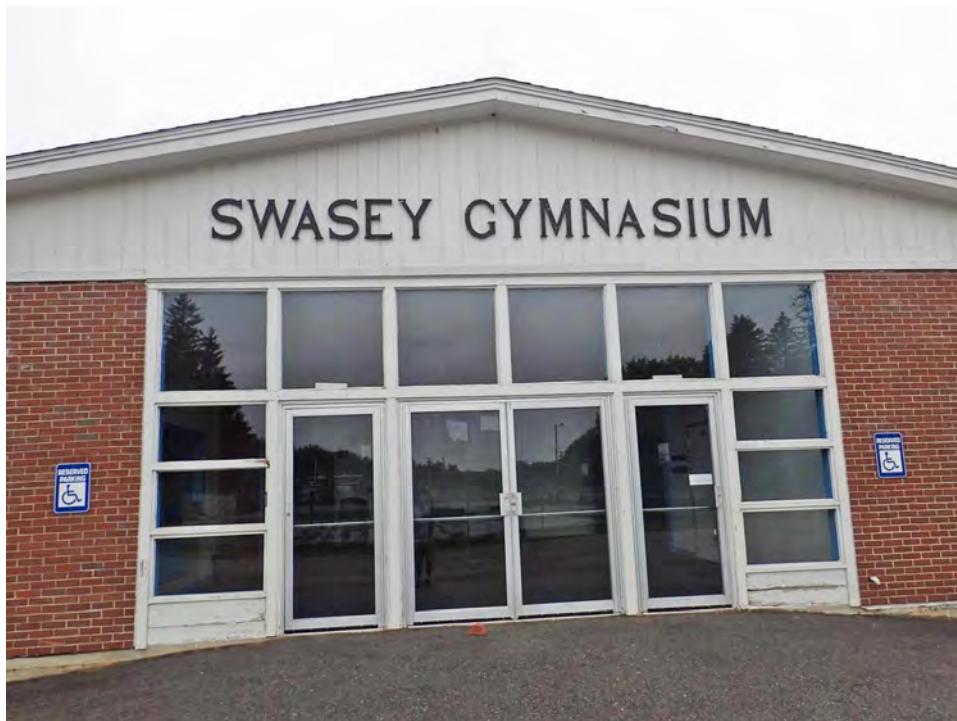
- The wood wall surface above the main entry door should be replaced with PVC panels.

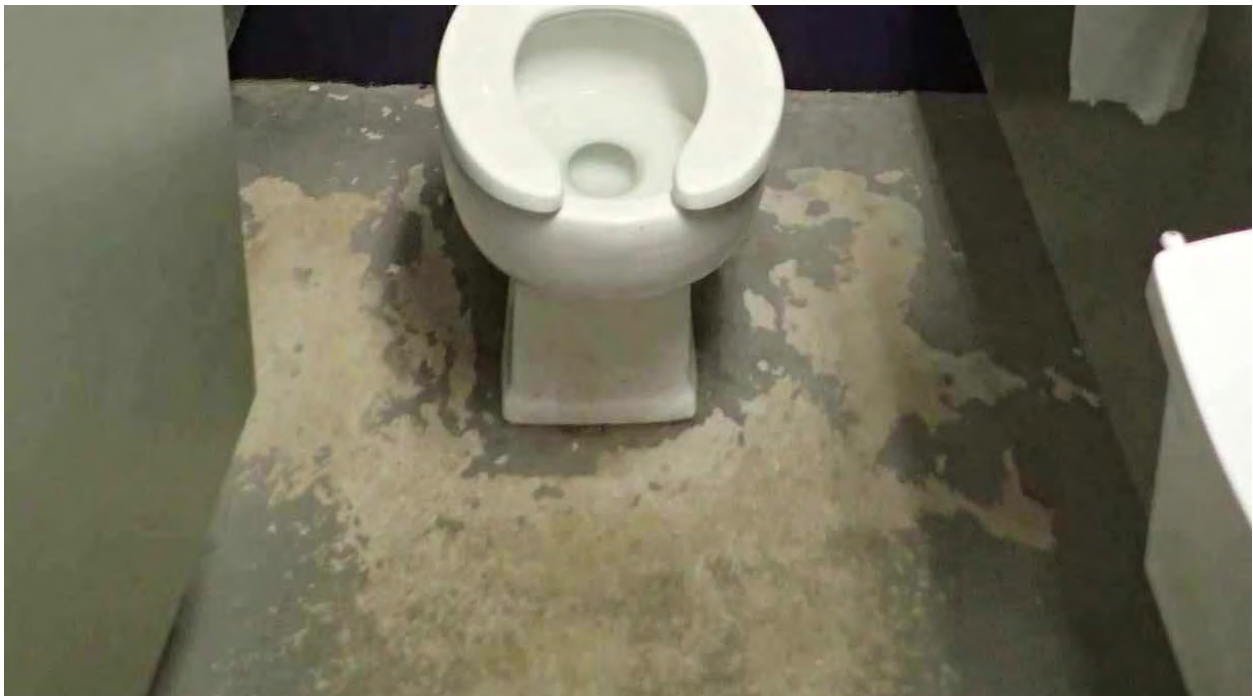
- Existing floors are painted concrete. The paint wears off quickly, and should be replaced with a durable quarry tile floor and base. Raise fixtures, partitions, lockers accordingly.

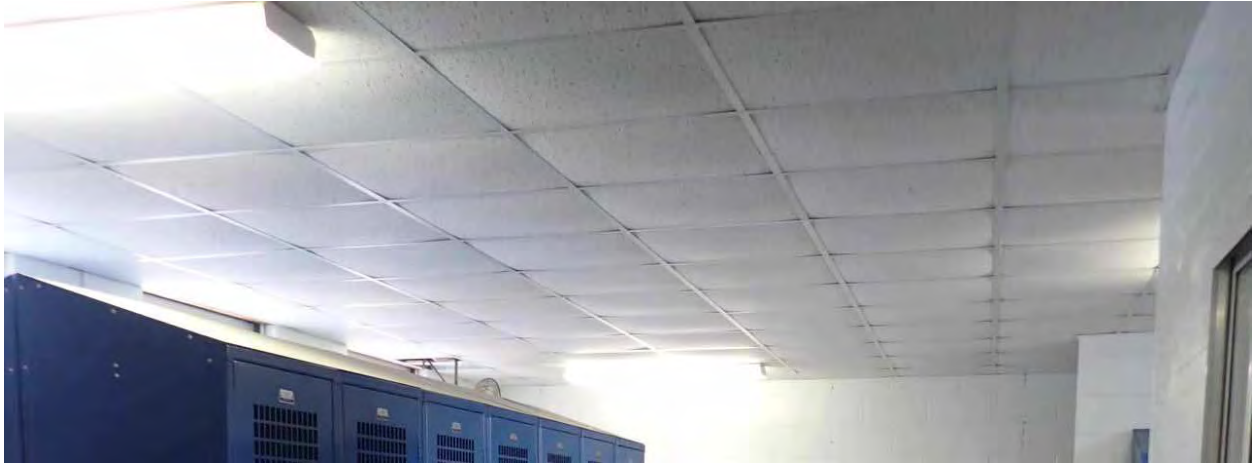
- Ceiling tiles have been affected by moisture and are sagging. Replace all ceiling tiles with moisture resistant ceiling tiles in the existing grid.

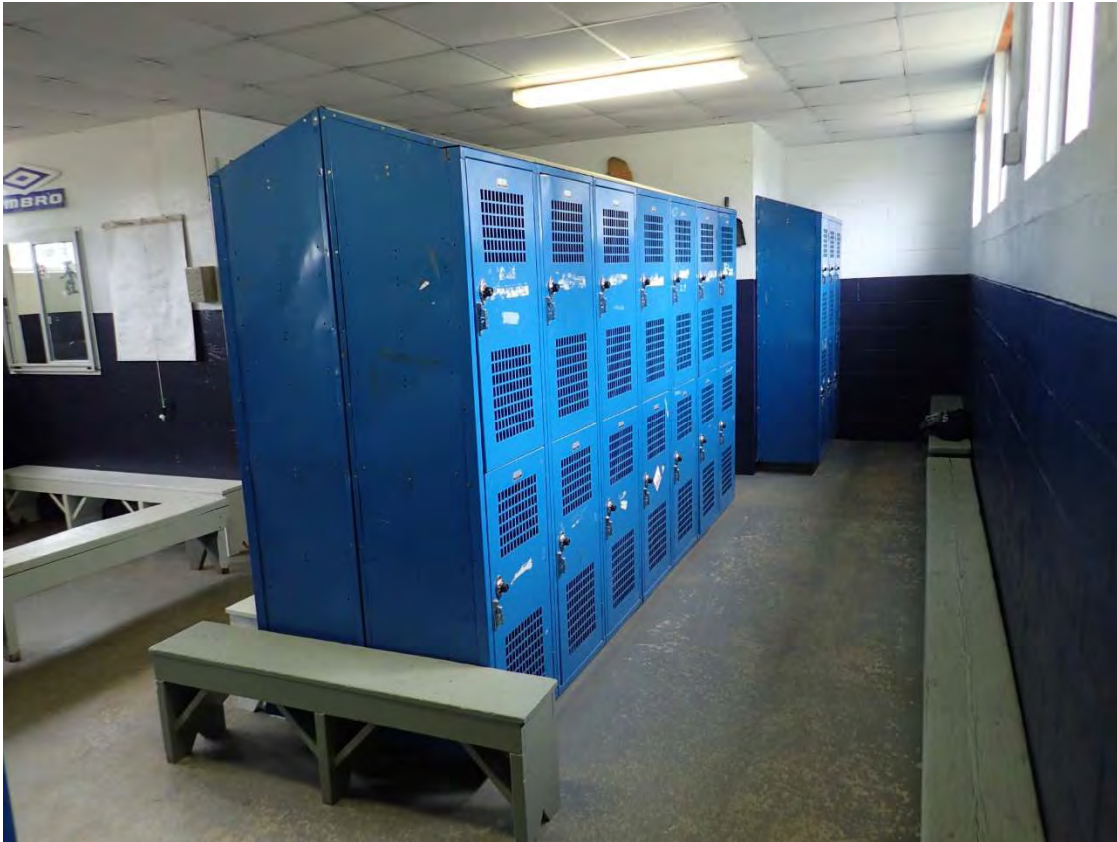
- Lockers are 15 years old and damaged. Replace lockers.

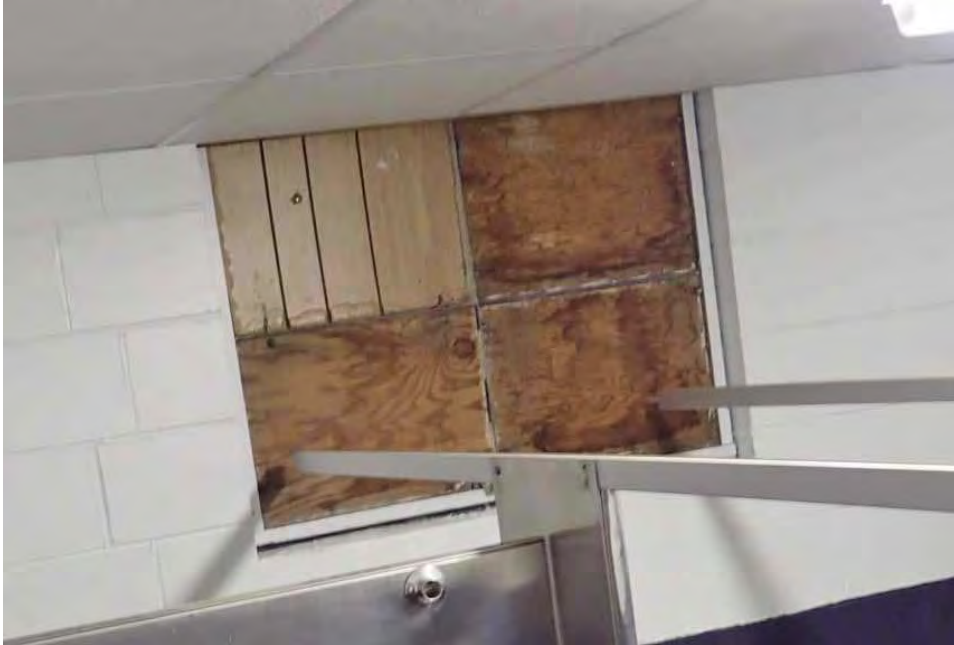
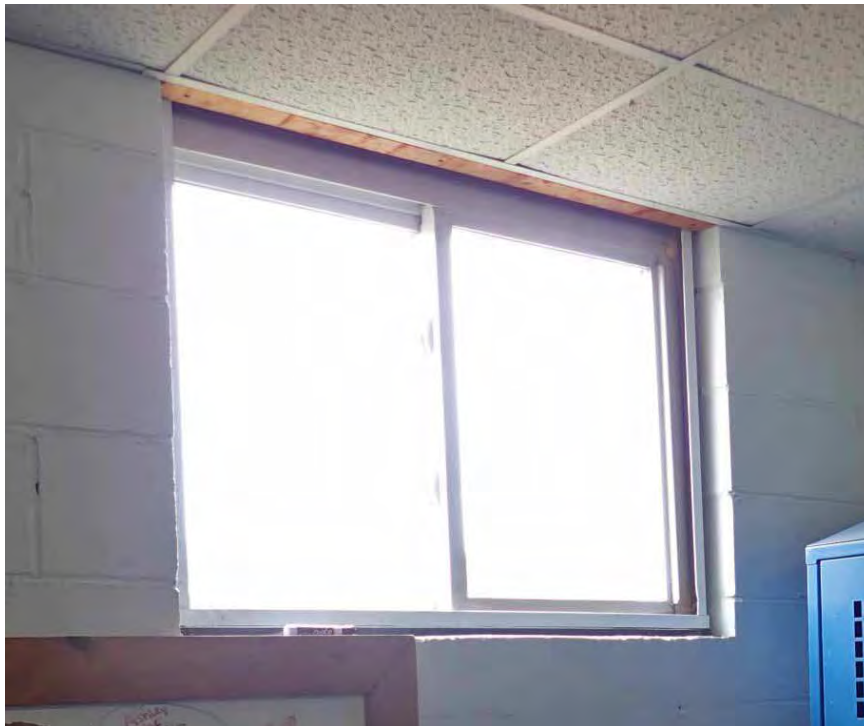
- The windows have been replaced recently, but the installation is not complete. Add interior trim at all windows and infill properly at abandoned windows.

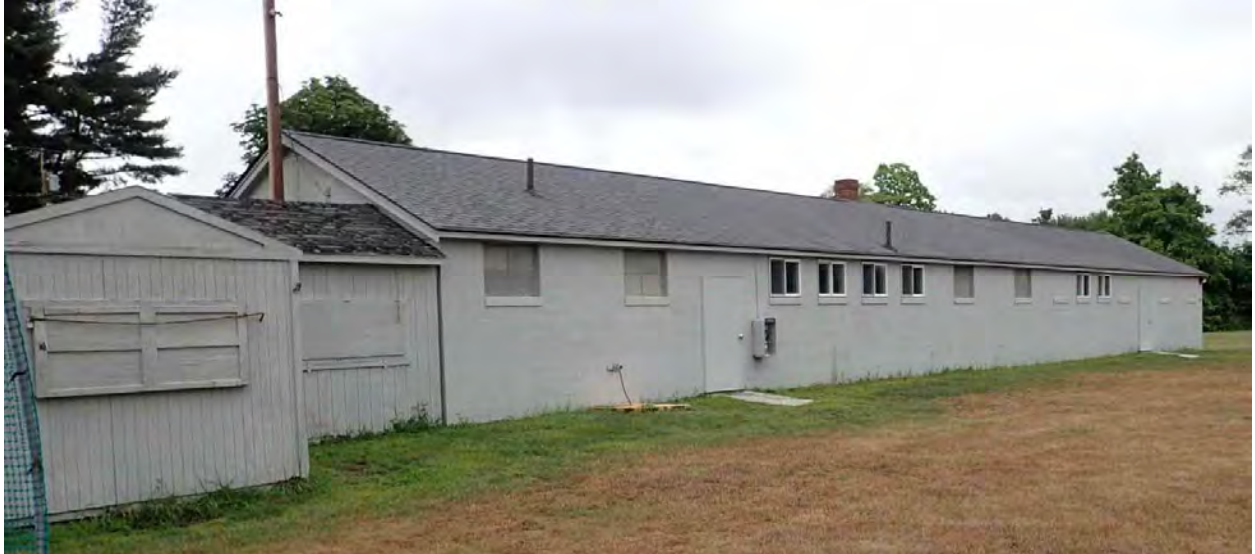
- The exterior of the building is painted concrete block. This is due to be repainted.

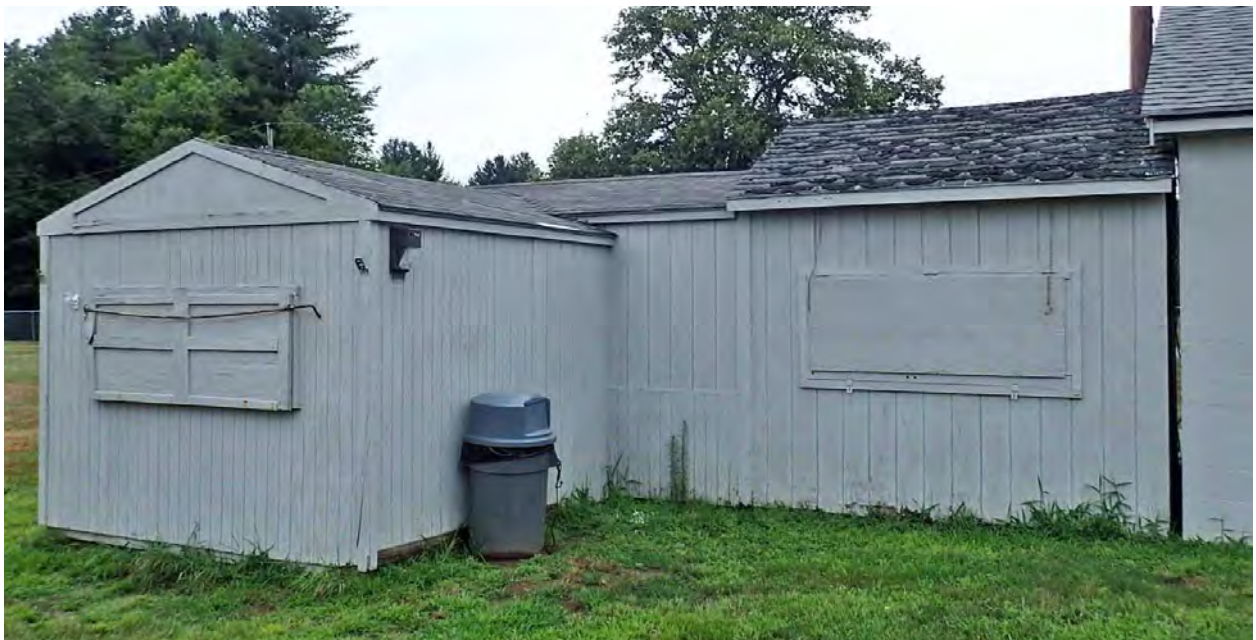
- The “snack shack” roof is in need of replacement with a new asphalt shingle roof.

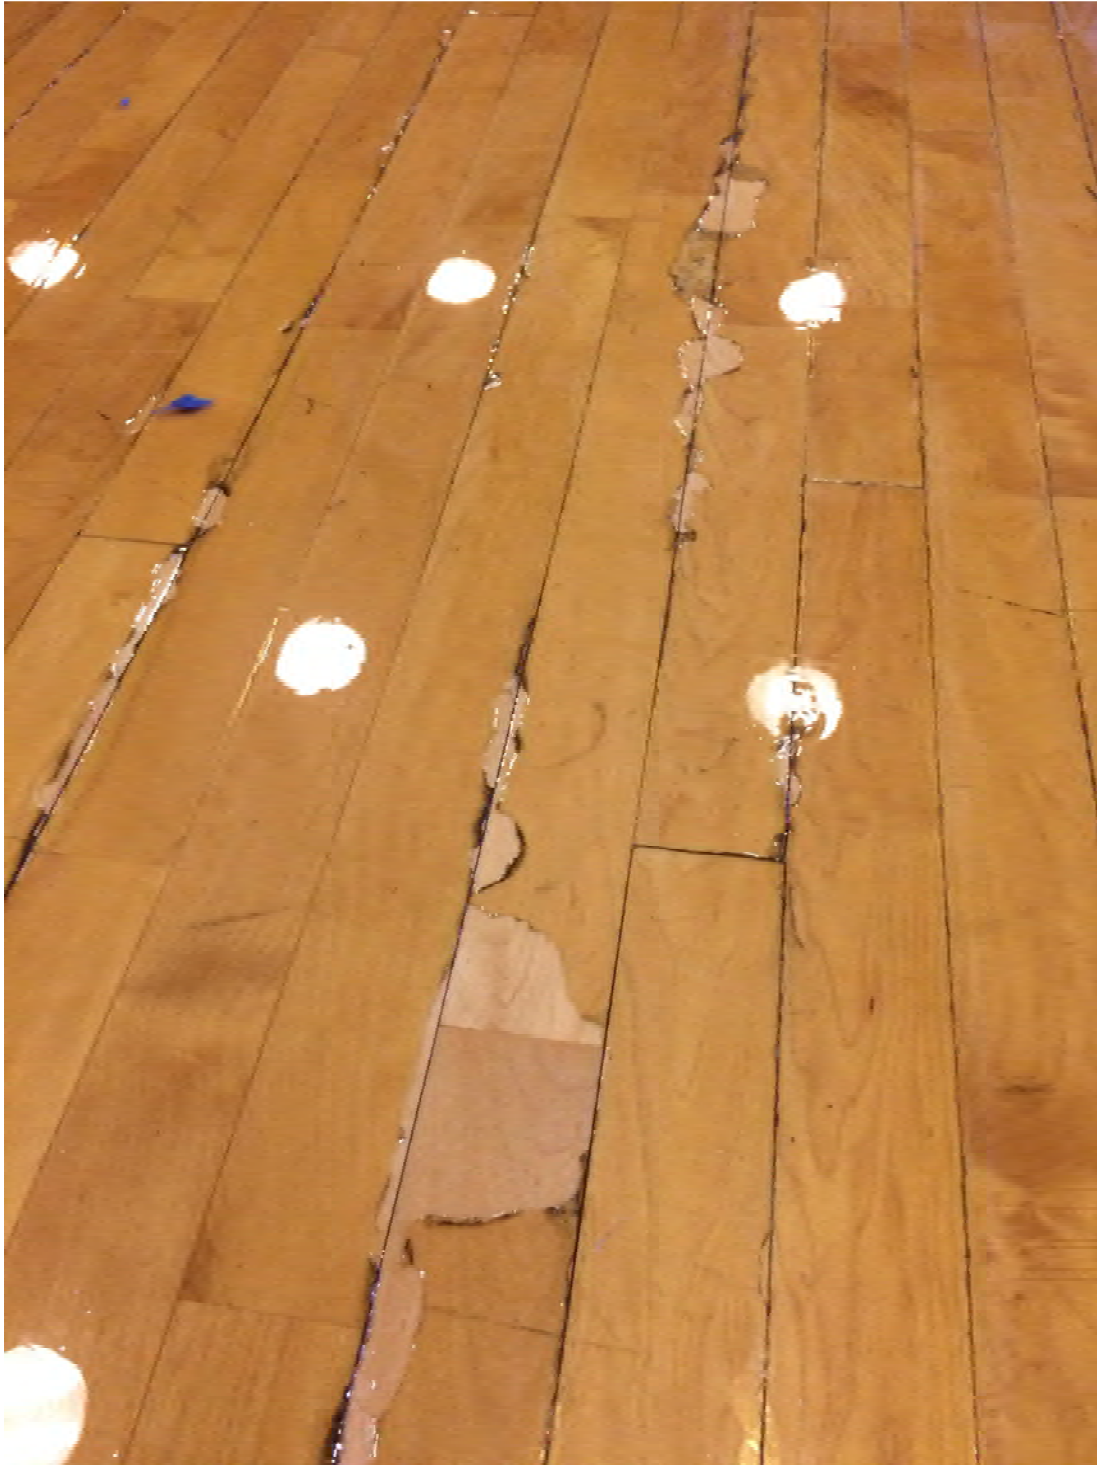
- The gym and minigym floors have had so many layers of finish applied that it is impossible to achieve a smooth surface where some finish has been removed. Sand both floors to bare wood, re-line the courts, and refinish the floors.
