Sanborn Regional School District

Facilities Study

Capital Improvement Projects 2018-2022

Marinace Architects

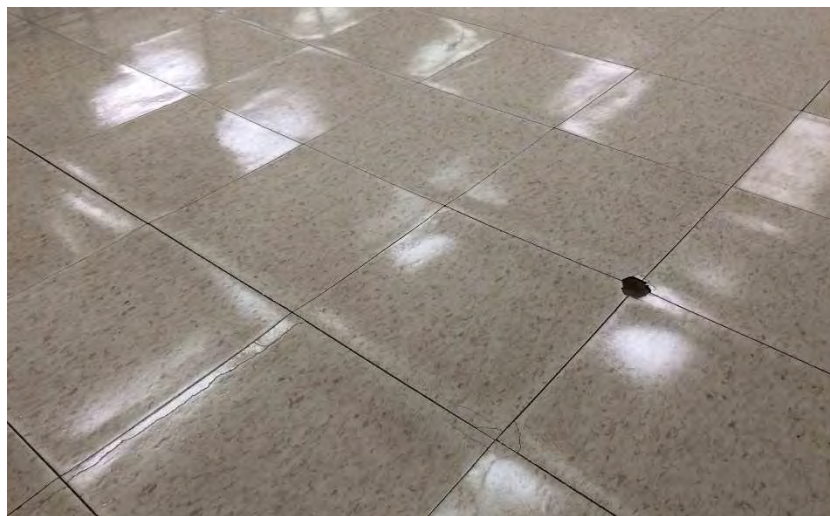
- The VCT flooring in Area D is in poor condition, and is lifting. This should be replaced unless the portables themselves are replaced.

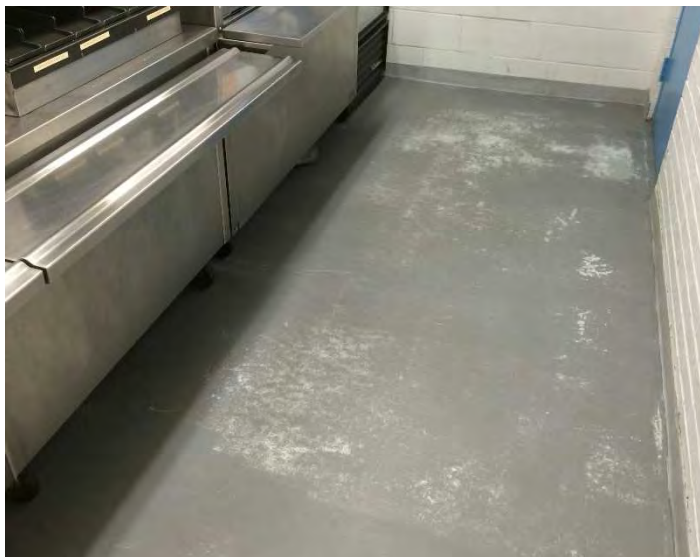
- The kitchen floor is painted concrete and is difficult to maintain. The best approach is to add quarry tile floor and base on top of the concrete.

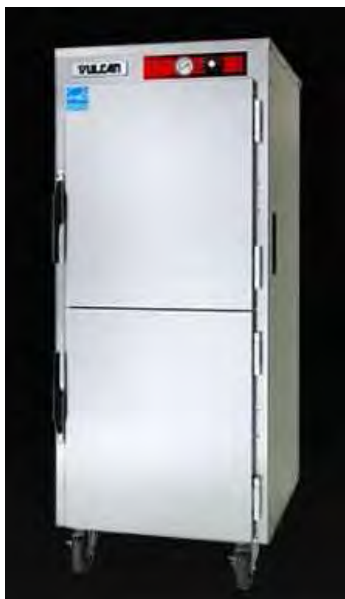
- Add an electric heated mobile holding cabinet to allow food to be served hot.

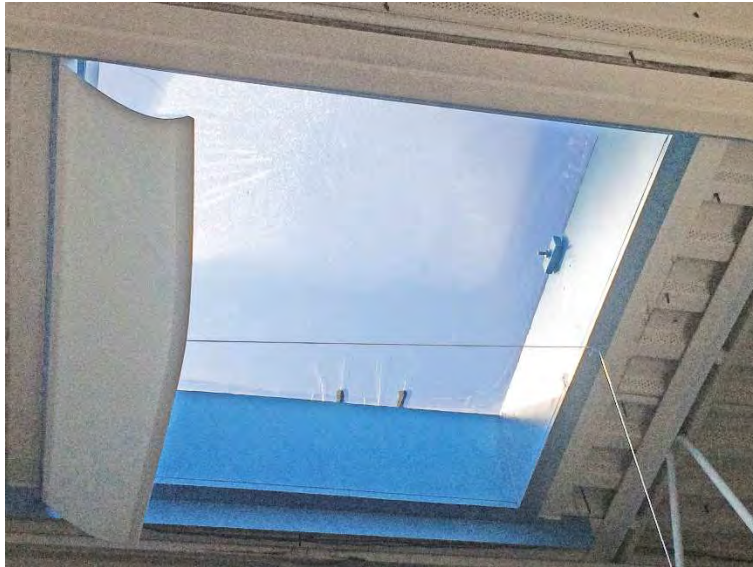
- (14) 4' x 4' plastic bubble skylights in the Gym, Art room and Library have started to fail. Many are cracked, have been caulked over the years, and several leak. Replace all skylights with new units.

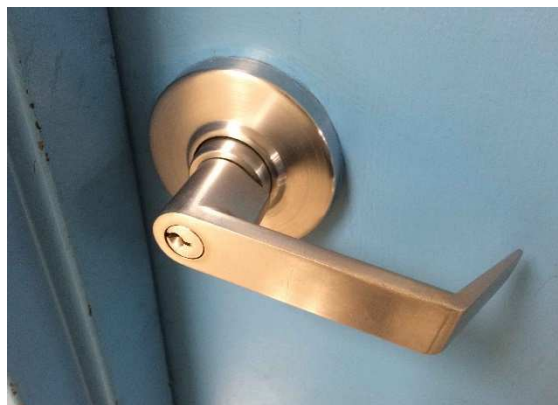
- Most of the school's door hardware dates to 1978-1995. The majority of door levers are loose and do not work properly. Many hinges are loose and in need of constant maintenance to keep doors operating. Replace all classroom-to-corridor door hardware. New hardware to include mortise locksets, Roton hinges if possible, and the classroom safety locking function, which is now standard in schools.

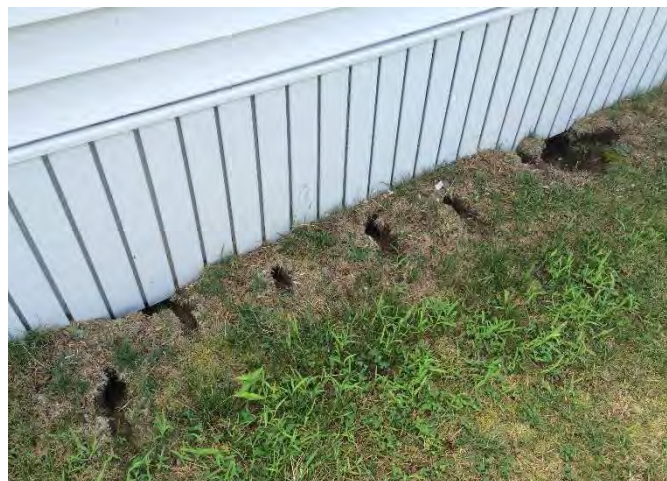
- There are 6 portable classrooms in Area D. Portable classrooms are an ongoing maintenance cost. These portables have low-grade windows that don't operate well, floors that are bubbling because of moisture, and a substantial number of animal holes dug beneath the vinyl skirt. Similar problems are likely to continue as long as the portables are in use. We therefore recommend that the six existing portable classrooms be replaced with permanent, high quality construction in the location of the existing portables.

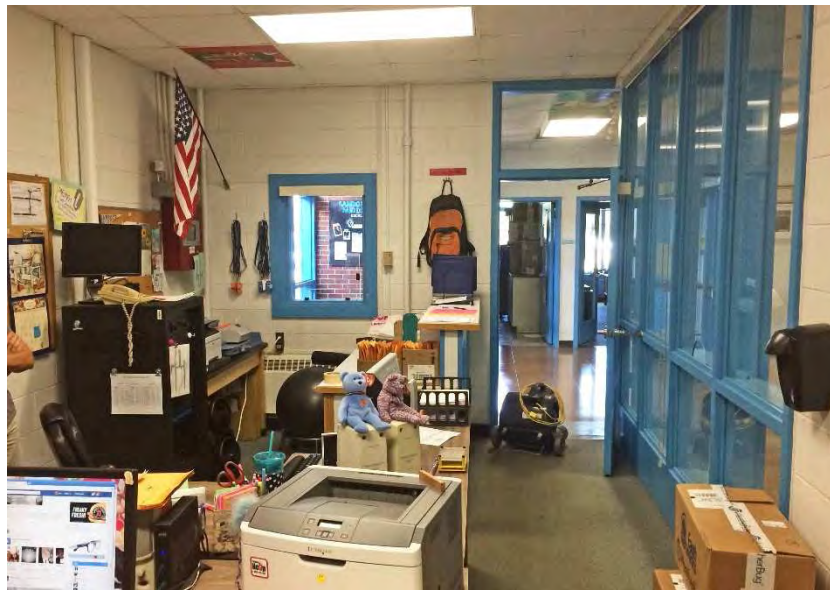
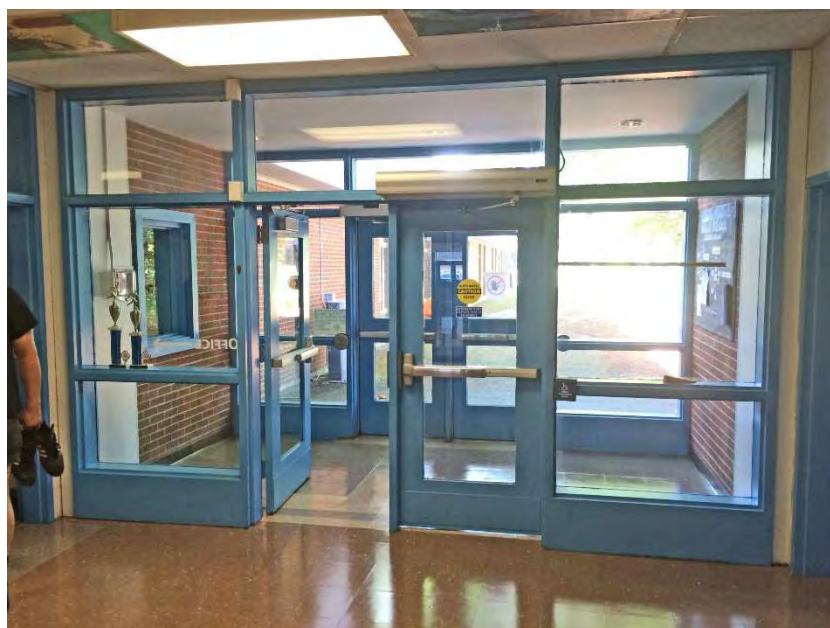
- The General Office does not have a secure waiting area where visitors check in with staff through a window and are then allowed into the building. This is not an ideal situation from a security standpoint. A good solution appears to be to create a secure reception area carved out of the existing office area. We believe this will require the expansion of the General Office into the adjacent classroom. Two benefits of this expansion could be the relocation of the Principal's Office back into the General Office area, and subsequently the expansion of the Nurse's Office into the current Principal's Office. See conceptual floor plan.

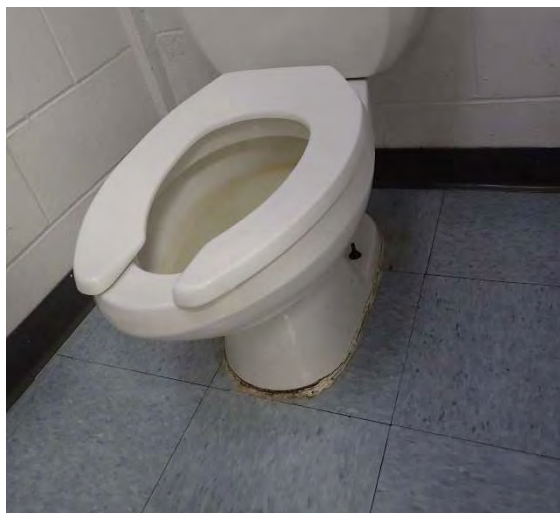
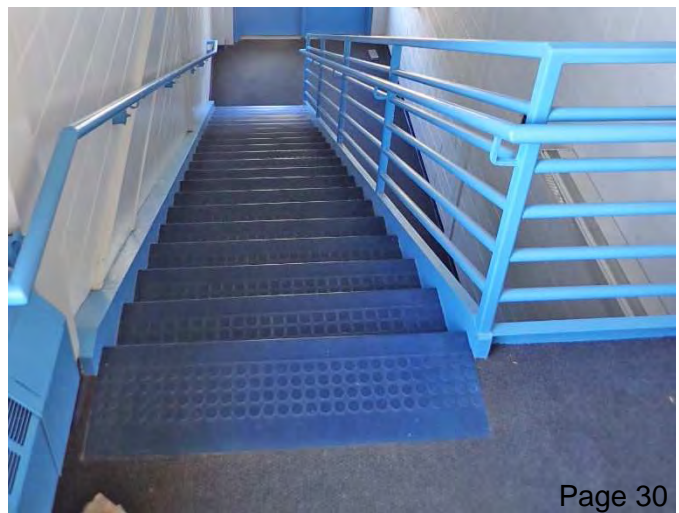
- Toilet room Floors: Two toilet rooms (nurse's toilet and art room toilet) have VCT flooring. Both should be changed to ceramic tile. The shower drain in the Nurse's toilet is not functional, and should be repaired as a maintenance item (not in CIP).
- Stair Floors: The first floor landings in stairs A, B and C are substantially worn. Replace with rubber tile flooring.

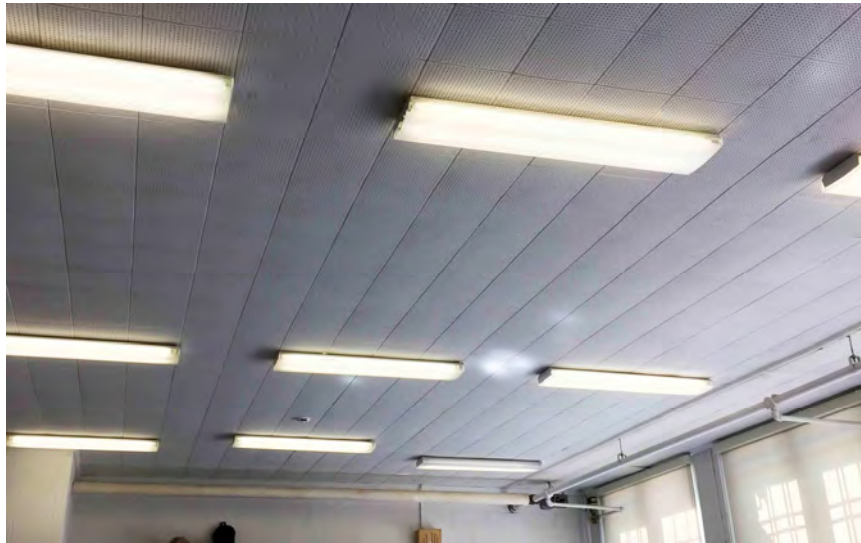
- Replace sagging kitchen ceiling tiles with moisture resistant vinyl faced tile, such as Armstrong “clean room mylar”.
- Replace stained ACT tiles at front conference room.
- The music room is quite loud and has old 1’ x 1’ tiles. To reduce noise, add a suspended acoustic ceiling system below the existing. Replace lights. Move down electrical devices.

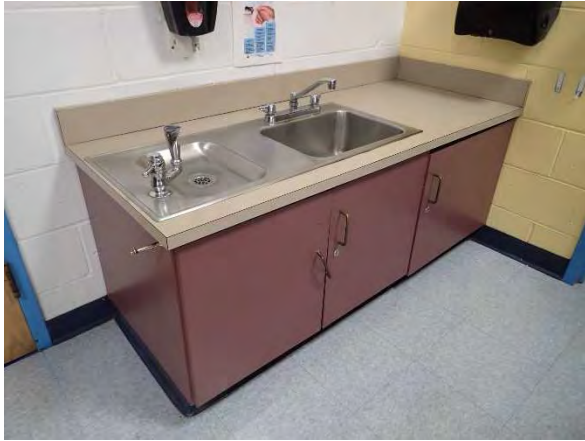
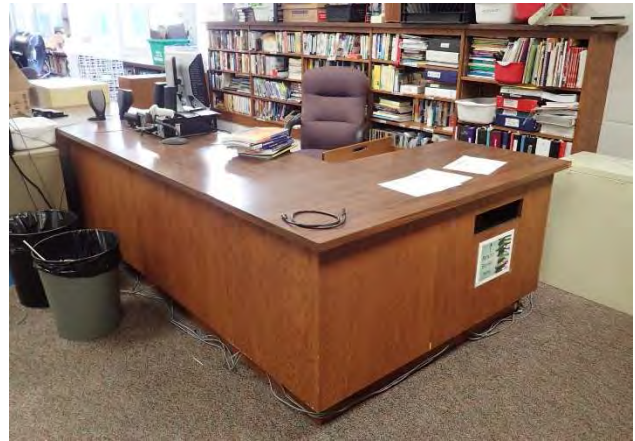
- Replace all casework, sinks & faucets in the building except those in the General Office area and Area B. Because frequent splashing by young students quickly delaminates plastic laminate counters, use solid surface counters & sinks at classrooms.

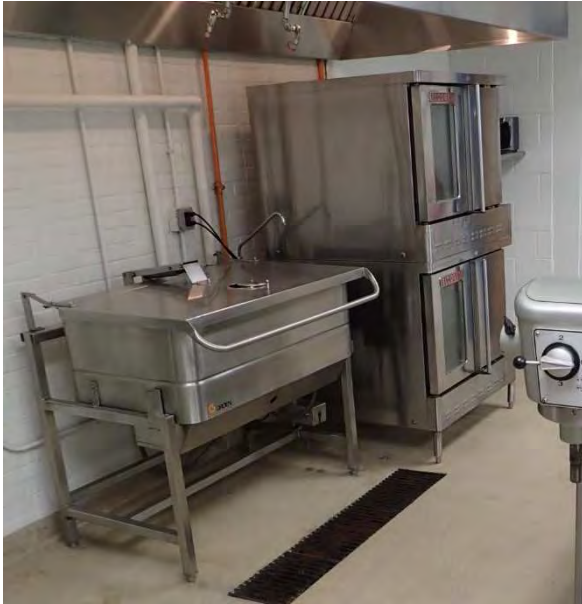
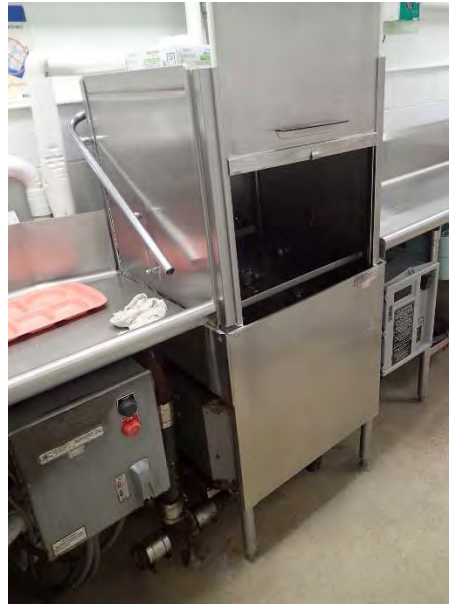
- After discussions with the kitchen staff, it was determined that the dishwasher is old and should be replaced, and that the obsolete skillet should be replaced with a new steamer.

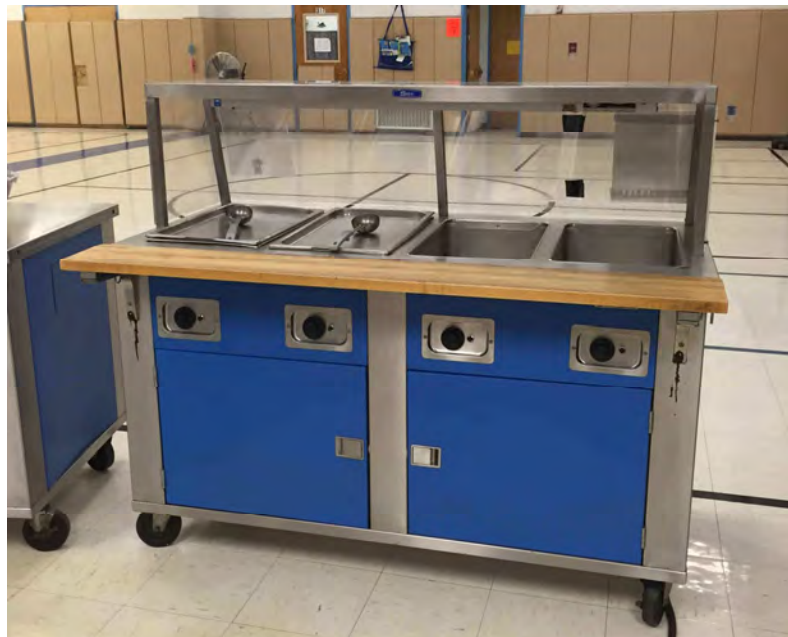
- Replace the wood tray slides at the serving line with stainless steel. The hot pan unit at the serving line is worn and needs replacement.

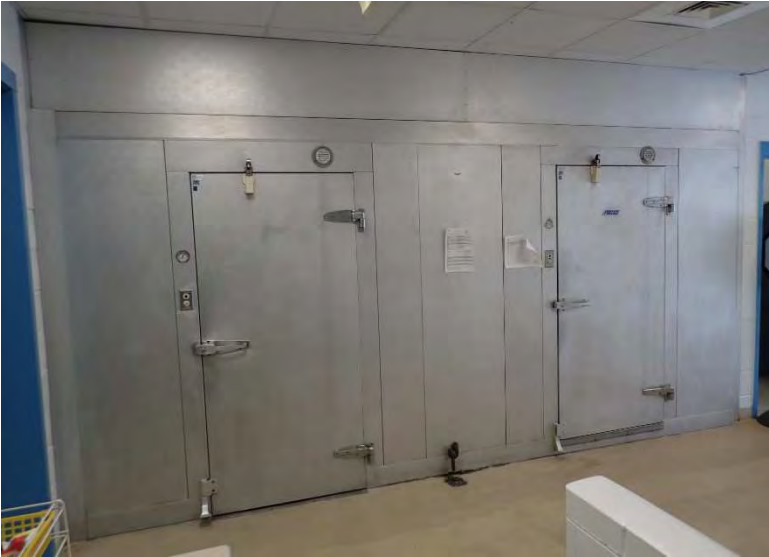
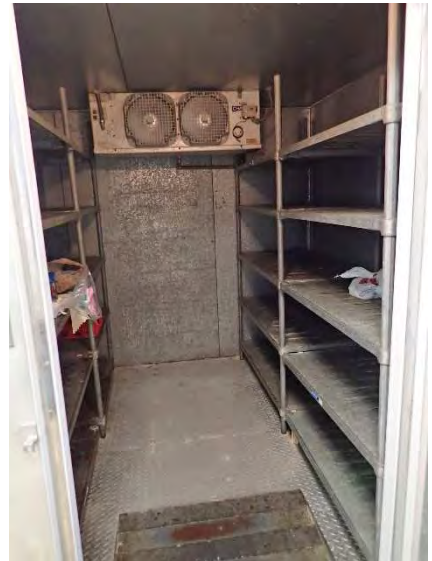
- Walk-in cooler & freezer are at the end of their life. Replace.

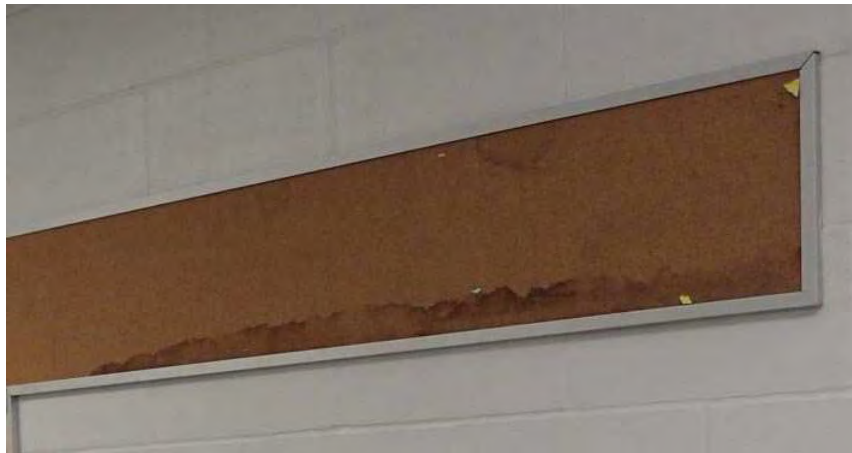
- All tackboards in the school show substantial wear. Most are currently covered to hide staining and peeling. All tackboards should be replaced with vinyl covered boards such as Claridge Fabricork Boards. Marker boards are in good condition.

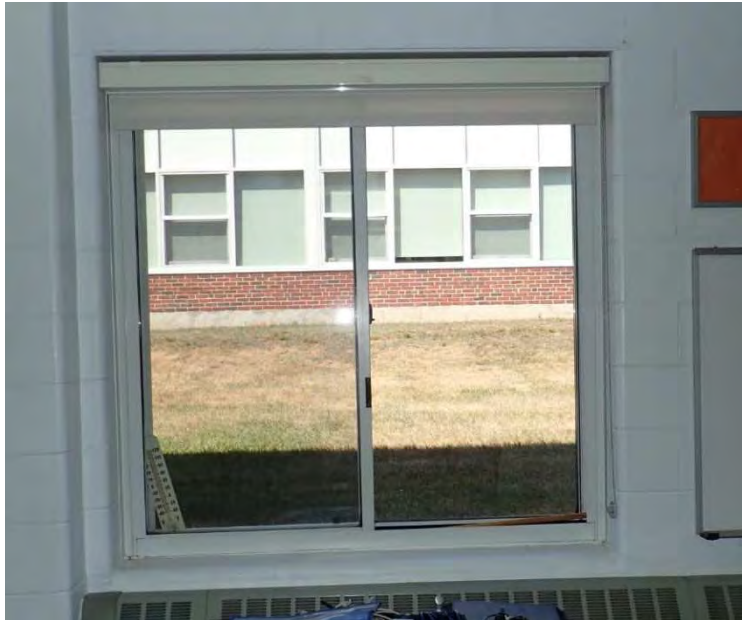
- Windows in the 1989 wing are old, starting to operate poorly, and are not energy efficient. Replace with new heavy duty commercial aluminum windows.

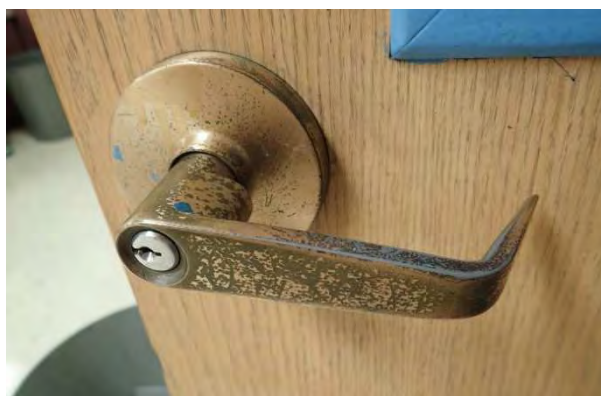
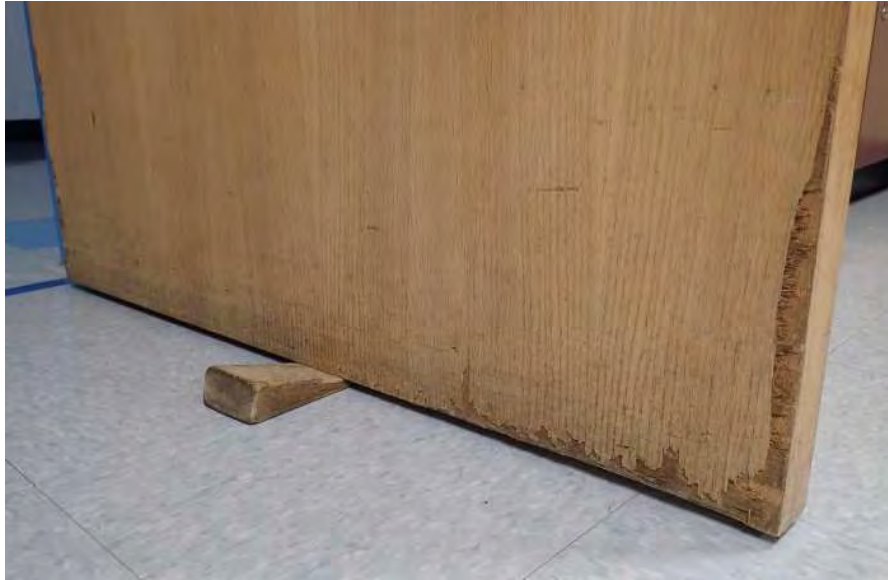
- Most of the school's door hardware dates to 1989. The majority of door levers are loose and do not work properly. Many hinges are loose and in need of constant maintenance to keep doors operating. Many classroom doors are in poor condition due to binding at the frame and from being propped open with wedges. Replace all classroom-to-corridor doors and hardware in areas B & C. New hardware to include mortise locksets, Roton hinges, and the classroom safety locking function, which is now standard in schools.

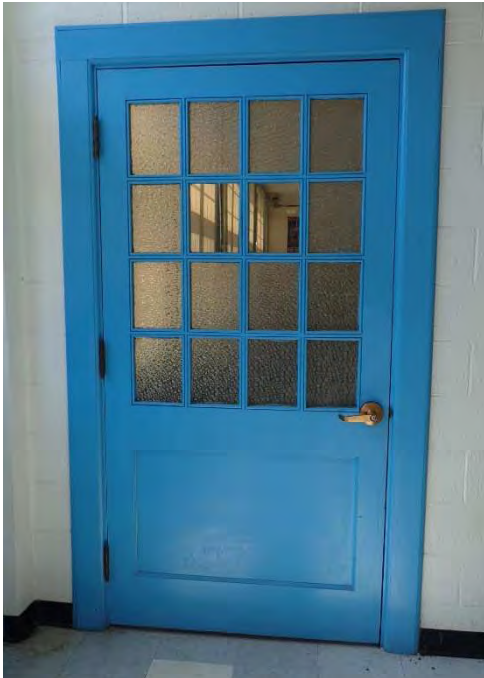
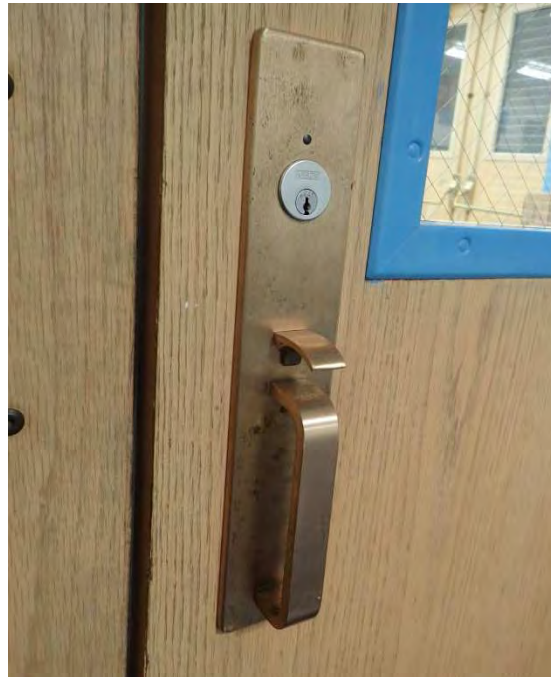
- Many original doors in Area A contain glass that is neither tempered nor wire glass, and should be replaced.
- Doors to the Multipurpose Room have thumb latches that do not meet ADA standards, and replacing hardware, closers and panic hardware on old doors typically results in the need to provide new doors too. Replace doors & hardware.

- Area A Corridor doors need upgraded hardware. See plan for locations.

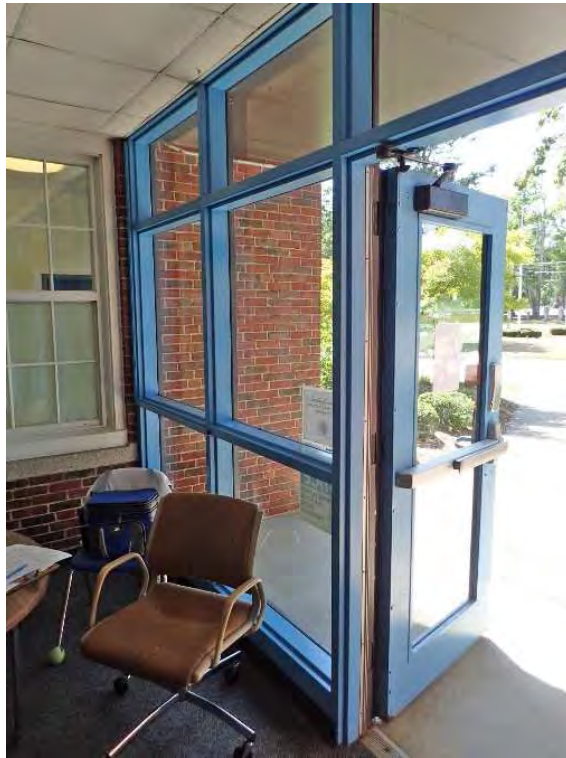
- The doors and storefront at Area B are single pane and uninsulated. Replace vestibule and exterior doors with new insulated doors and frames.

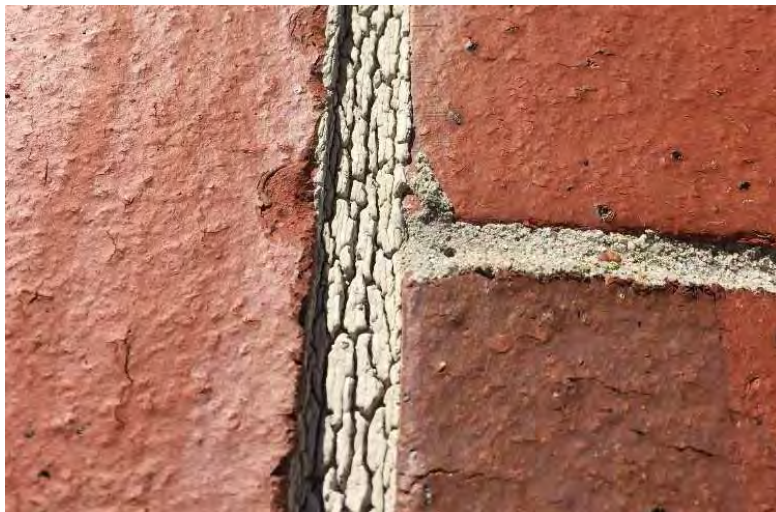
- Caulking at brick control joints is beginning to fail, with significant cracks starting to open up. This caulking should be replaced. Caulking at the new windows is in excellent condition.

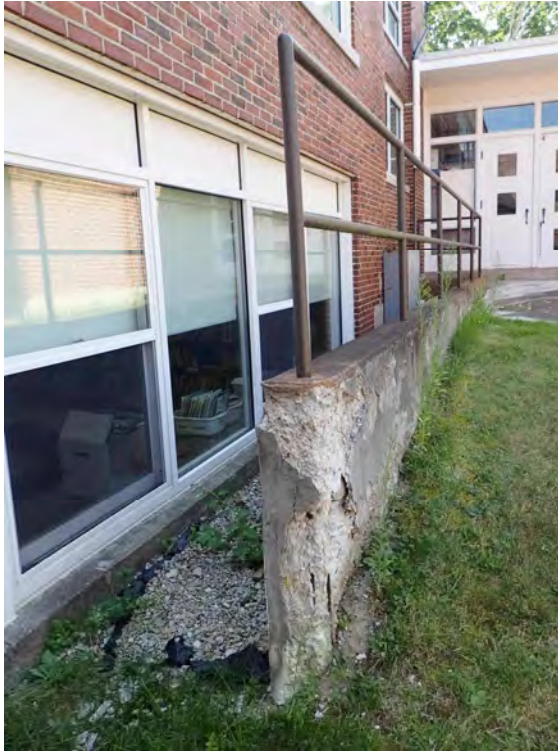
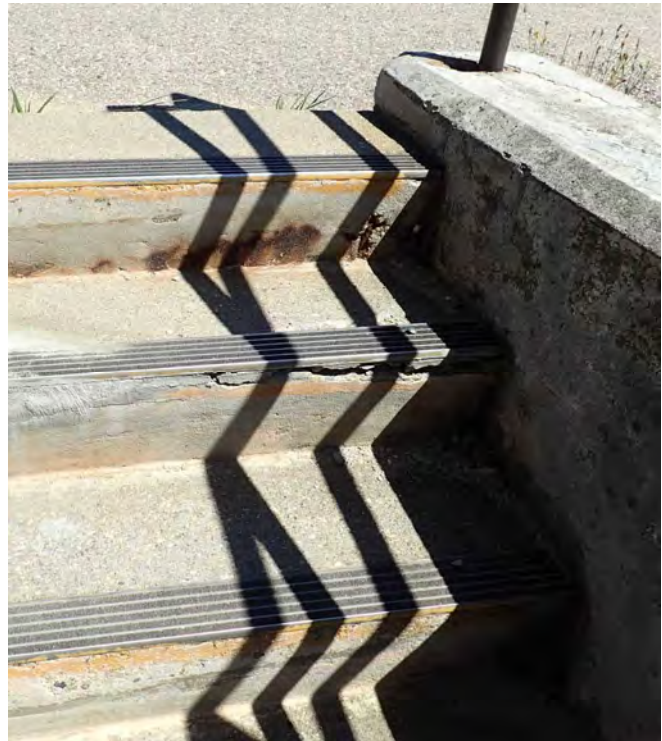
- Repair the concrete retaining wall outside the Media Center.
- Repair exterior stair at Stair A. Concrete is crumbling.

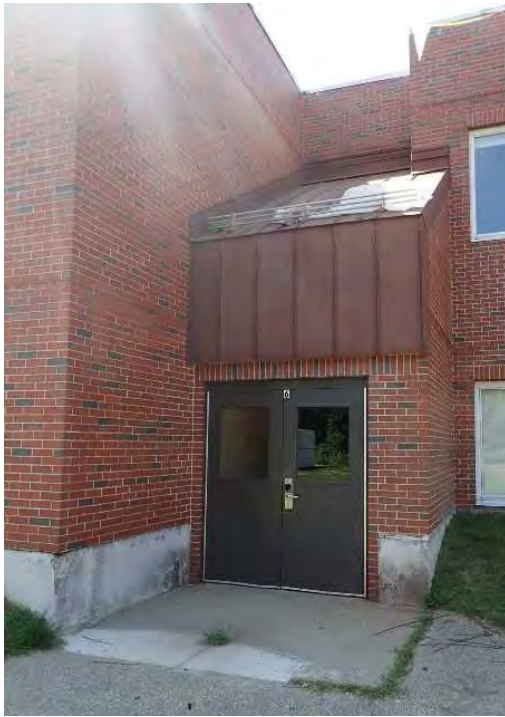
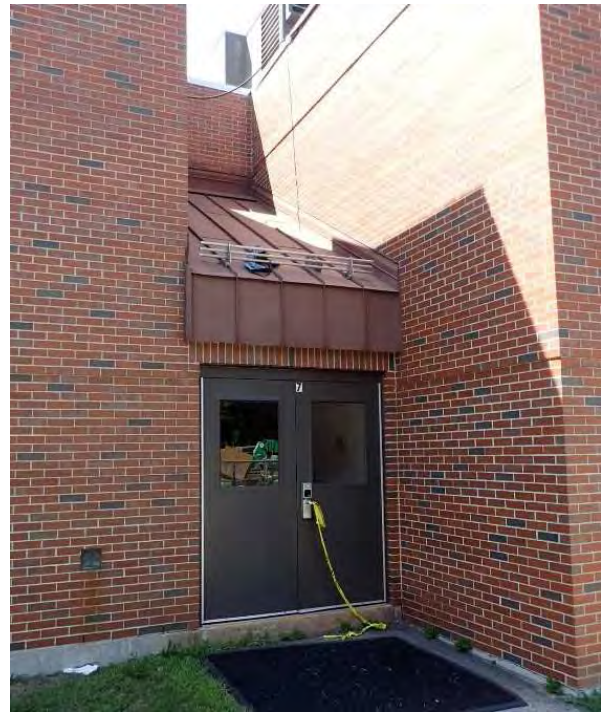
- The metal roofs at the three stair wells of Area C reportedly leak, and appear to be a hazard as they drop snow and water on the doors below. The leaking is likely due to the sloping flashing condition, which doesn't penetrate the cavity wall. At a minimum the roofs should be replaced, and the flashing corrected. The best solution would be to eliminate the sloping condition, and change these areas to flat membrane roofs which would capture snow and ice. This would involve taking off the existing roofs, building up the block / brick walls to the correct height, and adding new roof structure, insulation and roofing on top, with new roof drains.

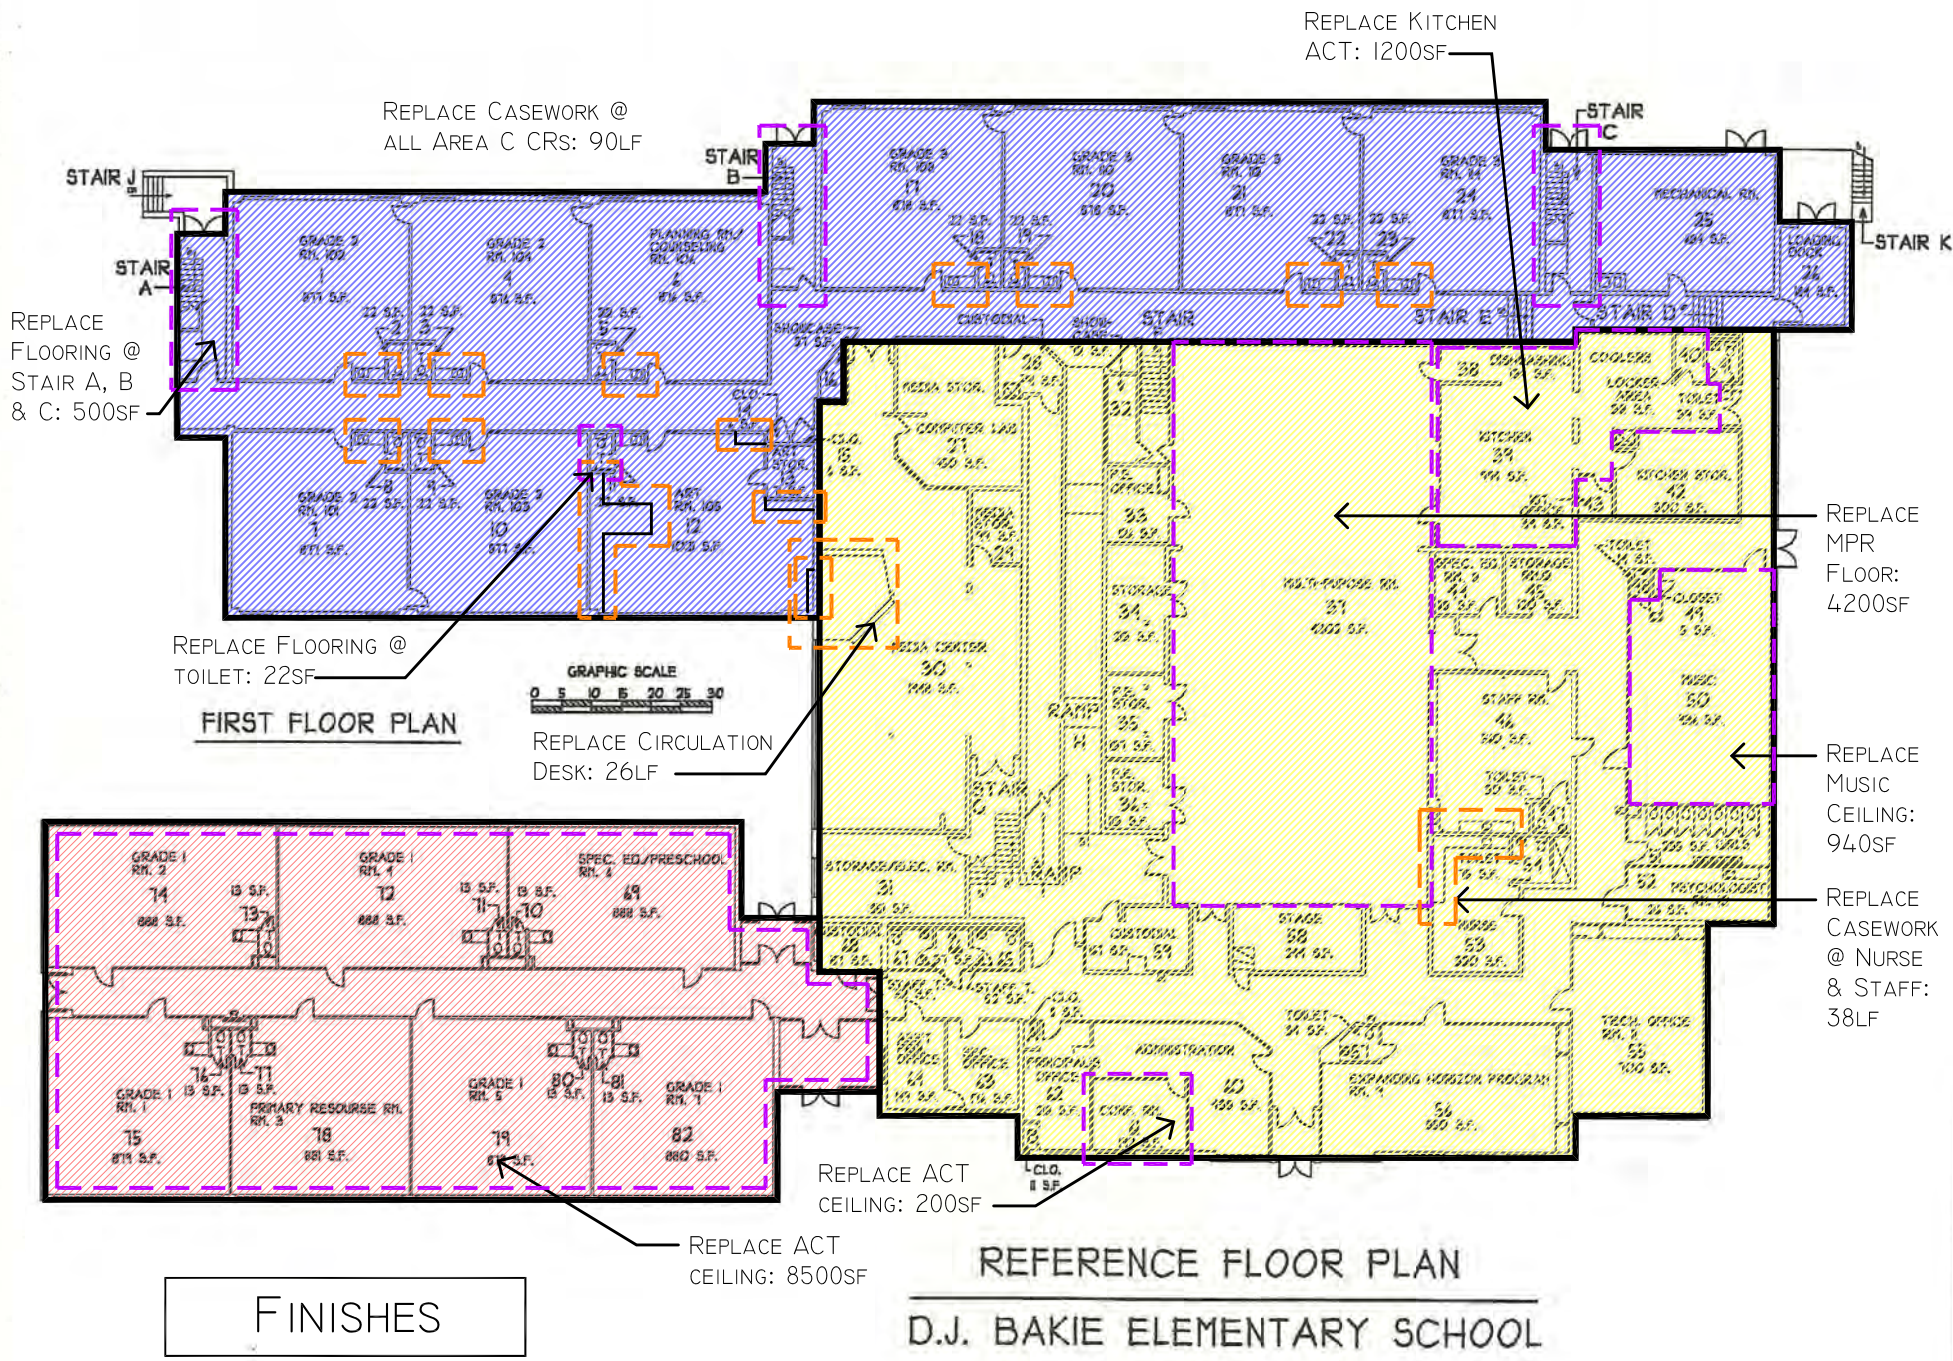
FIRST FLOOR PLAN

REPLACE FLOORING @
TOILET: 22SF

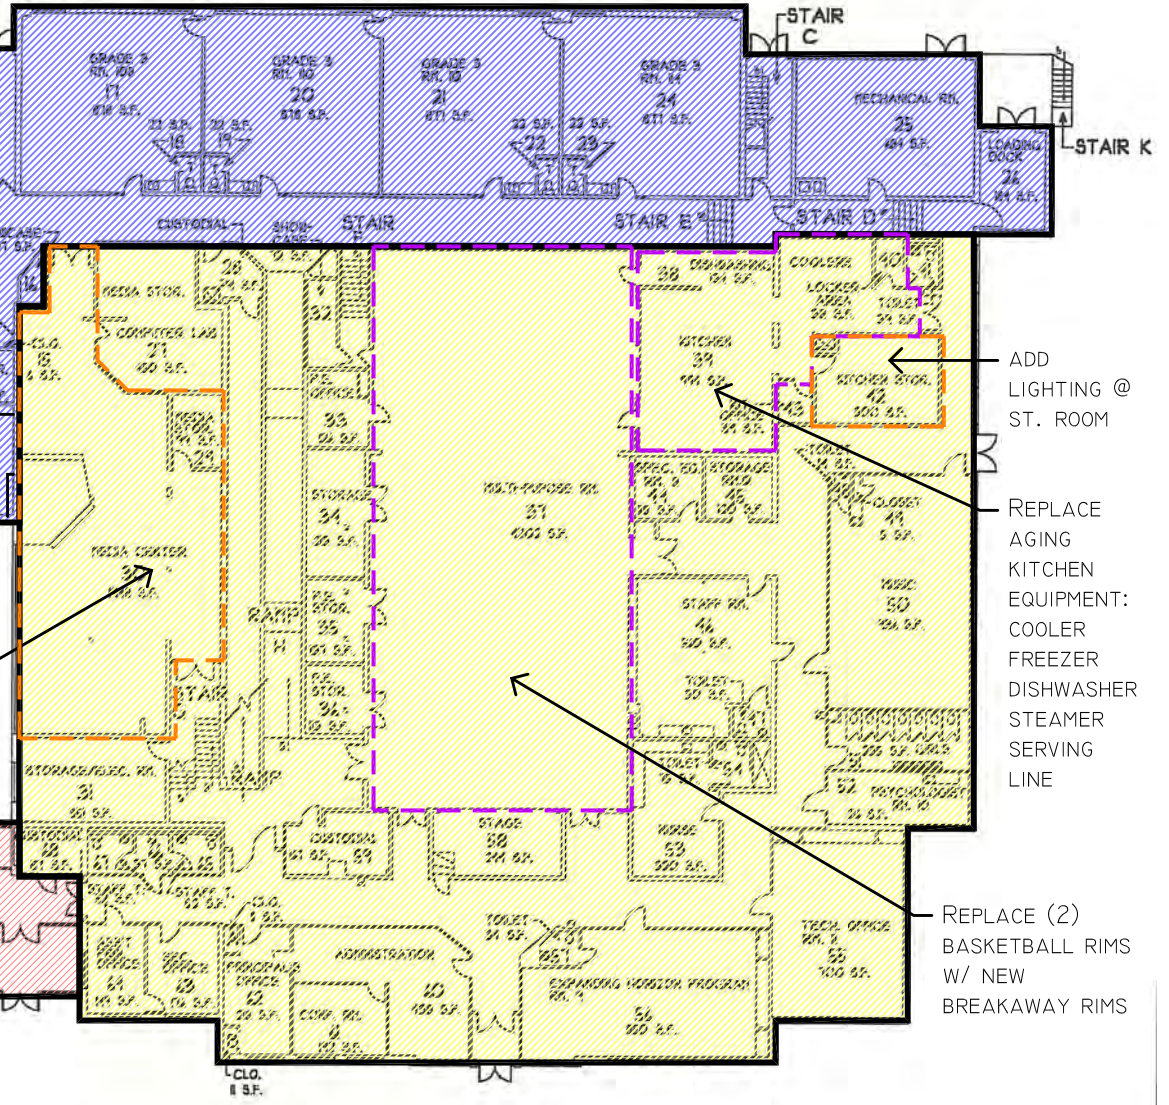
REFERENCE FLOOR PLAN
D.J. BAKIE ELEMENTARY SCHOOL

ADD LIGHTING @ ST. ROOM

REPLACE AGING KITCHEN EQUIPMENT:
COOLER
FREEZER
DISHWASHER
STEAMER
SERVING LINE

REPLACE (2) BASKETBALL RIMS W/ NEW BREAKAWAY RIMS

REPLACE TACKBOARDS IN ALL
CLASSROOMS IN ALL AREAS OF
SCHOOL

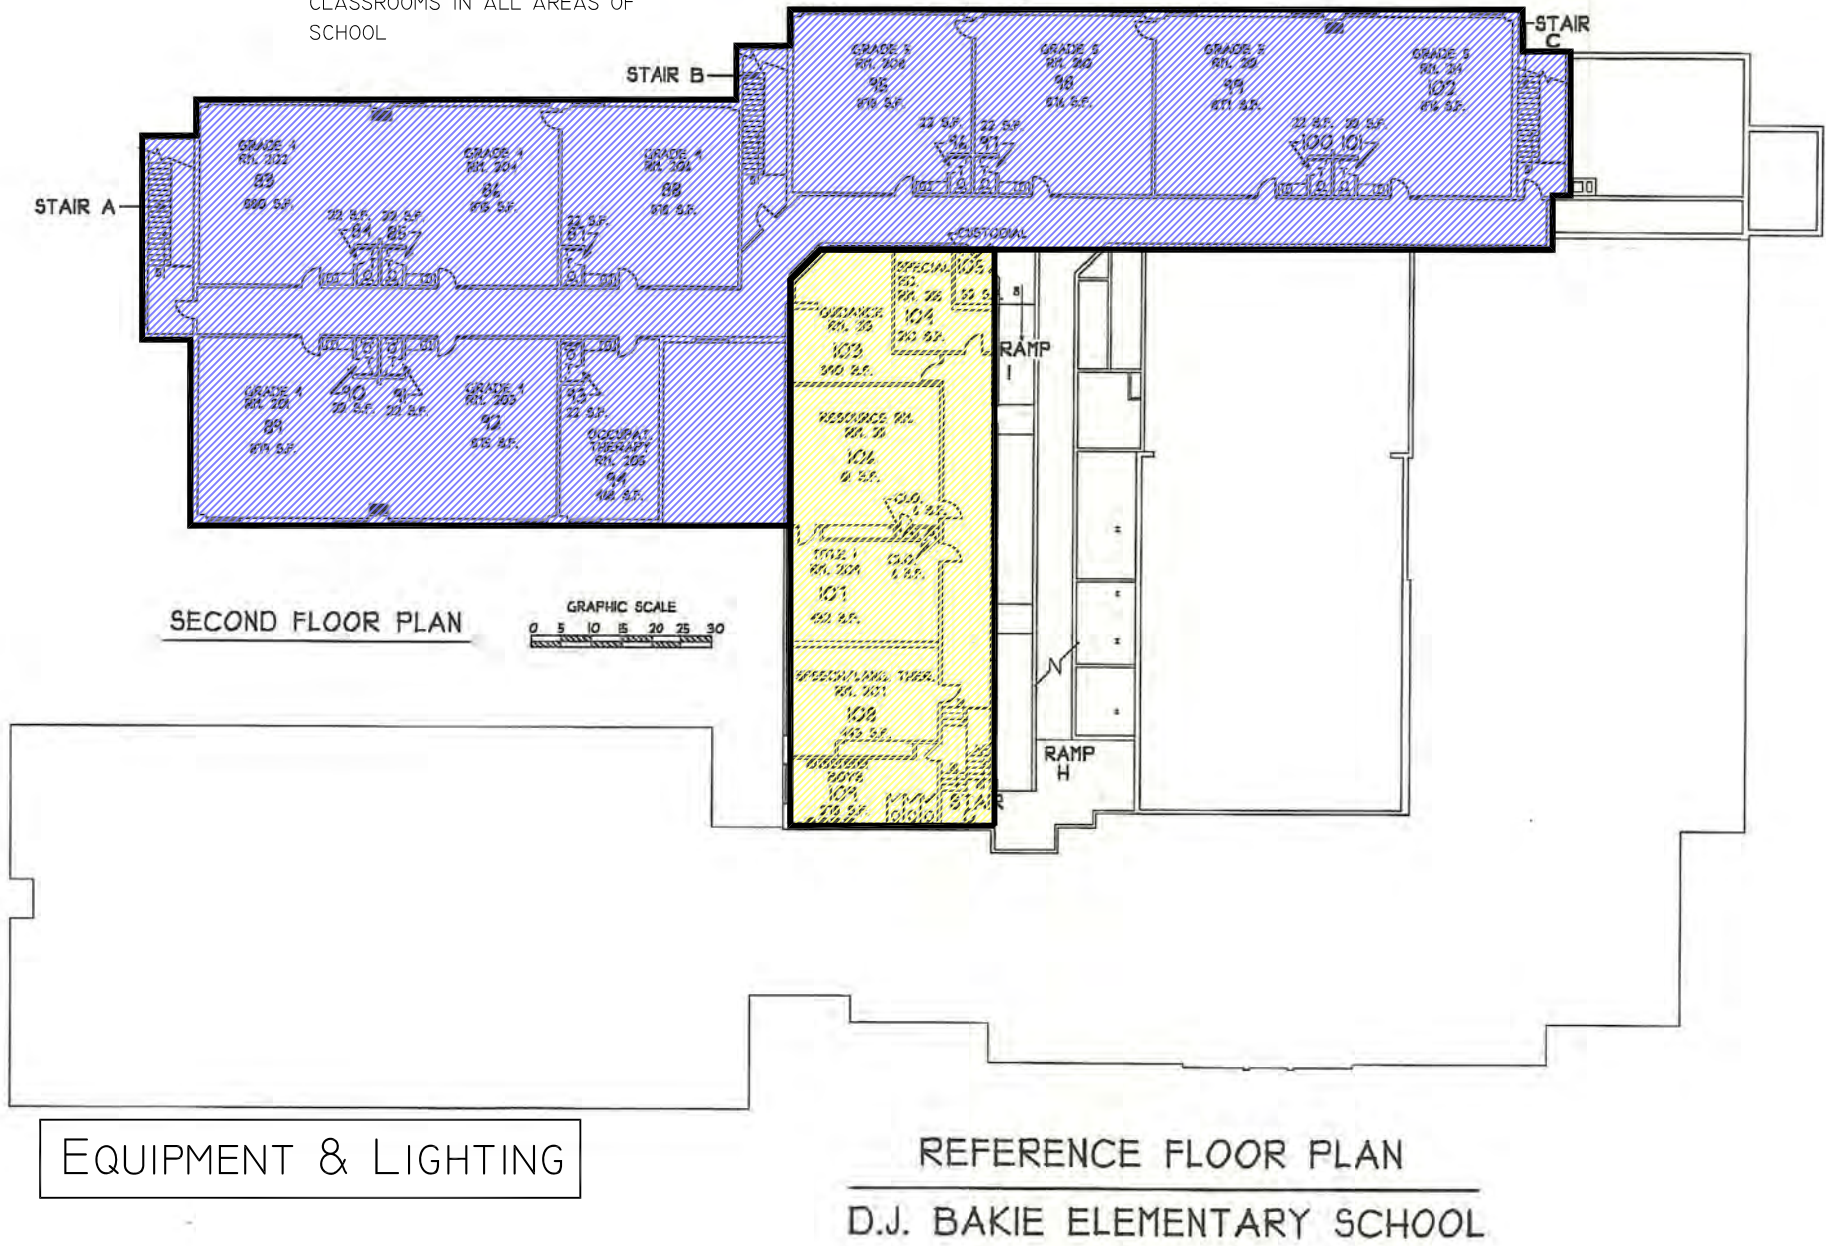
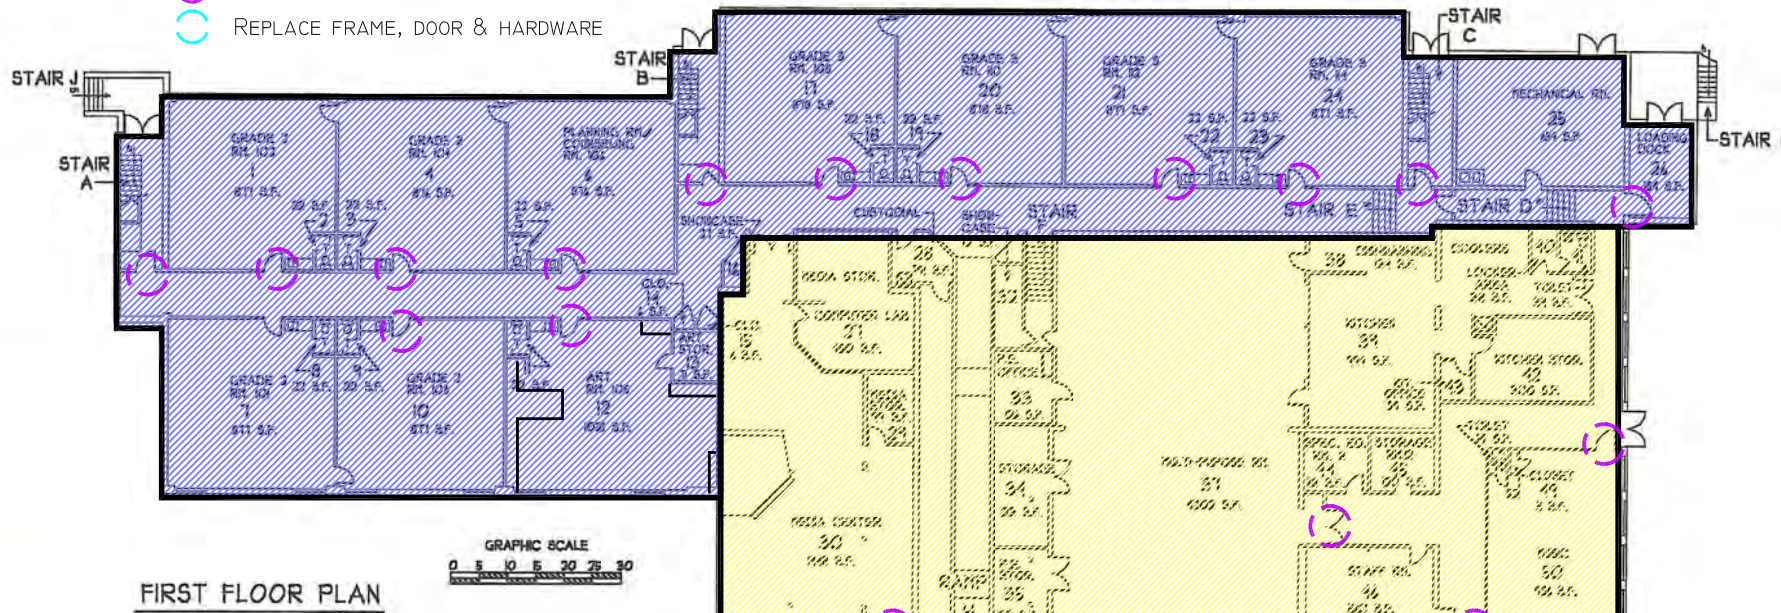
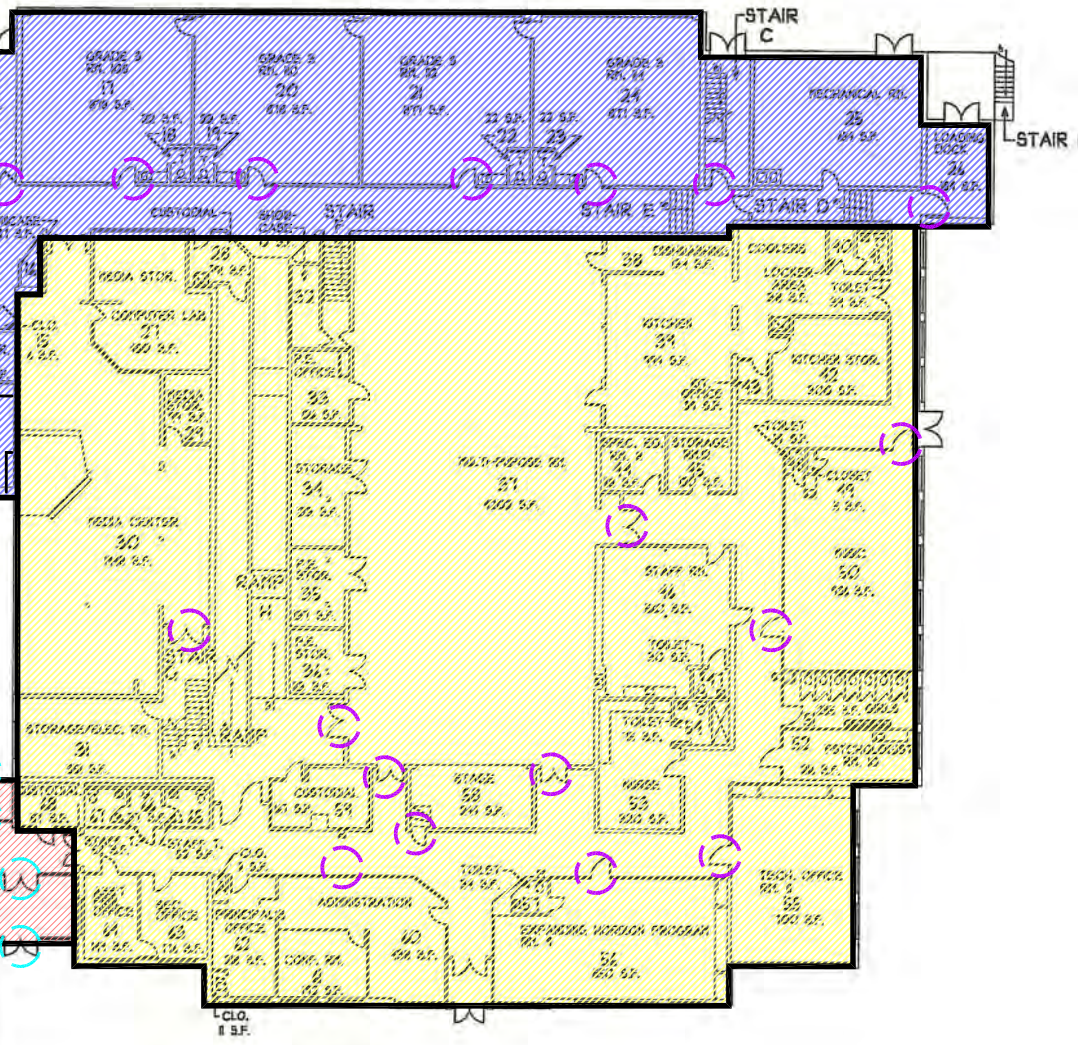
DOORS & HARDWARE

REPLACE HARDWARE ONLY
-

REPLACE DOOR & HARDWARE
-

REPLACE FRAME, DOOR & HARDWARE

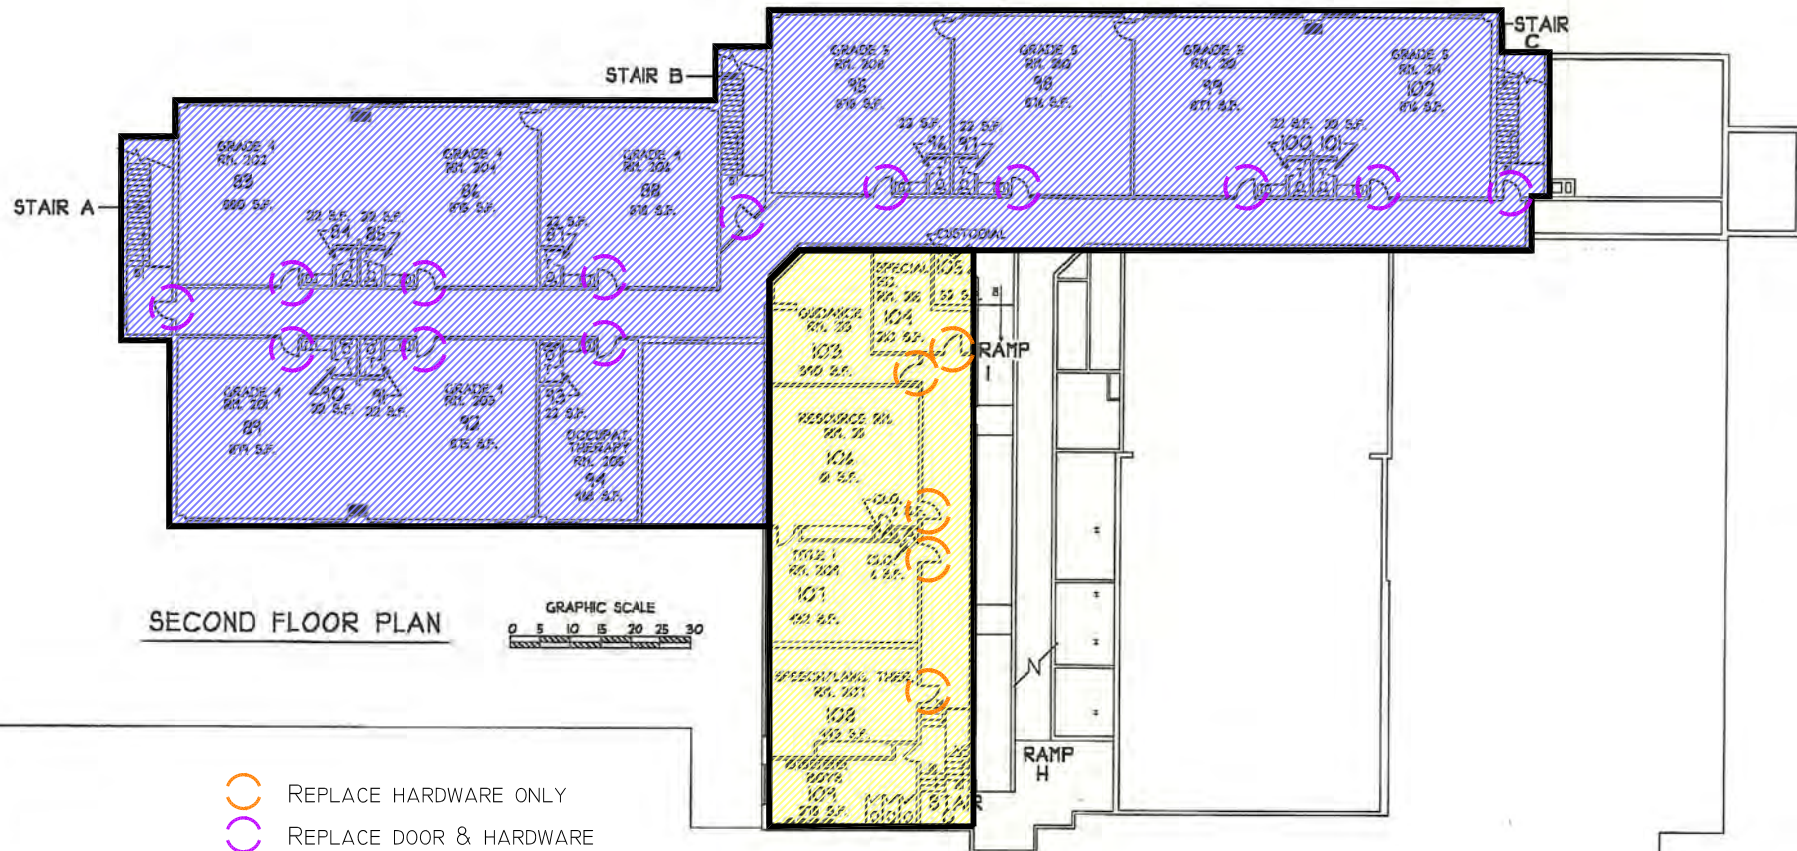
DOORS & HARDWARE

- REPLACE HARDWARE ONLY
- REPLACE DOOR & HARDWARE
- REPLACE FRAME, DOOR & HARDWARE
