Sanborn Regional School District

Facilities Study

Capital Improvement Projects 2018-2022

Marinace Architects

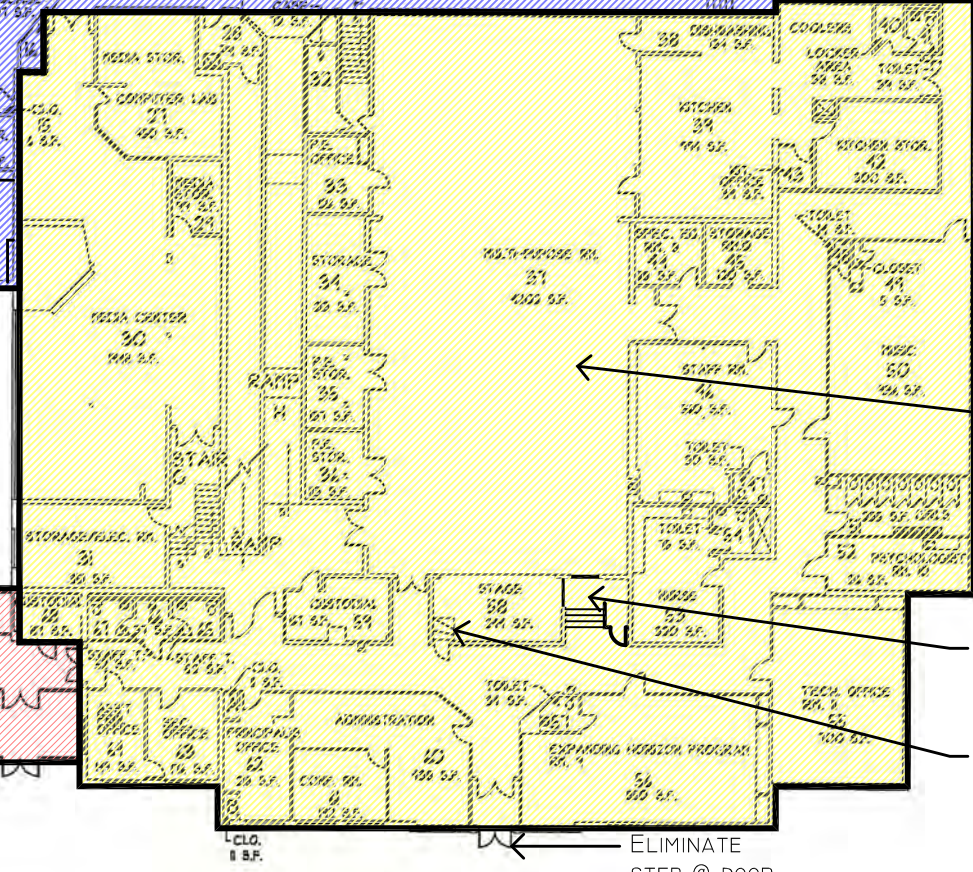
CODE COMPLIANCE

PROVIDE ADA ROOM SIGNAGE THOUGHTOUT.
PROVIDE FIRE EXIT SIGNS THROUGHOUT.

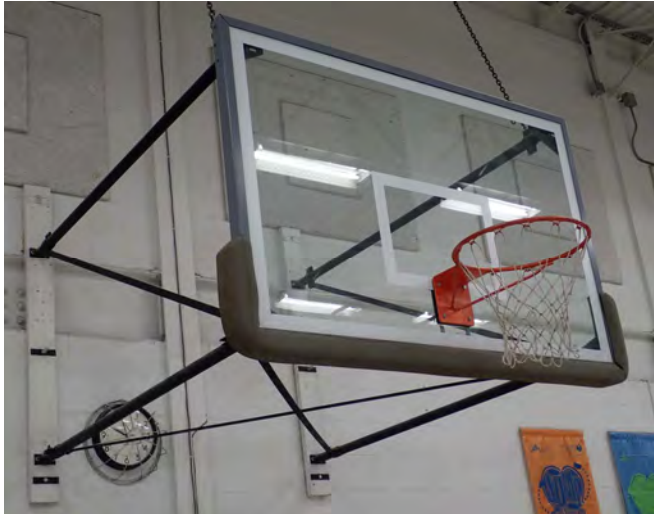
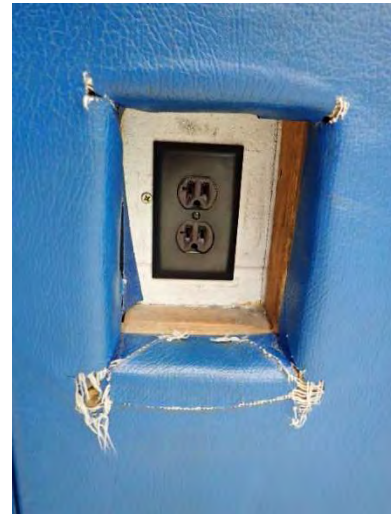
- Replace basketball rims with new breakaway rims. Replace pads around backboard.
- Wall pads are worn and are cracking along the seams. They have reached the end of their life and should be replaced.

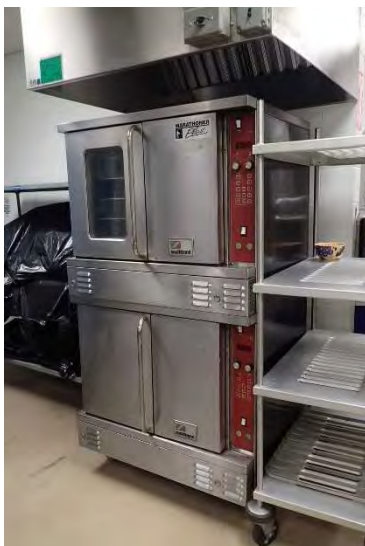
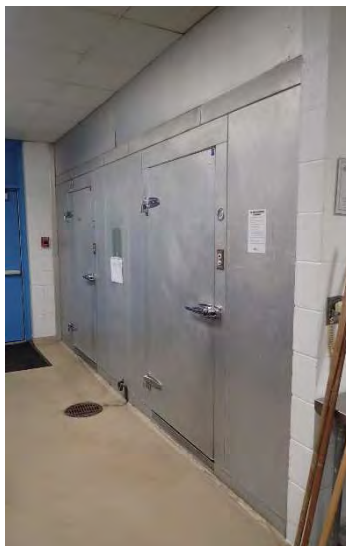
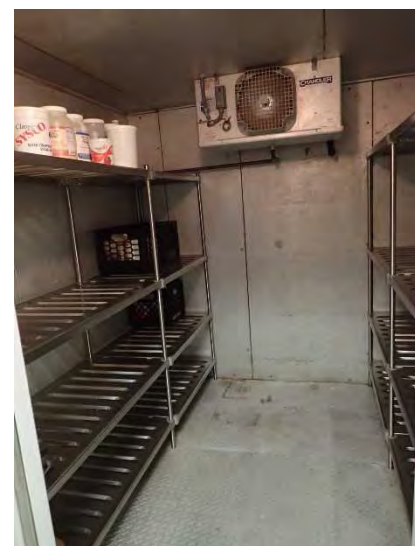
- Replace Oven and walk-in Cooler & Freezer: at end of life cycle.

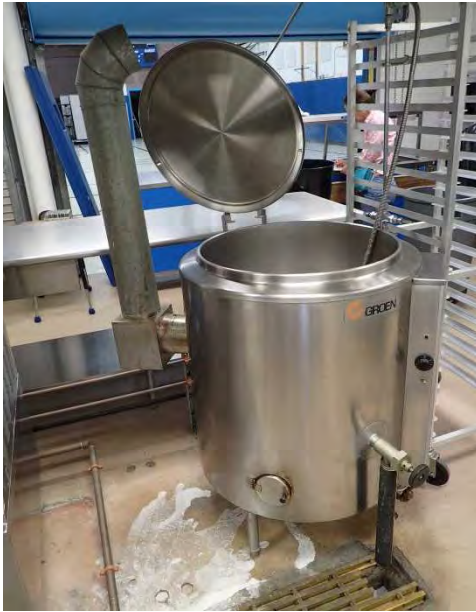
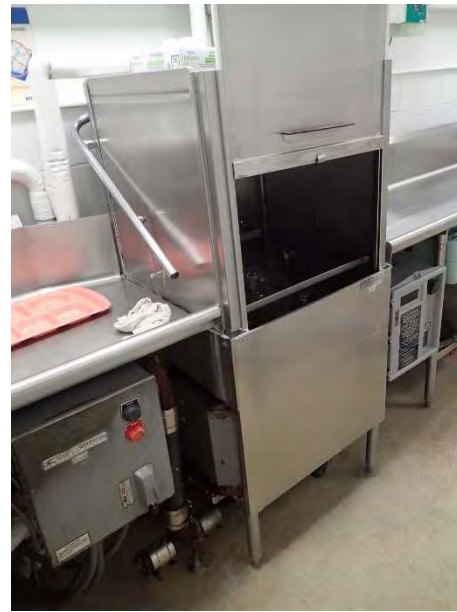
- Replace the wooden tray slides at the serving line with stainless steel
- Provide new Holding Cabinet as requested by food service staff.

- Replace the Kettle, Dishwasher, Holding Cabinet and Ice Machine: at end of life cycle.

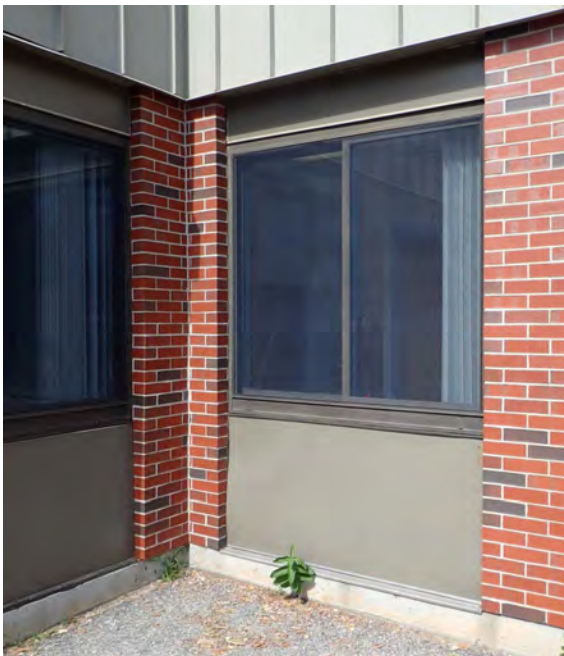
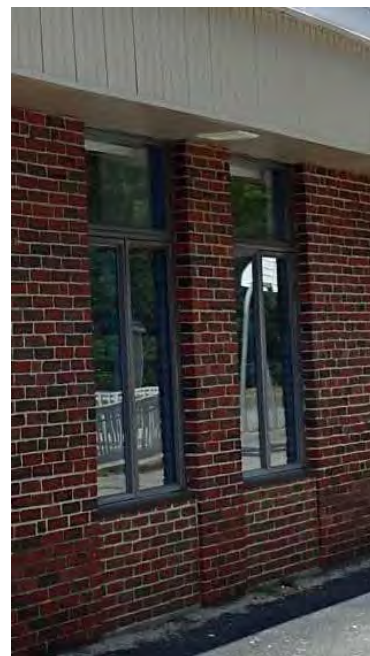
- Windows in Areas C and D are old, not energy efficient, and those in Area C do not provide the required opening size to comply with fire codes. Replace all with new heavy duty commercial aluminum windows. Replace insulated panels above and below windows in Area D.

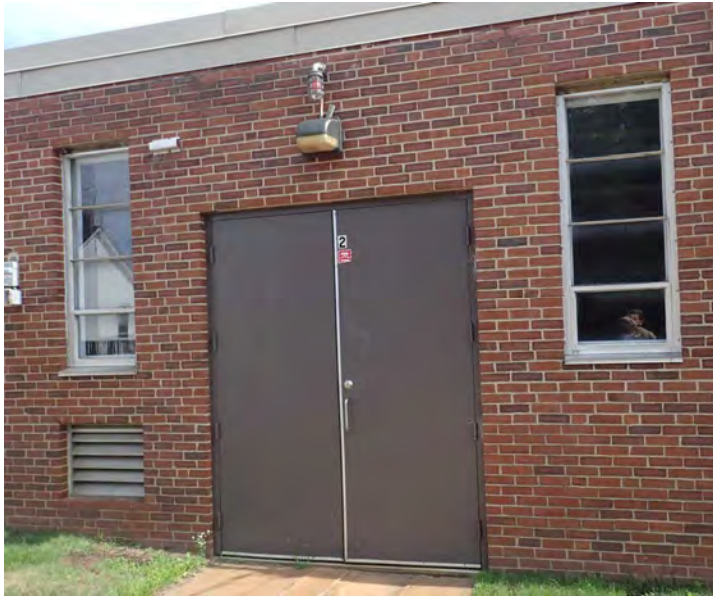
- Replace two original single-glazed windows in the Boiler Room with new heavy duty commercial aluminum windows.

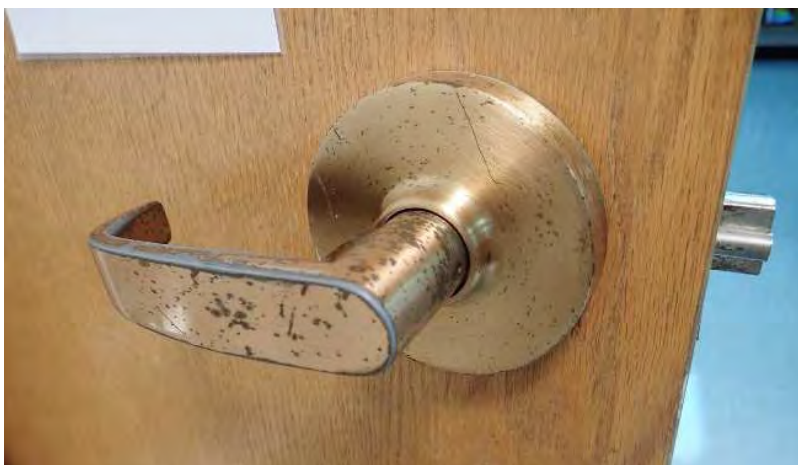
- Most of the school's door hardware dates to 1989. The majority of door levers are loose and do not work properly. Many hinges are loose and in need of constant maintenance to keep doors operating. Many classroom doors are in poor condition due to binding at the frame and from being propped open with wedges. Replace all classroom-to-corridor door hardware in areas B, C & D. New hardware to include mortise locksets, Roton hinges, and the classroom safety locking function, which is now standard in schools.

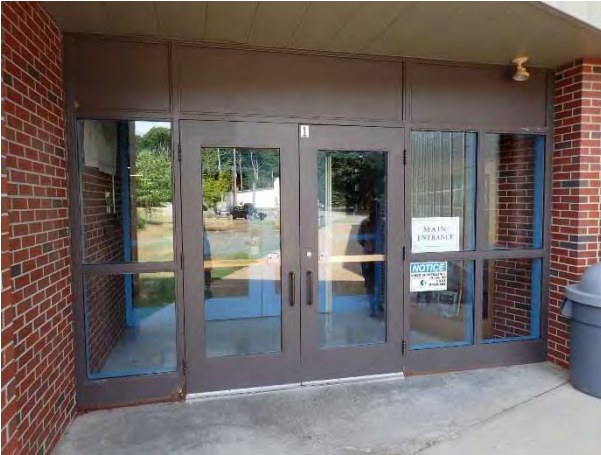
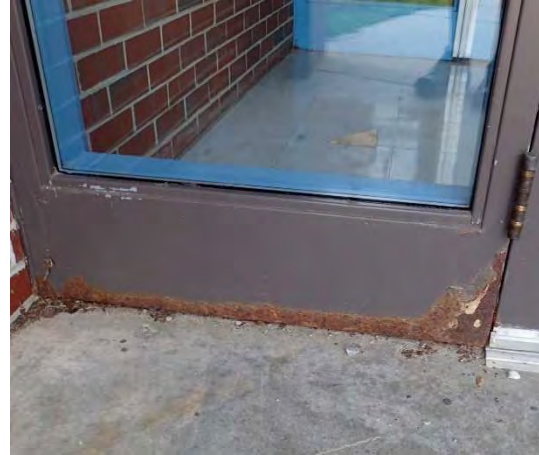
- The steel storefront at the main entry is rusting and showing significant wear. This should be replaced with new aluminum insulated doors and frames and insulated glass.

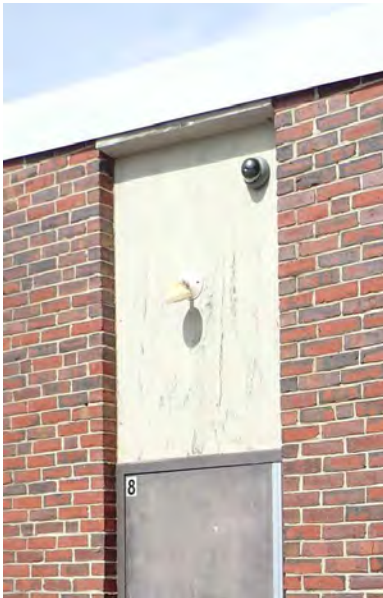
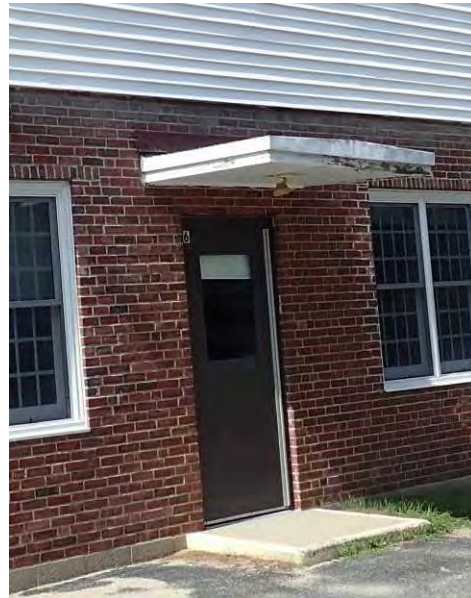
- Replace the plywood panel over the Area C exterior classroom door with a metal insulated panel.
- The Area A small canopy at the south end of the building is deteriorating. Replace all wood with PVC to eliminate maintenance.

- The canopy at Area A needs to have rust removed from the steel underside, and have all surfaces painted. Replace wood roof edge trim with PVC.

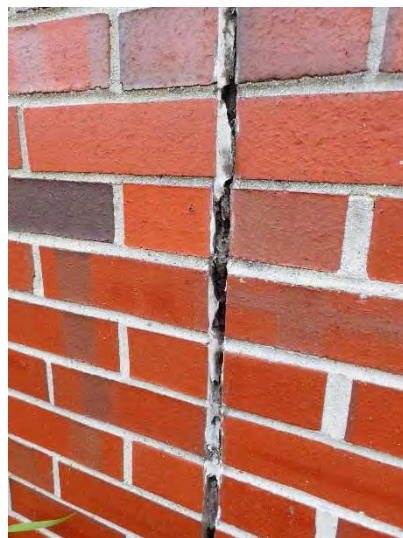
- Handicap accessibility should be provided to the Area A canopy by means of a new ramped sidewalk down to the driveway, approx. 30' long.
- All brick control joint caulking is cracked and pulling away from the brick. Replace.

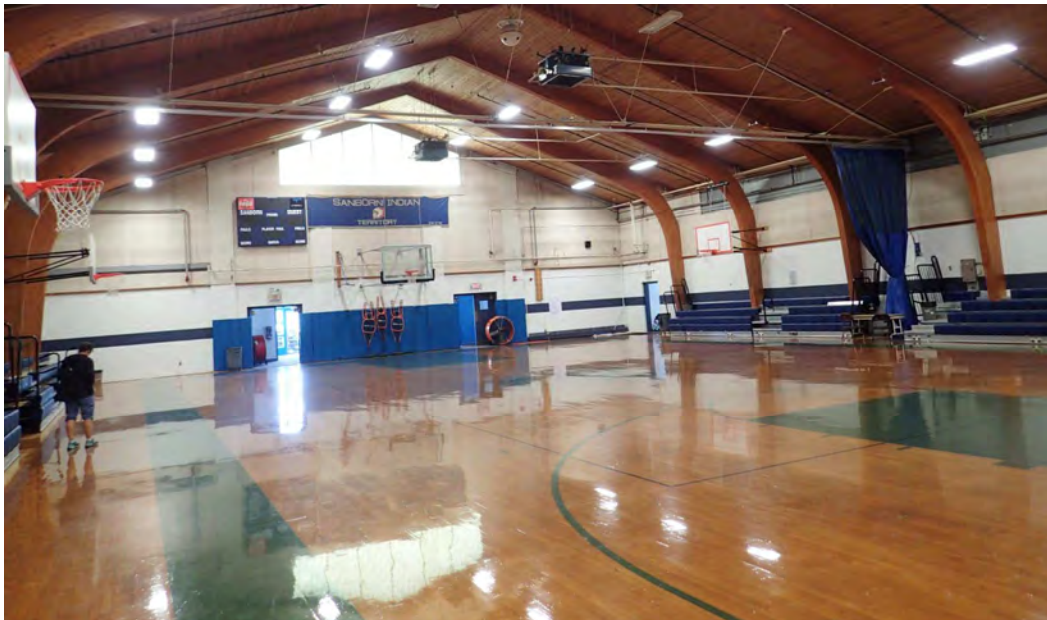
- The gym has a maple floor that is in need of refinishing. Sand down to bare wood and refinish with new court lines.

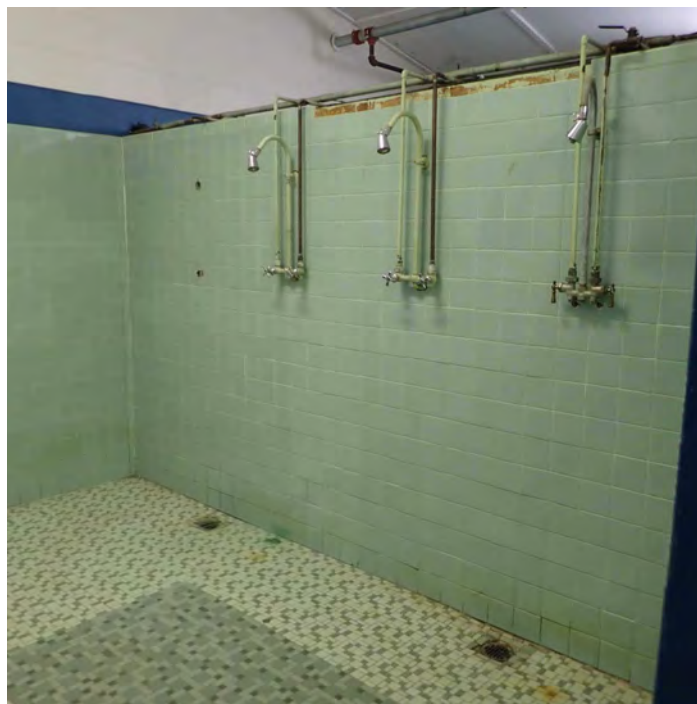
- Shower stalls are neither functional, nor ADA accessible. They have been cobbled together over the years, and are in poor condition. They should be demolished and rebuilt using ceramic tile-covered concrete block and HDPE partitions. Gang showers should be converted to stalls. Demo plumbing to showers and install new piping, drains & fixtures.

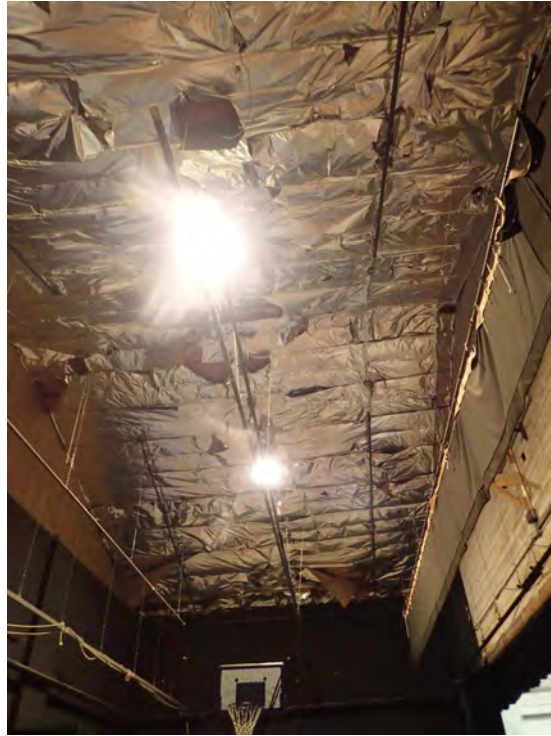
- Ceiling in the Stage consists of aluminum foil over fiberglass batt insulation. Extensive damage to this surface has taken place. Install a new angled suspended ceiling just below the roof structure.

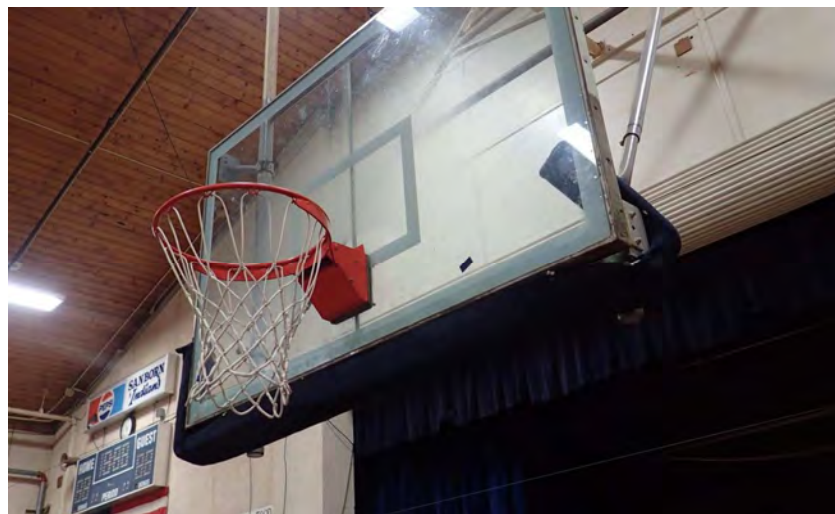
- Replace pads around backboards.

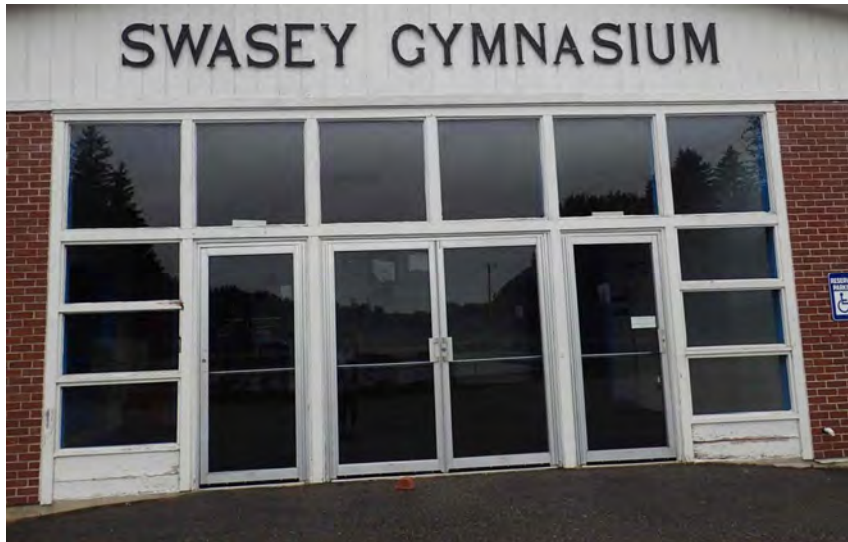
- The storefront at the main building entry is old and thermally inefficient. Replace with new high quality aluminum storefront and doors.

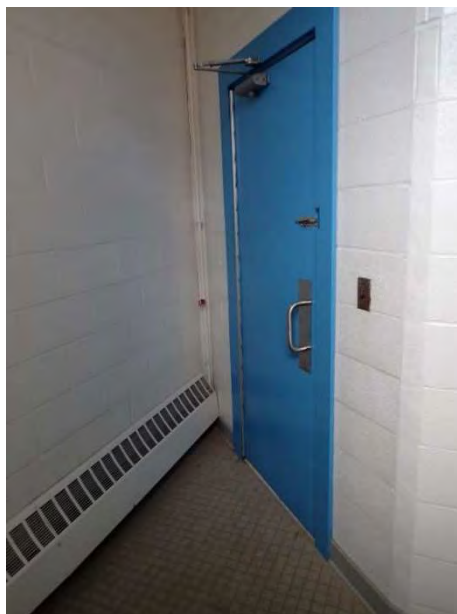
- There are currently no handicap accessible toilets for public use in the building (see photo of non-ADA compliant door below). Additionally, there is not sufficient capacity in the current toilet rooms for the number of people that could use the gym. To correct these two problems, the existing toilet rooms on either side of the lobby should be completely redone, and expanded into the adjacent concession stand and storage space. Concession would have to be eliminated or relocated (no obvious spot to do this). Provisions will also be made to make the front entrance ADA accessible.

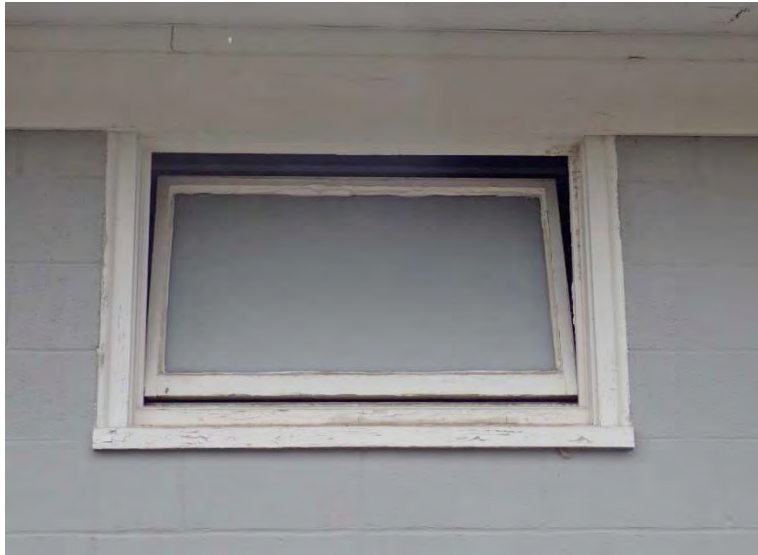
- All windows are in poor condition, deteriorating, and are poorly insulating. Replace all windows with heavy duty commercial windows.

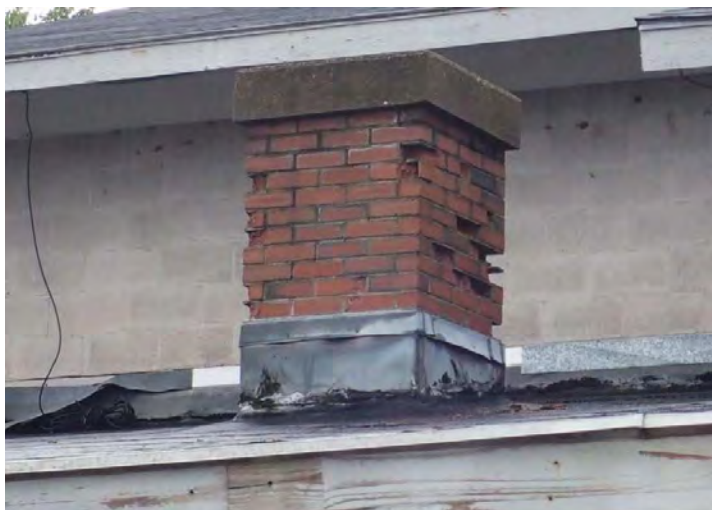
- The chimney brick is spalling badly, and should be rebuilt from the roof up, with a new precast concrete cap.

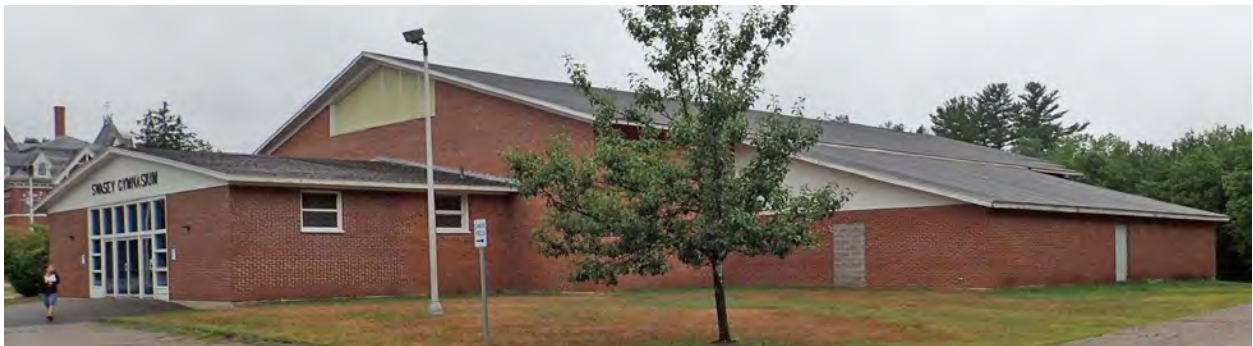
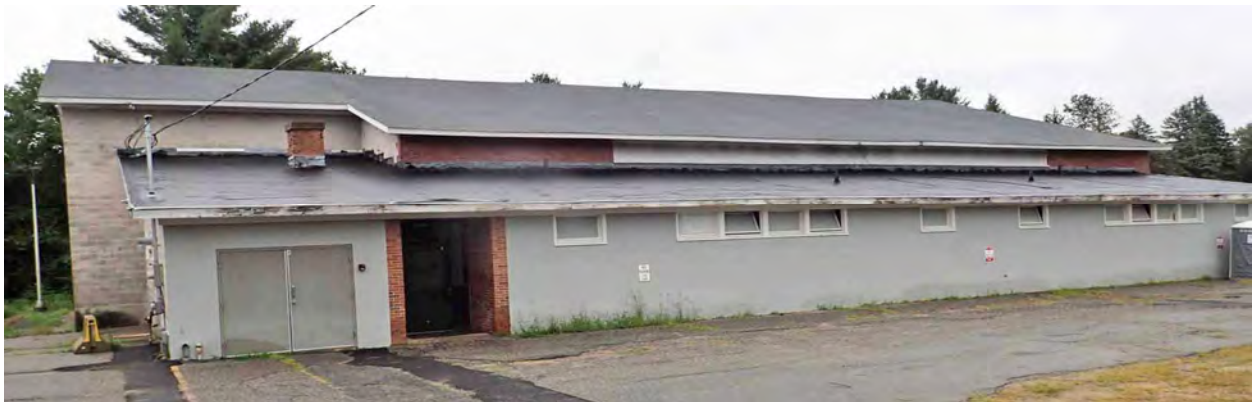
- The current asphalt shingle roof is in varying states of decay, and reportedly leaks in most areas. There is also no insulation in the current roofing system. Except for the portion over the front lobby, which is new, remove roofing down to deck, install 3” of new rigid insulation, new ice & water shield and new asphalt shingle roofing.
- The flashing from the low roofs into the higher gym walls is a mess. This should be removed and redone properly when the lower roofs are replaced.

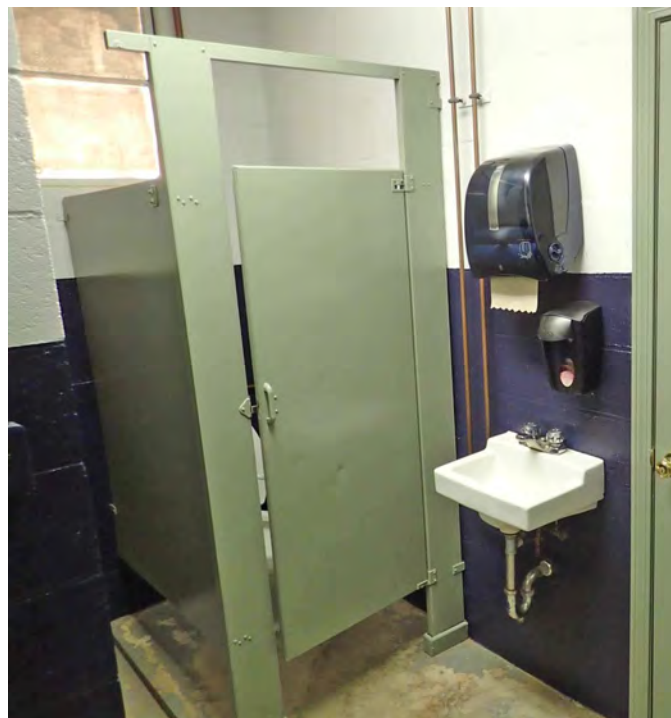
- Toilet partitions are in poor condition. Remove and replace with new HDPE partitions throughout.

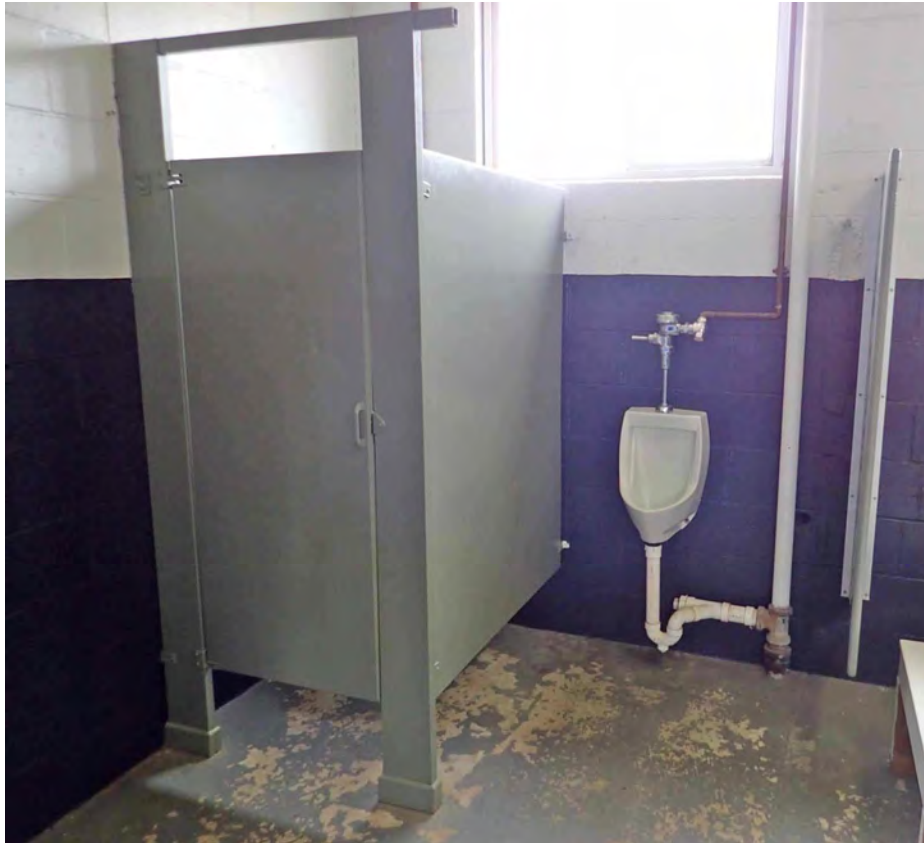
There are no ADA accessible toilets in the building. Reconfigure partitions in the locker rooms to provide one ADA accessible toilet in each, and reconfigure the single toilet in the hallway to provide public toilet access.

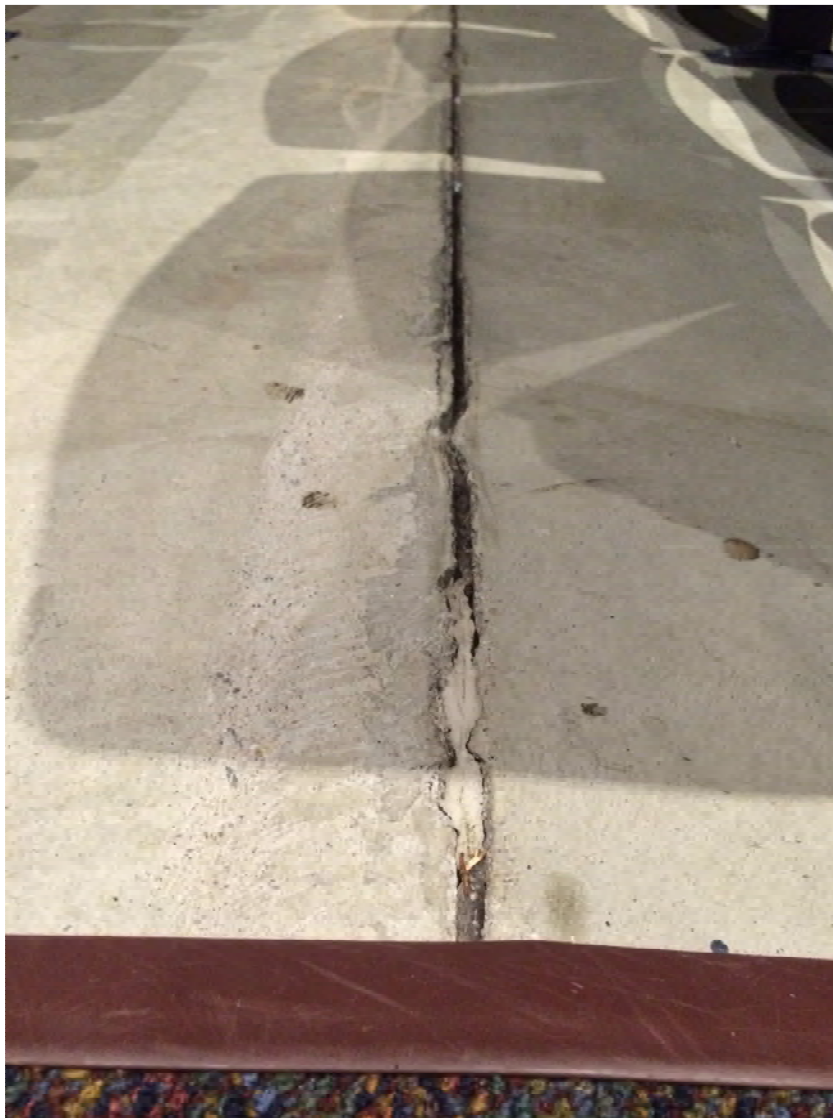
- There are two concrete construction / control joints that run through the floor of the auditorium. These joints have moved over time, and the caulking has pulled loose from the concrete. This should be redone.

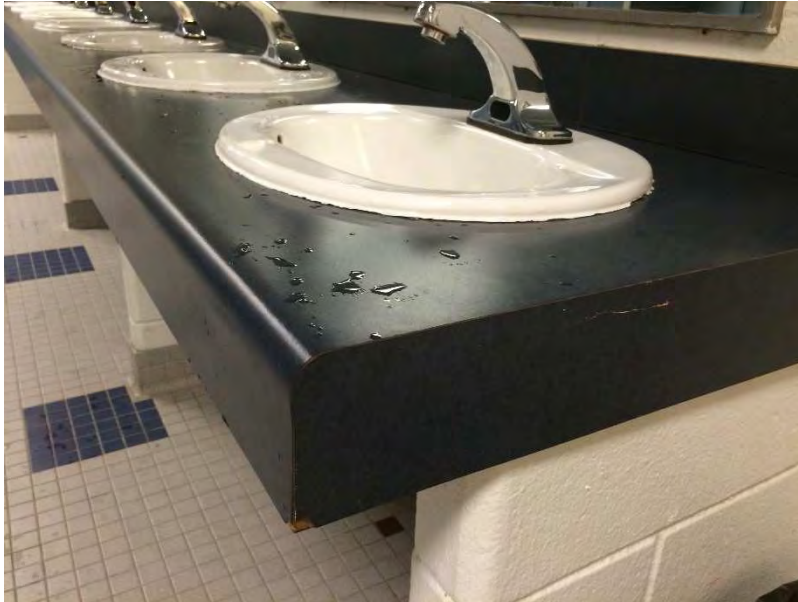
- The plastic laminate counters have chipped, and water has worked its way between the counter and the backsplash, and under the sinks. Because of movement, the caulking under the porcelain sinks has failed. We recommend replacing the counters and sinks with solid surface material. The existing faucets can be reused.

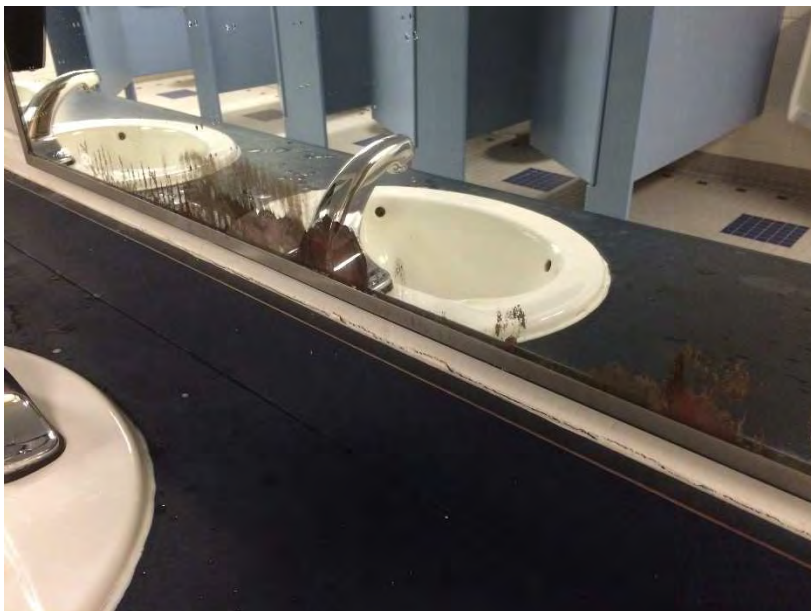
- The silvered surface on the backs of the large mirrors has failed. Replace mirrors.
